**NOT-IN-TRAFFIC SURVEILLANCE
CALSPAN REMOTE TRUNK ENTRAPMENT INVESTIGATION**

SCI CASE NO: CA07-020

**VEHICLE: 1996 AUDI A4
LOCATION: KENTUCKY
INCIDENT DATE: JUNE 2007**

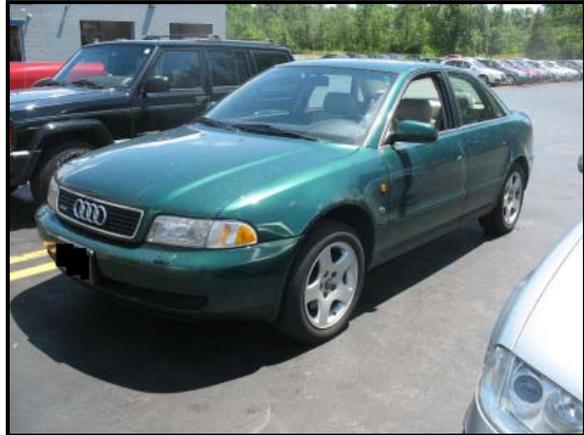
Figure 1: Exemplar Audi A4.

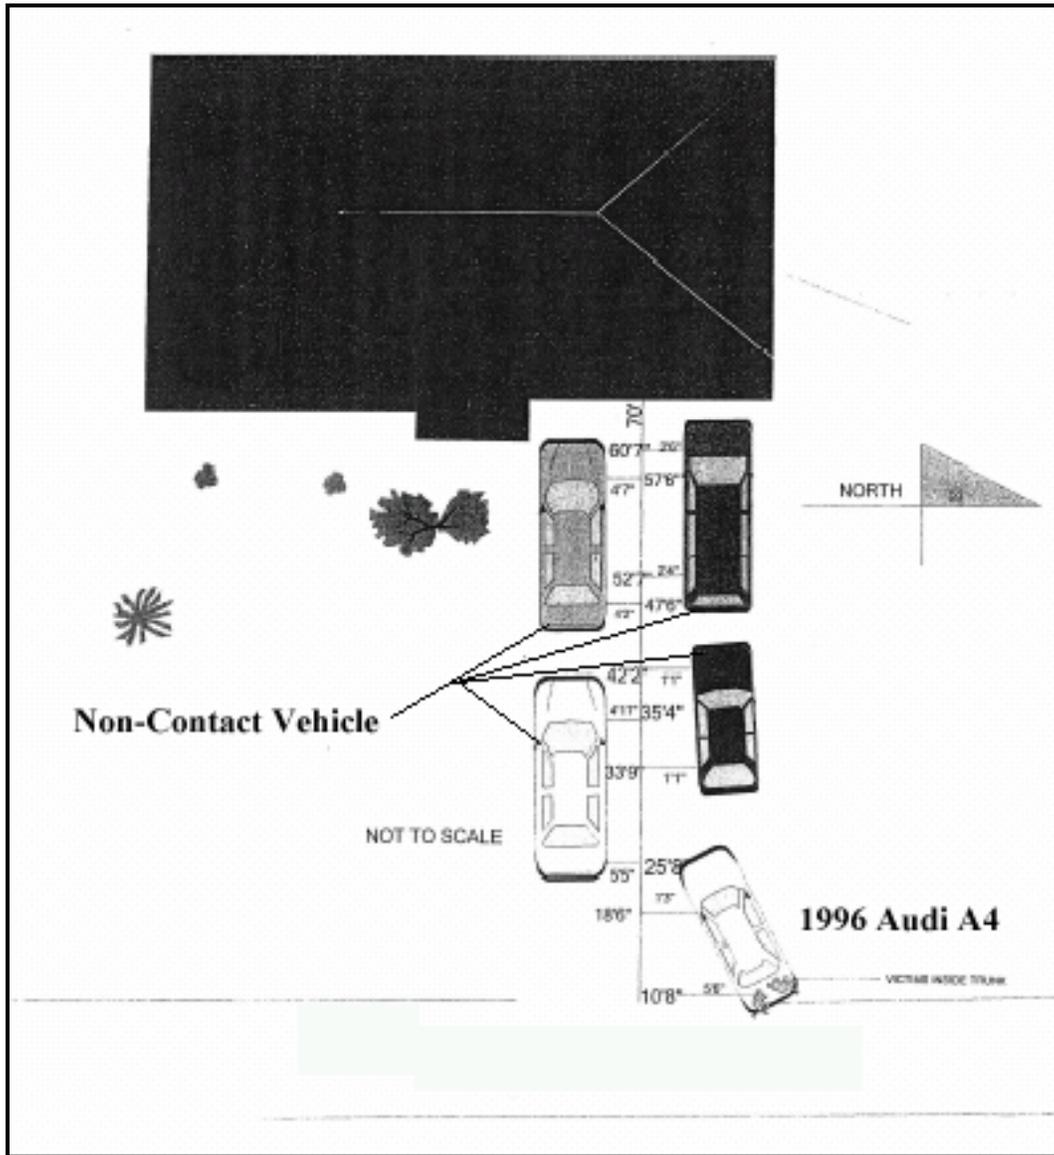
This incident occurred over a seven hour time period during the afternoon to evening hours in June 2007 in a rural setting. At the time the incident was initiated, the Audi was not locked and was parked outside the home of the children in full sun. The afternoon sky condition was reported as clear. The afternoon temperatures were in the 27 degree C (80 degree F) range and reached at maximum reported temperature of 28 degrees C (83 degrees F) at 1753 hours. The relative humidity range was 47 to 75 percent. At the time the children were discovered within the trunk of the Audi, the vehicle was parked in the driveway of the children’s grandfather after being used in the search effort by the mother. **Figure 2** is a Not-to-Scale police schematic that was included in the incident report.

Figure 2: Police schematic of the incident site.

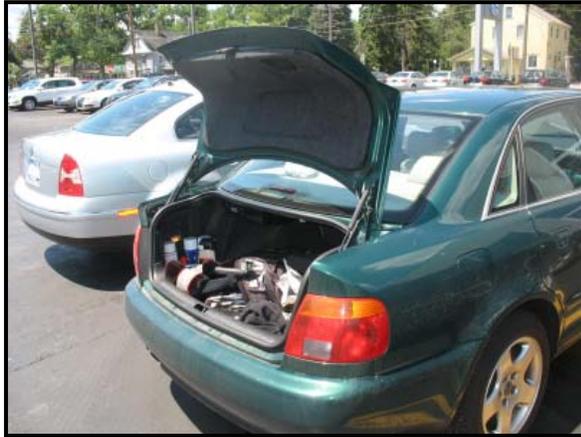
and inspected for this investigation. The specifications and equipment of the 1996 and 1997 model year A4's were reportedly identical. The trunk of the Audi was conventionally located in the aft aspect of the vehicle behind the rear seat. A rear deck lid hinged on gas filled struts enclosed the trunk space. The interior dimensions of the carpeted trunk measured approximately 107 cm x 102 cm x 51 cm (42 in x 40 in x 20 in), length x width x height. The trunk lock was not equipped with an internal release. **Figures 3 and 4** are rear views of an exemplar Audi and its trunk space.

Figure 3: Right rear oblique view.

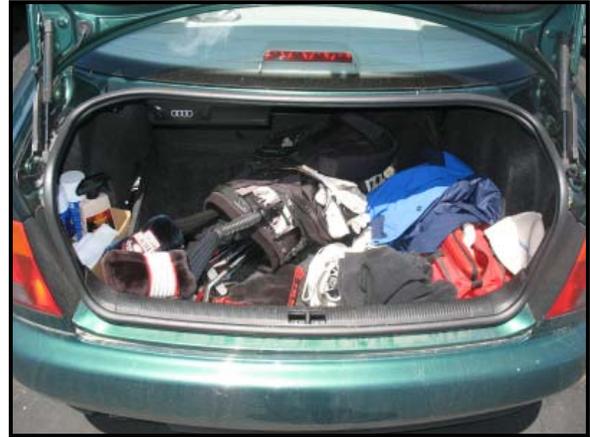
Figure 4: Trunk view.

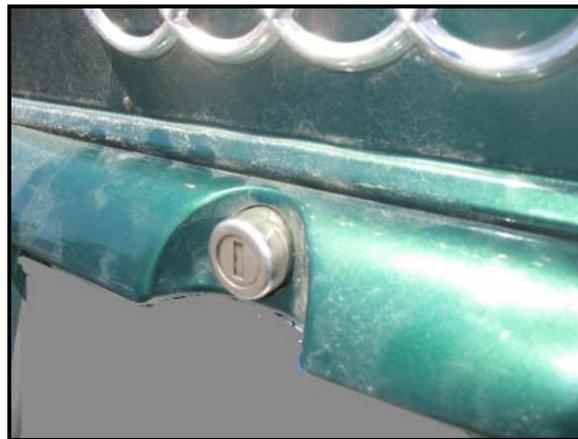
The 1996 Audi A4 was equipped with a “plunger-type” lock mechanism that did not require a key to open when it was in the unlocked position (vertical key slot). **Figure 5** is a close-up view of the lock mechanism. Pushing the unlocked plunger unlatched and opened the rear lid; closing and latching the rear lid reset the plunger for use. The vehicle’s key could be used to lock the plunger and render it inoperative. The children did not have the keys to the vehicle nor would have required them to open the unlocked trunk.

Figure 5: Close-up view of the plunger trunk lock mechanism.

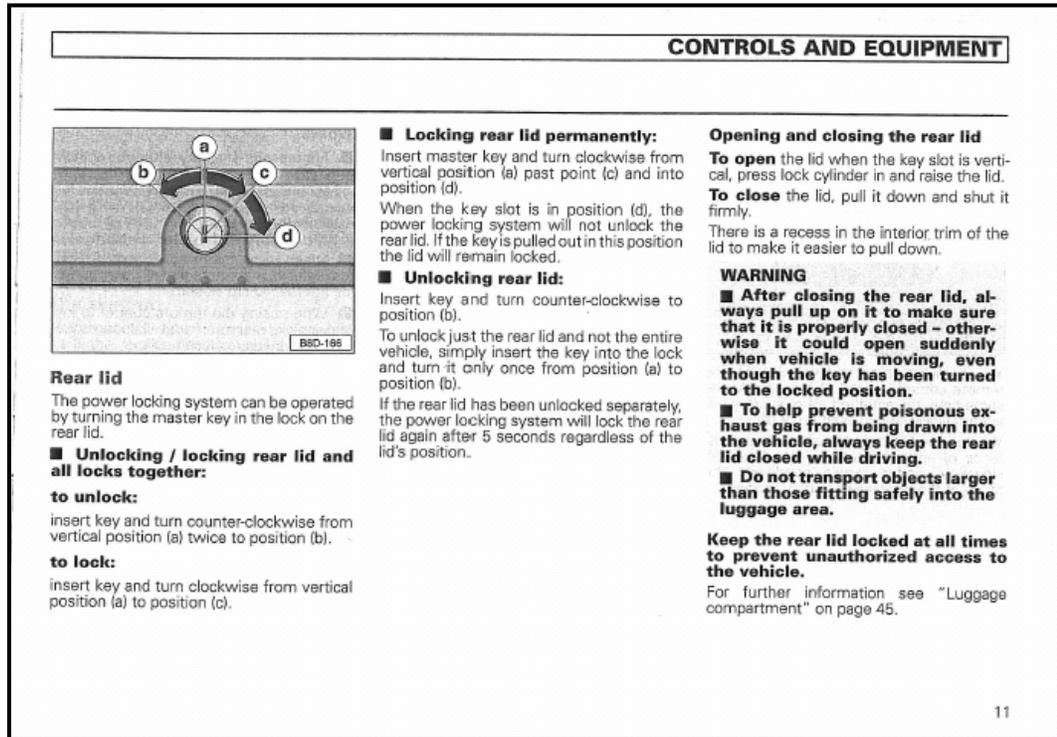
The operation of the Audi rear lid and lock were described on Page 11 of the vehicle's owner's manual. **Figure 6** is an image of that description that from the owner's manual of the exemplar vehicle.

Figure 6: Description of the rear lid and trunk lock operation from the Audi A4 Owner's
