CALSPAN ON-SITE BACK OVER FATALITY INVESTIGATION

SCI CASE NO.: CA07-023

VEHICLE: 1998 TOYOTA CAMRY

CRASH DATE: JUNE 2007

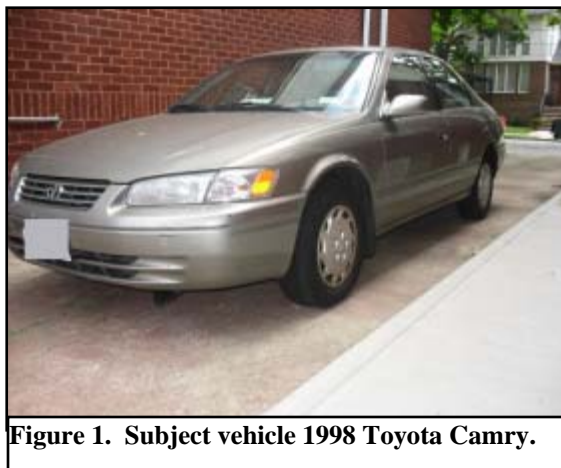
This on-site back over investigation focused on the pre-event dynamics and the rear visibility issues that resulted in the death of a 17-month old male toddler who was struck and subsequently run over by the left rear tire of a 1998 Toyota Camry (**Figure 1**). The back over event occurred on a private driveway of the driver's residence. There were no visual obstructions along the driver's sight line toward the approaching non-motorist. The 83-year old female driver was the neighbor of the struck toddler.

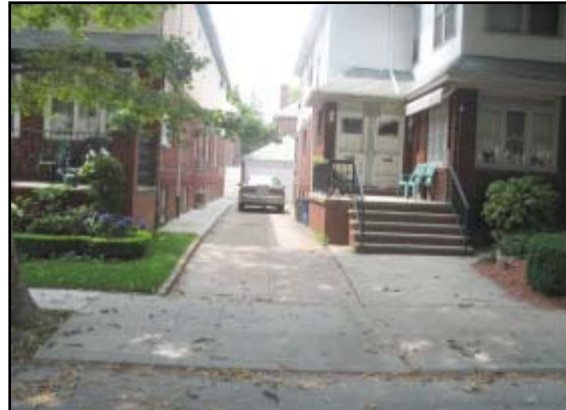
This incident occurred during the daylight hours of June 2007. The weather was reported as clear with a high temperature of 30 degrees C (86 degrees F). This incident occurred on a one-lane east/west private residential driveway. **Figure 2** is an overall view of the driveway looking westward. The position of the parked vehicle in **Figure 2** was not related to the pre-event location of the Toyota. The driveway measured 29.6 meters (97 feet) in length and 2.7 meters (8.9 feet) in width. The driveway contained a negative two percent grade which leveled at the sidewalk. The mouth of the driveway sloped to a negative four percent grade at its intersection with the road. A north/south concrete sidewalk traversed the driveway. The width of the sidewalk measured 2.4 meters (7.9 feet).

Figure 2. Overall view of the driveway from the roadway.

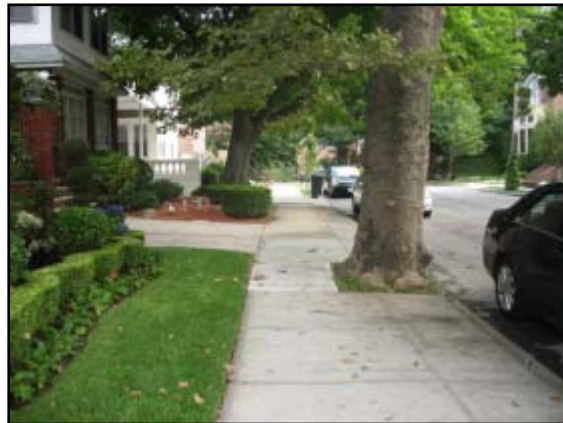
The child approached the vehicle from its left side (south) (**Figure 3**); therefore, the adjacent residence was also documented for visibility purposes. The residence was located 5.3 meters (17.3 feet) west of the curb line. This area consisted of a 2.4 meter (7.8 feet) wide sidewalk, 86 cm (34") diameter tree, and a 1.1 meter (3.6 feet) wide grass area. Located beyond the grass was a shrub landscaped area. The shrub area began 3.5 meters (11.5 feet) west of the curb and ranged in height from approximately 46 cm (18") to 178 cm (70"). The landscaped area terminated 5.3 meters

Figure 3. Child's northbound approach to the driveway.

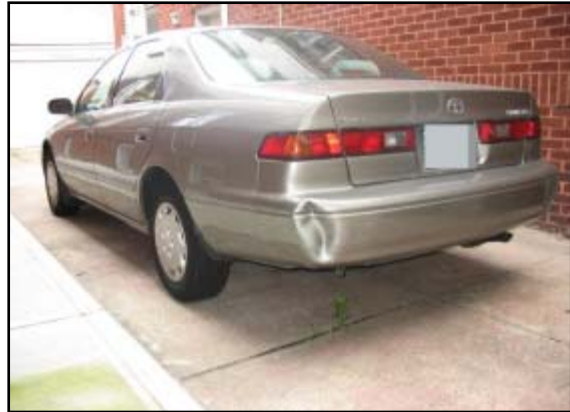
The subject vehicle in this incident was a 1998 Toyota Camry, 4-door sedan (**Figure 4**). The mileage at the time of the incident was unknown. The vehicle was identified by Vehicle Identification Number (VIN): JT2BG22K8W0 (production number deleted). The Toyota was equipped with a 2.2 liter, four cylinder engine linked to a four-speed automatic transmission with a console mounted transmission selector lever and front-wheel drive. The service brakes were front-wheel disc and rear drum with anti-lock.

Figure 4. 1998 Toyota Camry. Note damage to the rear left bumper corner occurred while the vehicle was at an impound area.

The exterior of the vehicle was finished in a gray color with matching bumper fascias. The window glazing was AS1 for the windshield and AS2 for the side and backlight glass with OEM solar tint. At the time of the SCI inspection, the glazing was clear. No aftermarket tint film was present on the glazing. A handicap parking placard was centered at the base of the windshield. The state inspection and registration stickers were affixed to the lower left corner of the windshield. There were no obstructions of the side or rear glazing and no aftermarket modifications to the exterior or interior of the Toyota. The rear left bumper corner contained deformation (**Figure 4**) which occurred while the vehicle was stored at the police impound area.

At the time of the SCI inspection, there was no residual contact evidence to either the bumper or undercarriage of the Toyota. Deformation was noted to the rear left bumper corner of the Toyota that was not related to this incident. A neighbor that was familiar with the vehicle stated to the SCI investigator, that the damage occurred while it was secured at the police impound area.

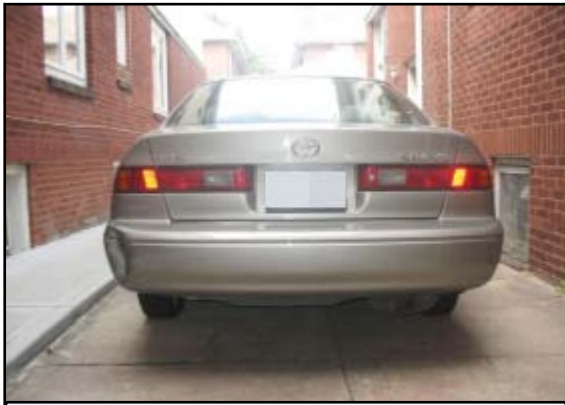
The ground clearance of the major rear components of the vehicle (**Figures 5 and 6**) were documented and are listed in the following table:

Component	Vertical Measurement
Bottom of rear bumper fascia	37 cm (14.75”)
Top of rear bumper fascia	60 cm (23.5”)
Top of trunk deck	98 cm (38.5”)
Height of backlight glass	105 cm (41.25”)
Beltline glass at midpoint of left front door	92 cm (36.25”)
Bottom of exhaust tailpipe	25 cm (9.75”)
Lowest point of muffler	20 cm (7.75”)

Figure 5. Rear bumper of the Toyota.

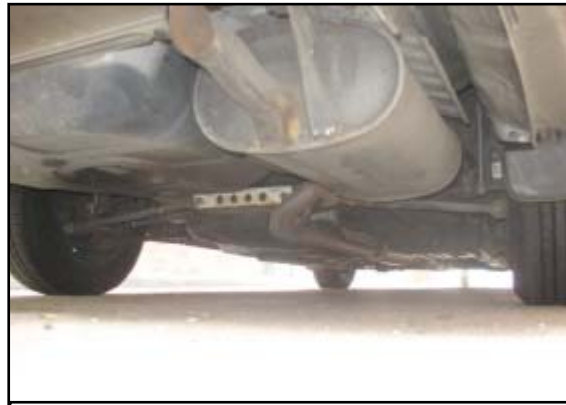
Component	Vertical Measurement
Lowest point of right rear control arm	18 cm (7.25")
Highest point of left control arm	23 (9.25")
Height of control arm bracket	23 cm (9.25")
Lowest point of trunk	24 cm (9.5")
Lowest point of exhaust pipe	14 cm (5.5")

Figure 6. Undercarriage components

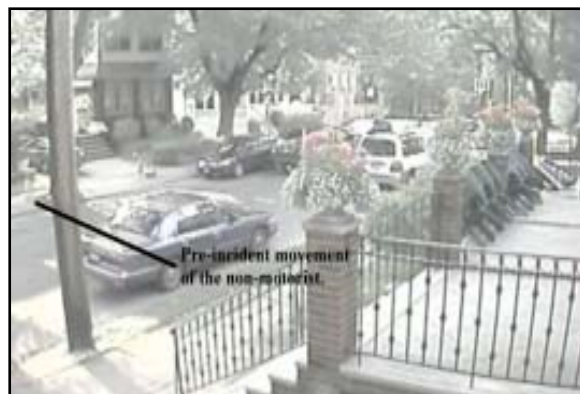
Figure 7. Surveillance video pre-incident location of the Toyota and approaching non-motorist.

bumper approximately 3 meters (10 feet) from the road edge. **Figure 7** is a view of the pre-incident location of the Toyota and the approaching non-motorist. In this position, the left front door was located near the patio. The vehicle was occupied by the 83-year-old female driver. At the time of the incident, the 17-month-old male was playing on the sidewalk with another child south of the driveway. The 83-year-old female entered the vehicle to initiate an eastward backing maneuver to exit the driveway of her residence. It was not clear if the driver turned her head or used the rear view mirrors to assist in the backing maneuver. Prior to this maneuver, the non-subject child approached the driveway from the left side of the vehicle crossed the path of the Toyota and stopped on the north side of the driveway. The 17-month-old male was walking a short distance behind the female child. The scene schematic is included in this report as **Figure 9**.

The final rest position of the child was obscured by a parked vehicle (**Figure 7**) and was not determined. The toddler was removed from the roadway by his mother and placed on the sidewalk behind an 86 cm (34") diameter tree. Police and emergency medical personnel responded to the incident site and began resuscitative efforts and continued these efforts during transport to a local hospital. The toddler was pronounced deceased a short time after arrival at the hospital. A neighbor who observed the child post-incident stated to the SCI investigator that he saw the child in the roadway and he appeared to be convulsing. He further observed that the child did not appear to have external injuries; however, he did note body fluid exiting his right ear. At the request of the family no autopsy was performed; therefore, the specific injuries and cause of death are unknown. The Toyota was towed from the incident site to a police impound area pending the police investigation.
