Remote Not In Traffic Surveillance Hyperthermia Investigation
Dynamic Science, Inc. / Case Number: DS07033
2004 Honda Civic
California
May 2007

**Dynamic Science, Inc.
Crash Investigation
Case Number: DS07033**

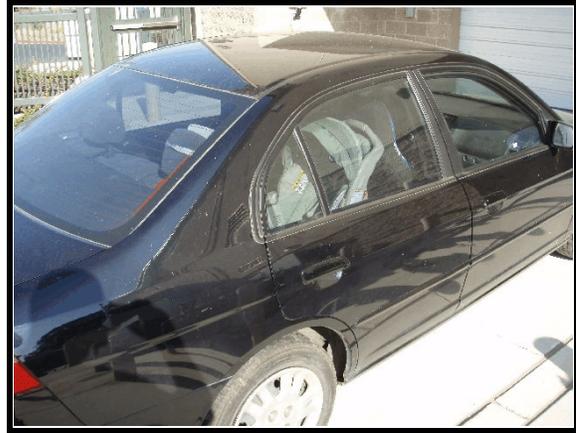
Figure 1. Subject vehicle, 2004 Honda Civic

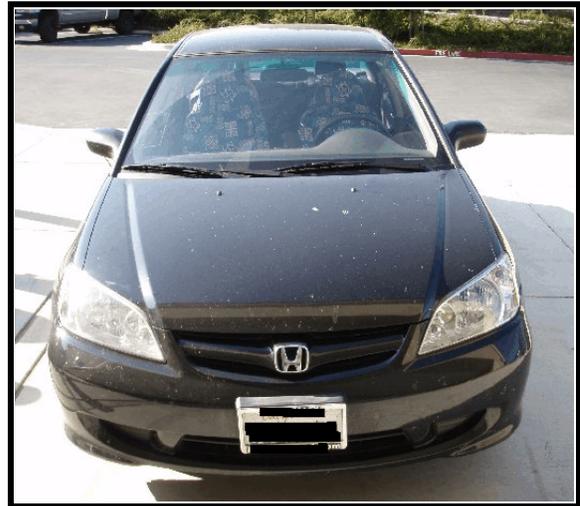
Figure 2. Front, 2004 Honda Civic.

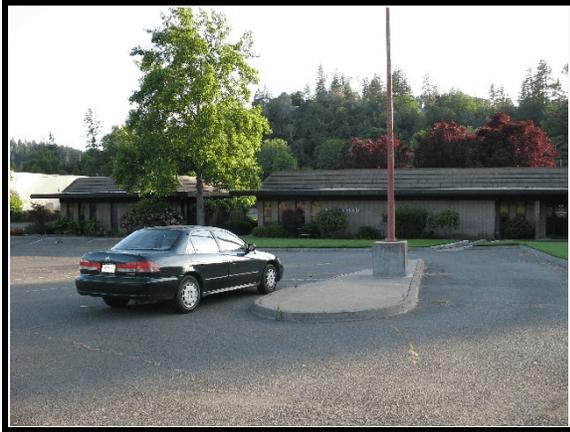
The incident occurred in an asphalt parking lot on a college campus in California. The driver's place of work was located on the west side of the parking lot. Traffic enters the parking lot from the south. Parking is set up as a diagonal relative to the buildings. The 2004 Honda Civic was parked near the north end of the parking lot and was facing west (**Figures 3-4**). Due to the configuration of the parking lot and the location of the vehicle relative to adjacent trees or buildings, no shade from the daytime sun would have been available to the vehicle.

Figure 3. Incident site (vehicle in photo is not the subject vehicle).

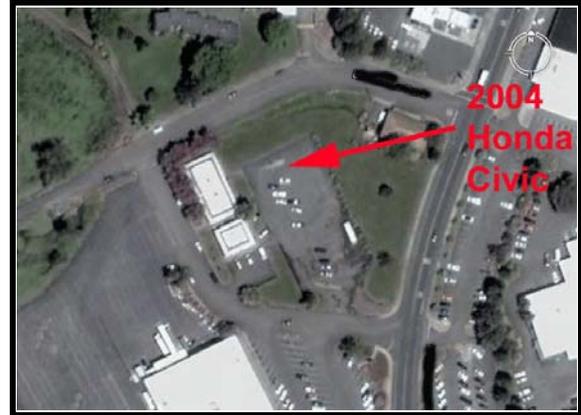
Figure 4. Overhead view of the incident site.

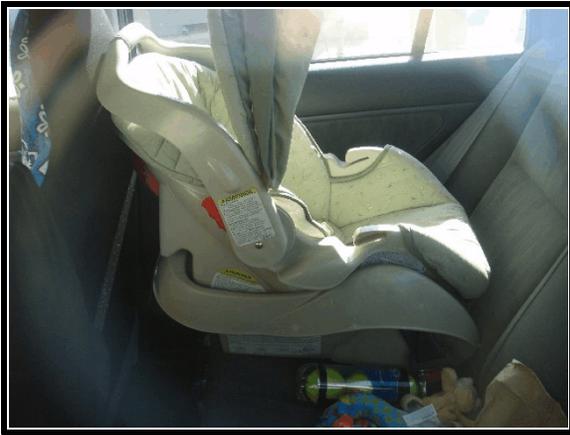
On the morning of the incident, the 27-year-old female driver placed the child in a Graco child safety seat that was anchored in the second row right seat of the Honda Civic (**Figure 5**). The child seat was rear facing. A mirror was placed on the right rear seat back that would allow the driver to see the child's face (**Figure 6**). The driver had placed the child in the seat at approximately 0800 hours.

Figure 5. Graco rear-facing child seat in right rear seat position.

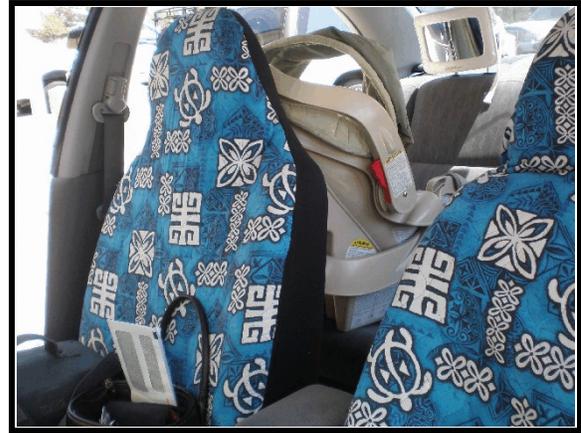
Figure 6. Rear facing child seat with mirror visible.
