Remote Not In Traffic Surveillance Trunk Entrapment Investigation  
Dynamic Science, Inc. (DSI), Case Number (DS07039)  
1999 Oldsmobile Intrigue  
South Dakota  
July 2007

1. Report No. DS07039	2. Government Accession No.		3. Recipient Catalog No.	
4. Title and Subtitle Remote Not In Traffic Surveillance Trunk Entrapment Investigation			5. Report Date April 1, 2008

**Dynamic Science, Inc.**  
**Crash Investigation**  
**Case Number: DS07039**

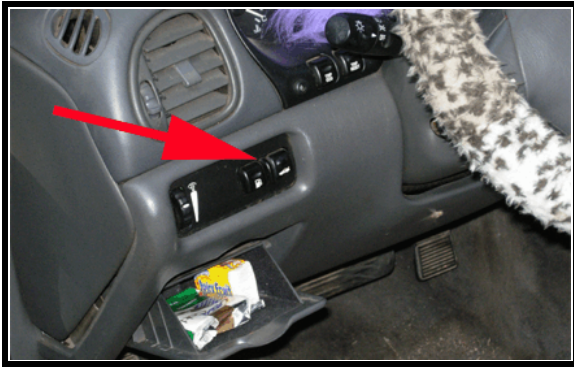
**Figure 2.** Trunk release button

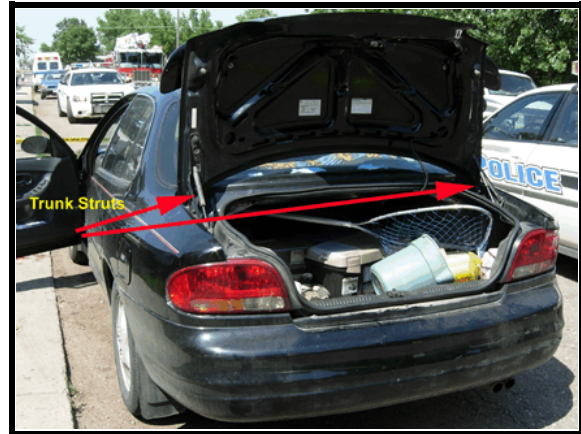
**Figure 3.** Trunk struts

bumping the vehicle would cause the lid to return to the fully opened position. He also found that if the lid was positioned below that level, shaking or bumping the vehicle would cause the trunk struts to compress downward. When the struts reached a point of 3.8 cm (1.5 in) on the rods, the struts would no longer hold the weight of the trunk lid and the lid would drop and close. The trunk lid would not close violently, but would drop with sufficient speed that it would latch every time. The vehicle was not equipped with an internal trunk release<sup>1</sup>. The family had been fishing the day before and there was fishing gear still in the trunk. The gear included a tackle box, a container of oil, two fishing reels, an oil jug, a bag of wood, two buckets, and a fishing net (see Figure 4).

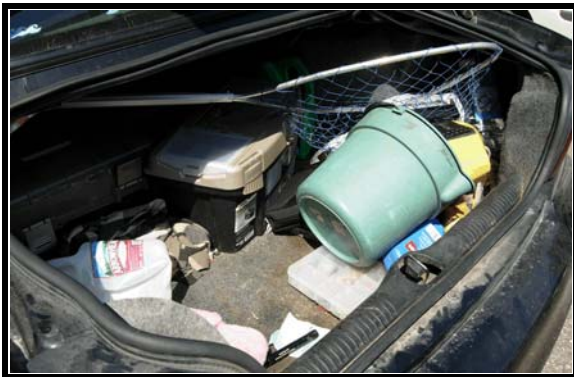
**Figure 4.** Trunk contents

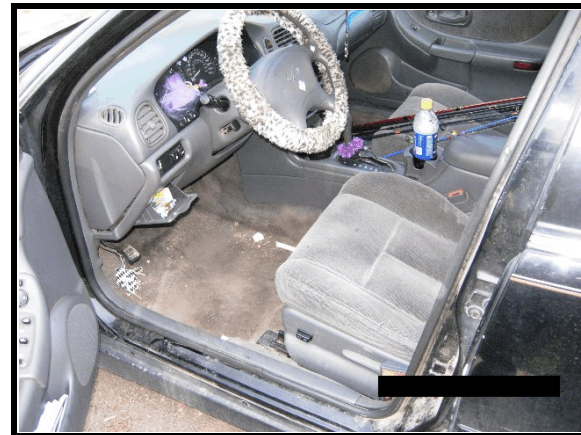
**Figure 5.** Interior view of subject vehicle

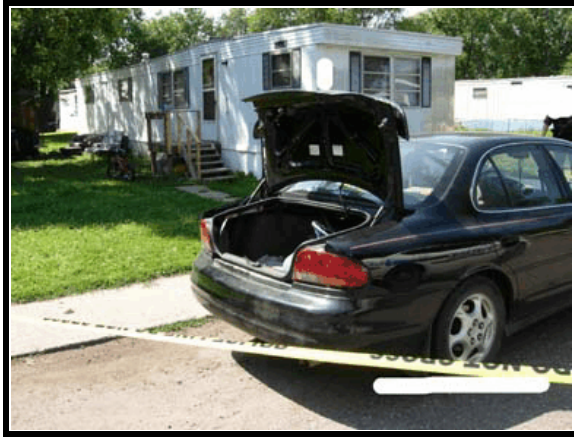
**Figure 6.** Location of vehicle relative to residence

The involved child was 5-years-old. He was wearing long blue jeans and a red tee shirt. The case vehicle was a black 1999 Oldsmobile Intrigue four-door sedan that belongs to the child's mother. The vehicle was parked in front of the driver's home facing north (see Figure 6-7).

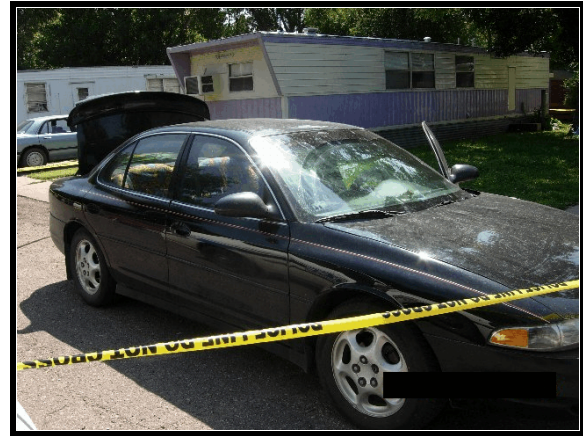
**Figure 7.** Right front oblique view of Buick at the incident site
