Not In Traffic Surveillance Back Over Investigation / Vehicle v. Two Non-Motorists  
Dynamic Science, Inc. / Case Number: DS07045  
1996 Dodge Ram Pickup  
Colorado  
August 2007

1. Report No. DS07045		2. Government Accession No.		3. Recipient Catalog No.	
4. Title and Subtitle Not In Traffic Surveillance Back Over Investigation				5. Report Date May 6, 2008

14. Sponsoring Agency Code	
15. Supplemental Notes					
16. Abstract This single vehicle incident occurred in August 2007 at 1550 hours. The subject vehicle was a 1996 Dodge Ram pickup. The incident took place on an east/west two-lane residential roadway. The weather was clear and calm at the time of the incident. The Dodge Ram was being driven by a 15-year-old male. There was one additional occupant in the vehicle. The front right seat was occupied by a 15-year-old male. There were two female children, ages 8 and 9, who were playing in the westbound lane of the residential roadway. The 8-year-old child was on a Razor-type scooter and the 9-year-old was on a bicycle. The two children were cousins. Based on witness accounts, the driver of the Dodge Ram was showing off by spinning the vehicle tires in front of several girls in

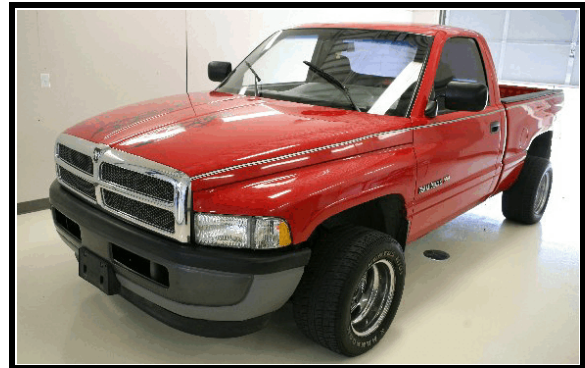
**Figure 1.** 1996 Dodge Ram pickup (police photo).

This single vehicle incident occurred in August 2007 at 1550 hours. The case vehicle was a 1996 Dodge Ram pickup (**Figure 1**). The incident took place on an east/west two-lane residential roadway. The weather was clear and calm at the time of the incident. The Dodge Ram was being driven by a 15-year-old male. There was one additional occupant in the vehicle. The front right seat was occupied by a 15-year-old male. There were two female children, ages 8 and 9, who were playing in the westbound lane of the residential roadway. The 8-year-old child was on a Razor-type scooter and the 9-year-old was on a bicycle. The two children were cousins. Based on witness accounts, the driver of the Dodge Ram was showing off by spinning the vehicle tires in front of several girls in the area. At some point, the driver began driving backward in the westbound lane at what police termed “a high rate of speed”. The Dodge Ram struck both children with its rear end. The 9-year-old child was run over. The 8-year-old was struck and pushed to the side. After backing over the children, the driver of the Dodge Ram began backing in a southern direction in order to turn around. The driver did turn the Dodge Ram around and fled from the scene by driving to the east. The 9-year-old child was fatally injured. She sustained blunt force injuries to the head, neck, thorax, and abdomen. The 8-year-old child sustained serious injuries. It has been reported that she sustained a liver laceration, in addition to multiple contusions and abrasions. She was transported to a local trauma center where she was hospitalized. A witness was able to get the license number of the Dodge Ram. The driver was located at his home later that day. The driver was arrested and the Dodge Ram was placed into police custody. He later pleaded guilty to vehicular homicide, vehicular assault, and hit-and-run involving death and was sentenced to prison.

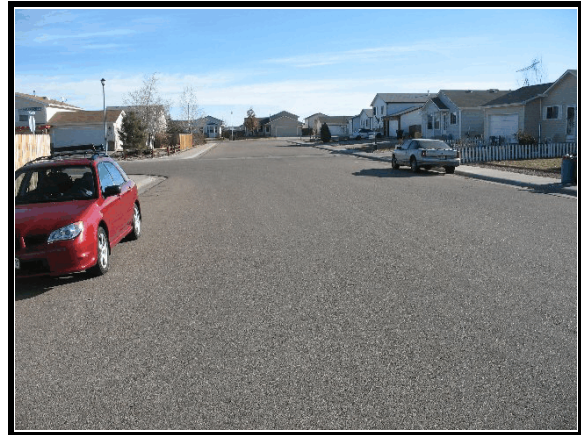
**Figure 2.** Path of Dodge Ram, backing east

Based on witness accounts, the driver of the Dodge Ram was showing off by spinning the vehicle tires in front of several girls in the area. At some point, the driver began driving backward in the westbound lane at what police termed "a high rate of speed" (**Figure 2**). The children would have been visible to the driver when he initially began backing. He began backing at a point west of the intersecting roadway, approximately 27 m (88.6 ft) from the area of impact.

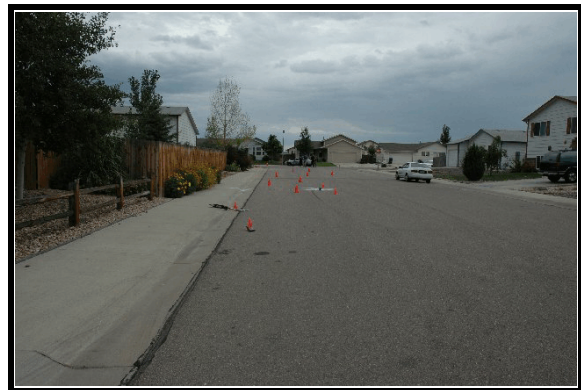
**Figure 3.** Area of impact

Just prior to the incident, the children began crossing the roadway going from north to south. The Dodge Ram struck both children with its rear end (**Figure 3**). The 8-year-old (Non-motorist 1) was struck and pushed to the side. She came to rest 66 m (215ft) west of the north/south intersecting roadway. The 9-year-old child (Non-motorist 2) was run over and trapped beneath the vehicle. She remained trapped under the vehicle as it continued backing. At some point during the backing, the right rear tire rolled over her head and torso. She came to rest 56 m (184 ft) west of the north/south intersecting roadway (**Figure 4**). The scooter came to rest near the area of impact (**Figure 5**).

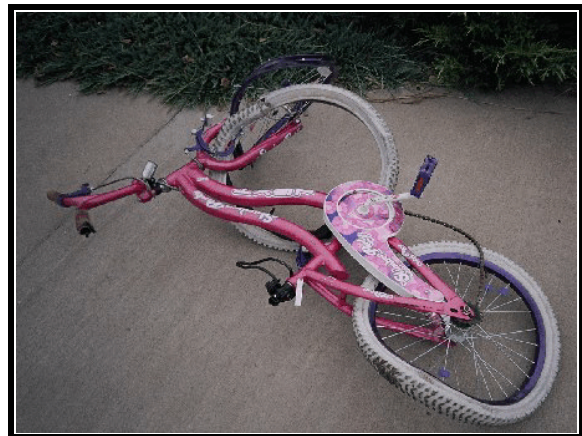
**Figure 6.** Damaged bicycle

After backing over the children, the driver of the Dodge Ram began backing in a southern direction in order to turn around. The driver did turn the Dodge Ram around and fled from the scene by driving to the east. The bicycle remained trapped under the Dodge Ram until the vehicle reached the north/south roadway and began traveling north (**Figure 6**).

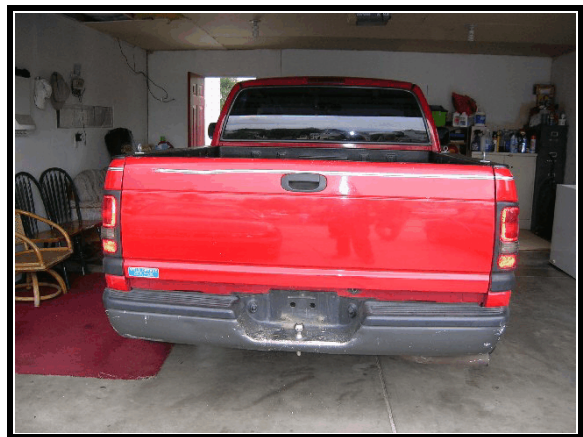
**Figure 7.** Police photo showing 1996 Dodge Ram pickup at driver's residence

A witness was able to get the license number of the Dodge Ram. The driver and the Dodge were located at the driver's residence later that day (**Figure 7**). The vehicle plates had been removed from the vehicle and the vehicle parked in the garage. The driver was arrested and the Dodge Ram was placed into police custody. In March 2008, the driver pled guilty to vehicular homicide,

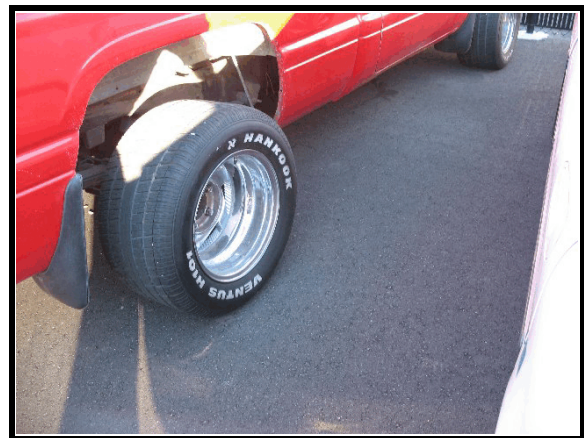
**Figure 8.** Right rear tire

The 1996 Dodge Ram pickup was identified by the Vehicle Identification Number (VIN): 1B7HC16Y4TSxxxxxx. The vehicle belonged to the father of the driver. There were 139,032 kilometers (86,393 miles) on the odometer at the time of inspection. The Dodge Ram regular cab pickup was equipped with a 5.2 liter, eight cylinder engine, automatic transmission, rear-wheel drive, and disc/rear drum brakes with ABS. The Dodge Ram was configured with after-market tires and rims. The Ram was using Hankook Ventus P295/50R15 tires with a tire diameter of 60.4 cm (23.8 in). The tires extended 11.0 cm (4.3 in) laterally from the wheel well (**Figure 8**). The measured track width was 191.0 cm (75.1 in). The vehicle manufacturer's recommended cold tire pressure was 283 kPa (41 psi). The tire manufacturer's maximum tire pressure was 303 kPa (44 psi). The standard tire size for this vehicle is P225/75R16 with a tire diameter of 74.4 cm (29.3 in). The specific tire information is as follows:

Position	Measured Pressure	Measured Tread Depth	Restricted	Damage
LF	228 kPa (33 psi)	6 mm (7/32 in)	No	None
LR	Flat	5 mm (6/32 in)	No	None
RR	214 kPa (31 psi)	4 mm (5/32 in)	No	None
RF	193 kPa (28 psi)	6 mm (7/32 in)	No	None

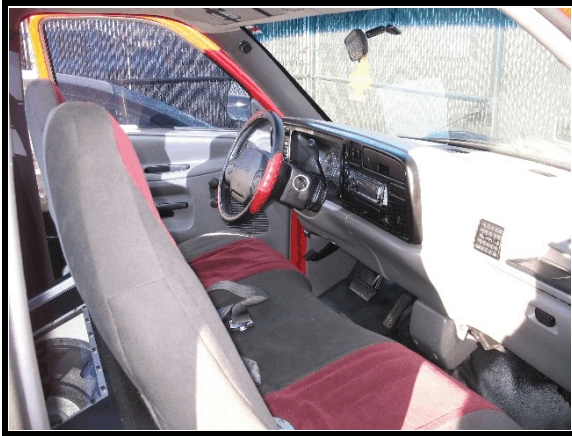
**Figure 9.** Driver's seated position

The seating in the Dodge Ram was configured with a cloth cover front bench seat with seating for three. The seat had been adjusted to the forward most track position in order to accommodate an after-market stereo/amplifier system (**Figures 9-10**). The outboard seat positions were configured with integral head restraints.

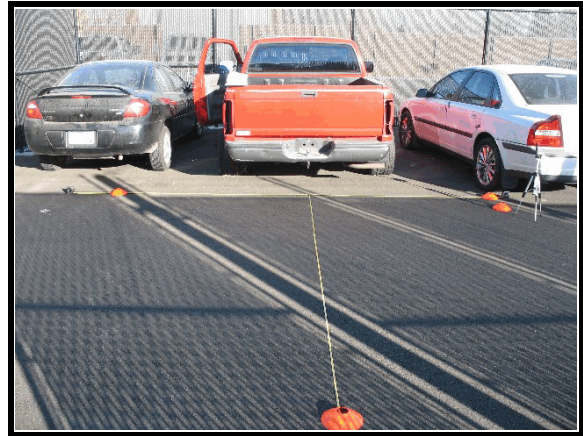
**Figure 11.** Overview of rear blind zone

A visibility study was conducted during the inspection of the Dodge Ram pickup in order to determine the nominal blind zone behind the Dodge as well as the nominal blind zone of both side view mirrors. The standard 71 cm (28 in) high target was used for the observations. The investigating officer assisted the SCI investigator in making the visibility observations. The observations were conducted on the case vehicle inside the police impound lot.

The driver's eye height was estimated to be 161.5 cm (63.5 in) above the ground and was based on a 50<sup>th</sup> percentile male seated eye height. Observations were taken at this height. The initial set of measurements were made as if the driver were looking over his right shoulder out the backlight. The target was moved rearward from the back bumper along the Dodge's centerline until it came into view. The target had to be moved rearward from the back bumper 4.1 m (13.5 ft) before the top of the target came into view (**Figure 11**). The target was then moved 8.5 m (27.8 ft) to the right of the centerline where it became obstructed by the right B-pillar (**Figure 12**).

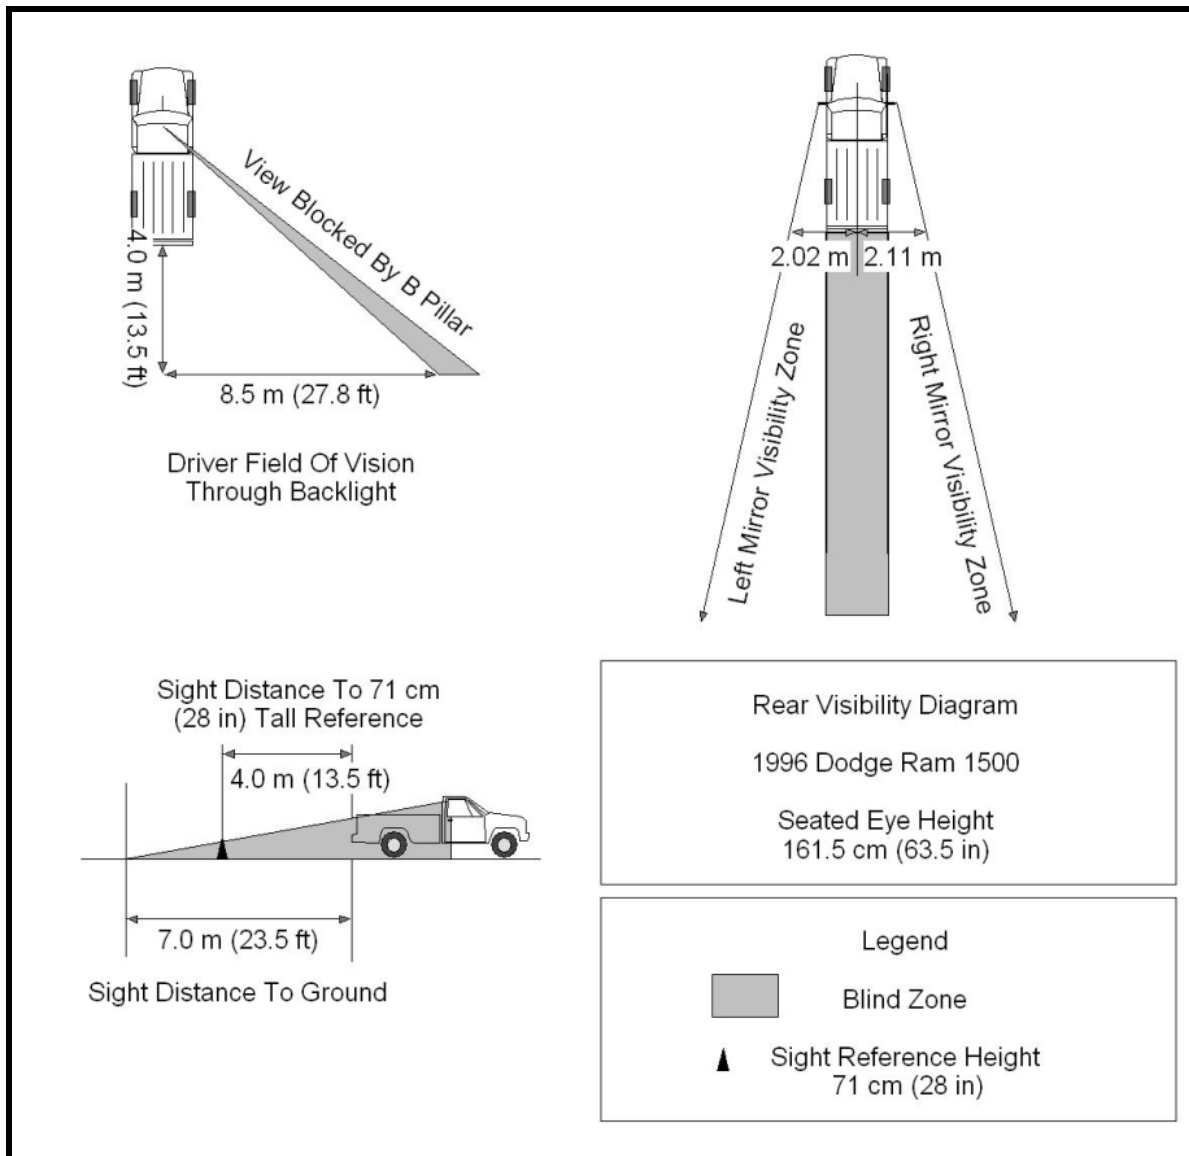
Figure 13. Nominal Visibility Diagram

The left and right side view mirrors had been moved prior to this investigator's on-site inspection. The mirrors were re-positioned to a position that provided a clear view down the side of the vehicle for a driver with the estimated 161.5 cm (63.5 in) seated eye height. The target was moved from the centerline at the rear bumper laterally to the right until the target became visible through the right side view mirror. This occurred as the target moved outboard of the side of the vehicle. The target was then moved laterally to the right until the target was no longer visible. This process was repeated on the left side of the vehicle.

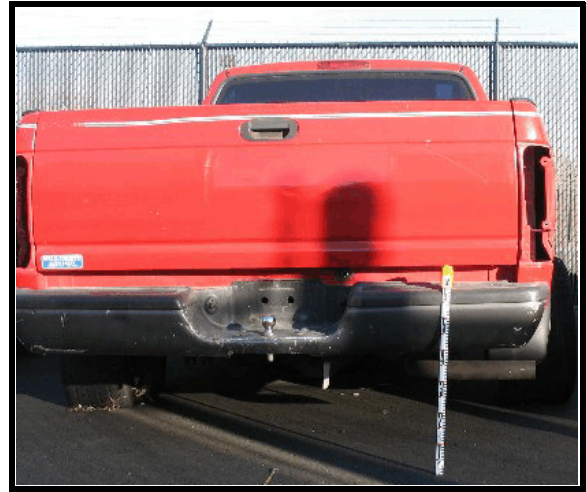
**Figure 14.** View of Dodge's back bumper (no indications of contact)

The 1996 Dodge Ram sustained minor scuffing and scratching damage as a result of contacting the two children, the Razor-type scooter, and the bicycle. There were no indications of direct contact to the rear bumper (**Figure 14**). There was contact damage to the tail pipe, the muffler, the rear axle and the differential (**Figures 15-16**). Contact between the two events could not be separated. A combined Collision Deformation Classification (CDC) of 06BZLU1 was assigned to the second event.

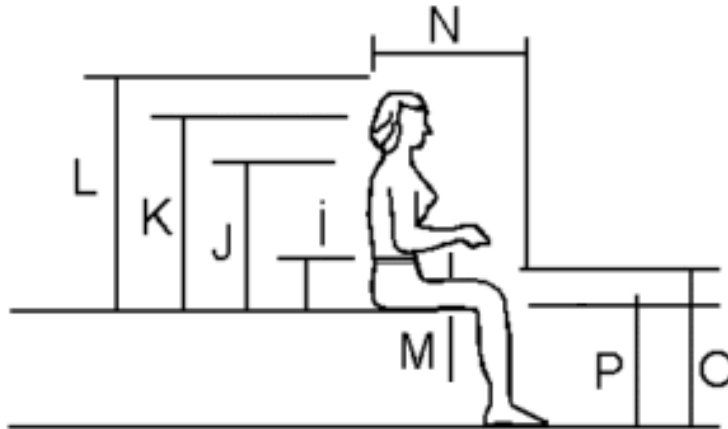
Attachment 3. Anthropometric Measurements<sup>1</sup>

Men in (cm)			Women in (cm)		
		5th	50th	95th	5th	50th	95th
I	Elbow Rest Height	7.7 (19.6)	9.4 (23.9)	11.2 (28.4)	7.4 (18.8)	9.4 (23.9)	10.6 (26.9)
J	Shoulder Height	21.6 (54.9)	23.8 (60.5)	25.9 (65.8)	20.3 (51.6)	22.4 (56.9)	24.6 (62.5)
K	Eye Height	29.3 (74.4)	31.7 (80.5)	38.0 (96.5)	27.2 (69.1)	29.4 (74.7)	31.5 (80.0)
L	Sitting Height	33.7 (85.6)	36.0 (91.4)	38.3 (97.3)	31.3 (79.5)	33.6 (85.3)	35.9 (91.2)
M	Thigh Clearance	5.0 (12.7)	6.0 (15.2)	7.0 (17.8)	4.1 (10.4)	5.5 (14.0)	6.9 (17.5)
N	Buttock-Knee Length	21.6 (54.9)	23.5 (59.7)	25.4 (64.5)	20.7 (52.6)	22.7 (57.7)	24.7 (62.7)
O	Knee Height	19.7 (50.0)	21.5 (54.6)	23.3 (59.2)	18.9 (48.0)	19.8 (50.3)	21.4 (54.4)
P	Stool Height (Popliteal Height)	14.6 (37.1)	16.3 (41.4)	18.1 (46.0)	13.4 (34.0)	15.0 (38.1)	16.7 (42.4)
