Remote Not In Traffic Surveillance Back Over Investigation
Dynamic Science, Inc. (DSI), Case Number DS08023
1999 Toyota Corolla
Washington
May 2008

1. Report No. DS08023	2. Government Accession No.		3. Recipient Catalog No.	
4. Title and Subtitle Remote Not in Traffic Surveillance Back Over Investigation			5. Report Date January 20, 2009

Dynamic Science, Inc.
Crash Investigation
Case Number: DS08023

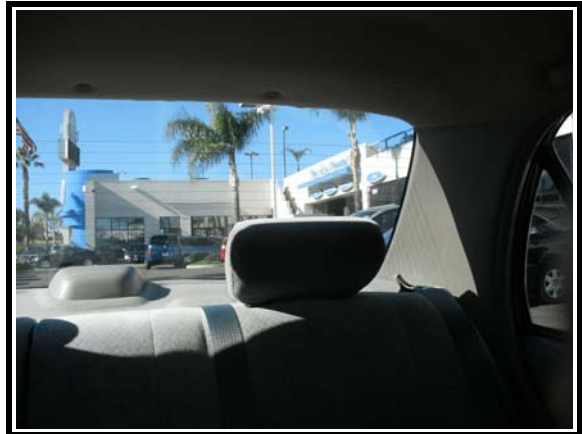
Figure 7. Overview of over the shoulder view

The initial set of measurements was taken with the investigator looking over his right shoulder through the backlight (**Figure 7**). When the investigator looked over his right shoulder and through the backlight, the view down the vehicle's longitudinal centerline was obscured by the vehicle's center stop lamp. The target was moved aft of the rear bumper along the vehicle's centerline until it became visible above the center stop lamp. The point at which the target became visible to the investigator measured 13.26 m (43.5 ft) aft of the rear bumper (**Figure 8**). That measurement was used as the point of origin for two sets of lateral measurements which was then taken. Measurements taken laterally to the left and right resulted in a visible zone that could be viewed through the backlight. The lateral measurements were taken from the vehicle's center line to the left and right sides of the backlight until the target was out of view due to the presence of the second row head restraints and the C-pillars. The target was out of view due to the left head restraint and C-pillar at a distance of 0.75 m (2.46 ft) lateral to the vehicle's longitudinal center. The target was out of view due to the right head restraint and C-pillar at a distance of 4.9 m (16.08 ft) lateral to the vehicle's longitudinal center. At 13.26 m (43.5 ft) aft of the rear bumper, the visible zone from the left head restraint to the right head restraint measured 5.65 m (18.54 ft) in width, and 87 percent of the visible zone was to the right of the vehicle's longitudinal center.
