## ON-SITE SIDE IMPACT INFLATABLE OCCUPANT PROTECTION INVESTIGATION

CASE NUMBER - IN08047

LOCATION - TEXAS

VEHICLE - 2001 CADILLAC DEVILLE

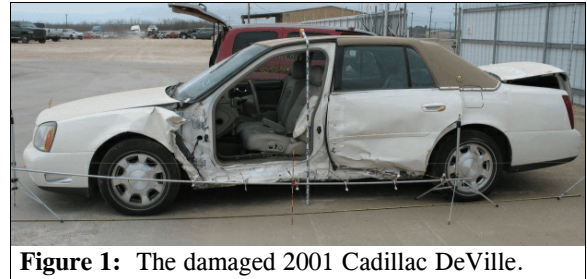
**Figure 1:** The damaged 2001 Cadillac DeVille.

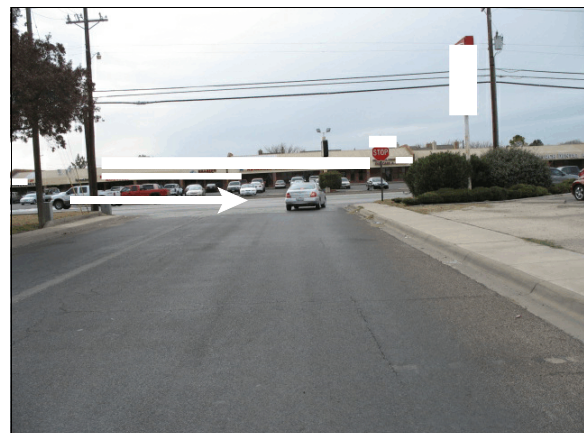
**Figure 2:** Approach of the 2001 Cadillac to the intersection; arrow shows approach of the 2005 Cadillac

**Pre-Crash:** The 2001 Cadillac's restrained 87-year-old female driver was stopped at the stop sign heading west (**Figure 2**). She intended to turn left and travel south. The 2005 Cadillac's 72-year-old restrained female driver was traveling north in the second lane from the right (**Figure 3**) and intended to continue north. The 2001 Cadillac's driver stated during the SCI interview that she looked but

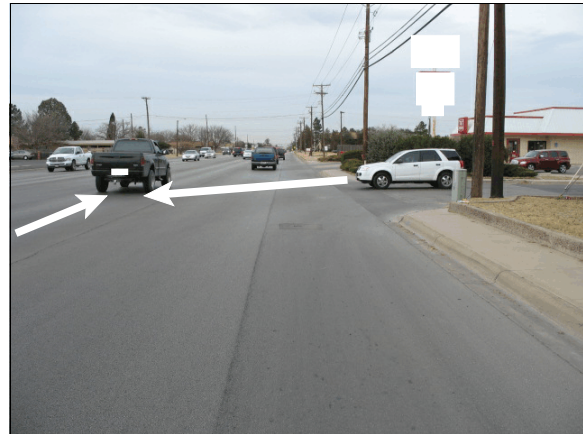
Figure 3: Approach of the 2005 Cadillac to the impact area, arrows show converging trajectories

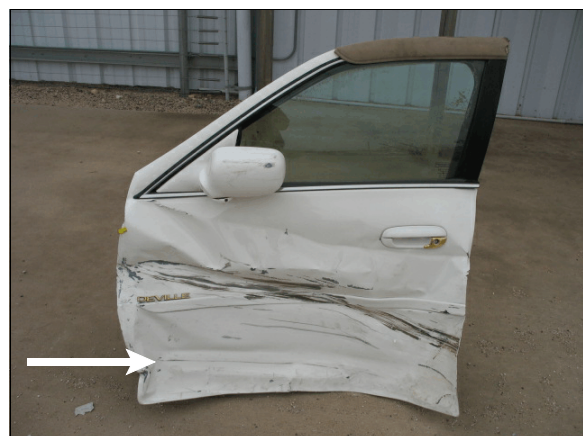
**Crash:** As the 2001 Cadillac entered the intersection and the driver initiated a left turn, the front plane of the 2005 Cadillac impacted its left side plane (Figures 4 and 5). The 2001 Cadillac's direction of force was within the 10 o'clock sector and the impact force was sufficient to trigger deployment of the driver's seat back-mounted side impact air bag. The impact caused the 2001 Cadillac to rotate slightly counterclockwise and it came to final rest on the inside north lane heading southwest. The 2005 Cadillac remained engaged with the left side of the vehicle and came to final rest heading north.

Figure 4: Direct damage to the 2001 Cadillac's left front door from impact with the 2005 Cadillac; arrow shows level of bumper contact

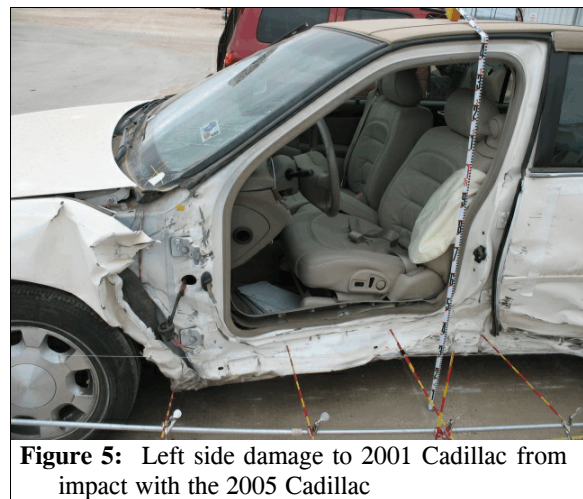
Figure 5: Left side damage to 2001 Cadillac from impact with the 2005 Cadillac

**Exterior Damage:** The 2001 Cadillac’s impact with the 2005 Cadillac involved the left side plane. The left front and left rear doors were directly damaged. The left fender was bent outward and had pry marks on it that occurred when the left front door was removed. The direct damage began 52 cm (20.1 in) rear of the left front axle and extended 202 cm (79.5 in) rearward on the left front and rear doors. The level of maximum crush occurred at the lower left front door and corresponded to the crush at the mid sill level. The measurements were therefore taken on the sill because the left front door could not be tied back on the vehicle in such a manner to allow accurate measurements on the door. The residual maximum crush was 21 cm (8.3 in) and occurred at C<sub>4</sub> (Figure 6). The sill height was 32 cm (12.6 in) and the height of the maximum crush was 35 cm (13.8 in). The Door Sill Differential was 0 cm because the maximum crush occurred at the mid sill level. The table below shows the vehicle’s right side crush profile.

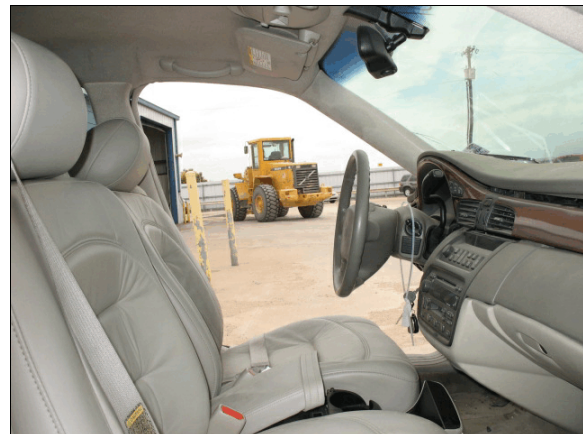
**Vehicle Interior:** The inspection of the 2001 Cadillac’s interior (**Figures 7**) and the detached left front door (**Figure 8**) revealed no discernable evidence of occupant contact. There was no evidence of steering rim deformation or compression of the energy absorbing steering column.

**Figure 7:** Driver seating position, steering wheel and instrument panel

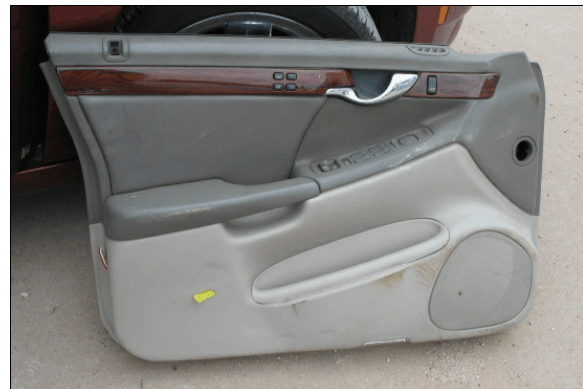
**Figure 8:** Left front door panel; yellow tape shows dent from contact with seat control panel on driver’s seat

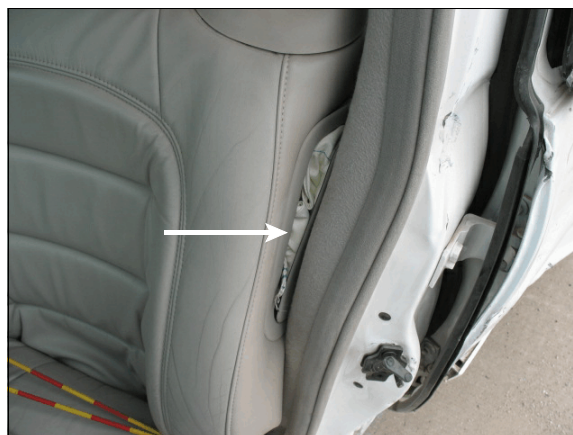
The vehicle was also equipped with front seat back-mounted side impact air bags, which were located within the outboard side of the driver's and front right passenger's seat backs (**Figure 9**). Based on the Holmatro Rescuer's Guide to Vehicle Safety Systems, the vehicle's side impact sensors were located within the lower B pillars. The driver's seat back-mounted side impact air bag deployed in this crash.

**Figure 9:** Arrow shows the location of the left front seat back-mounted side impact air bag

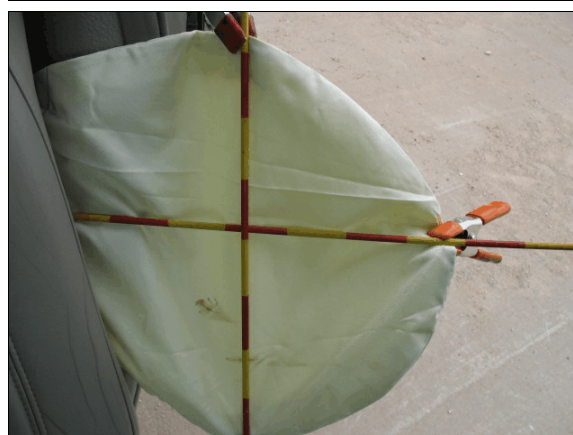
The deployed driver's side impact air bag (**Figure 10**) was oval and was 35 cm (13.4 in) in width and 38 cm (14.9 in) in height. It deployed through a rectangular module cover flap that was 8 cm (3.1 in) in width and 21 cm (8.3 in) in height. The air bag was not equipped with vent ports or tethers. Inspection of the air bag revealed two blood transfers on the inside surface. One was 3 cm (1.2 in) in length and was located on the air bags lower rear quadrant. The second was 14 cm (5.5 in) in length and was located on the air bags forward lower quadrant.

**Figure 10:** The deployed left front seat back-mounted side impact air bag
