Remote Not-In-Traffic Surveillance Falling Vehicle Investigation
Dynamic Science, Inc. (DSI), Case Number DS09009
1997 Dodge Intrepid
Nebraska
February 2009

| 4. Title and Subtitle Remote Not-In-Traffic Surveillance Falling Vehicle Investigation | | | 5. Report Date September 1, 2009 | | |

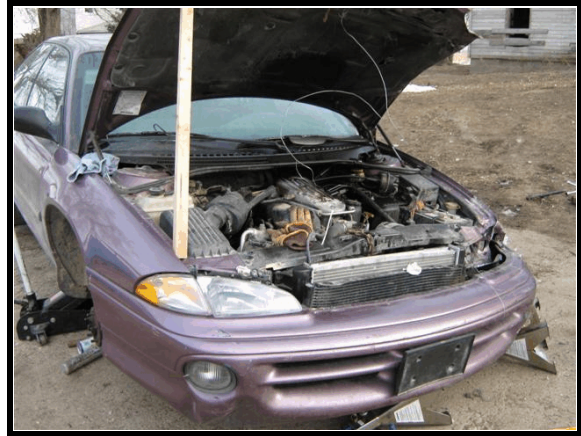
Figure 1. Subject vehicle, 1997 Dodge Intrepid (police photo)

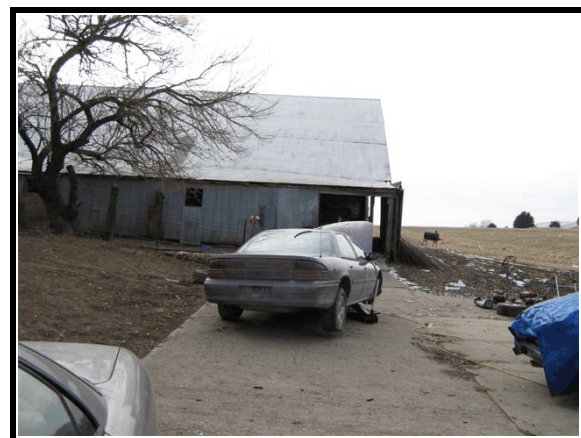
The incident occurred in an east/west driveway that intersected a north/south roadway. The driveway was located south of a garage and east of a barn (**Figure 2**). The driveway was of concrete composition and had an estimated negative 3% superelevation to the north. Dirt and grass bordered the south side of the driveway. The temperature at the nearest reporting station was 4 degrees C (39 degrees F) at 1552 hours. The weather was cloudy and the wind was out of the southeast at 24 km/h (15 mph) gusting to 38 km/h (24 mph). The driveway was dry.

Figure 2. Overview of incident scene, looking west (police photo)

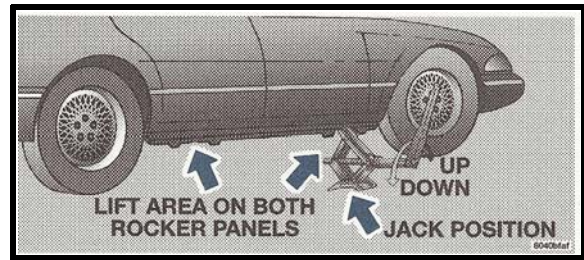
removed. The rear wheels were not chocked. The vehicle was resting on a pair of ratchet style metal jack stands that had been placed forward of the front axle. According to the owner's manual, the stands should have been placed at or near the vehicle's lift area of the sill flange rearward of the front axles (**Figure 3**). The hood was propped open by a block of wood. The non-motorist was working on the front suspension from the right side of the vehicle. He was lying on his back with his head and torso beneath the vehicle. A hydraulic bottle jack and the vehicle's scissors jack¹ were being used to manipulate an unknown undercarriage component. The interviewee was not sure exactly what his son was trying to do and his son did not provide him with any clarification. As the hydraulic jack lifted the component/vehicle, the weight came off the jacks and the vehicle shifted to the right.

Figure 3. Location of lift areas. Source: 1997 Dodge Intrepid Owner's Manual

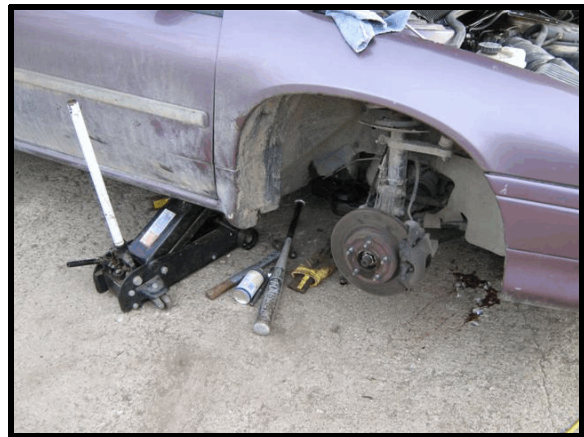
Both jack stands, the hydraulic jack, and the scissors jack all tipped over to the north, and the vehicle fell on the non-motorist. The non-motorist was trapped near the right front wheel (**Figure 4**).

Figure 4. Area where non-motorist was trapped by vehicle (police photo)
