**NOT-IN-TRAFFIC SURVEILLANCE  
CALSPAN REMOTE CARBON MONOXIDE POISONING FATALITY  
INVESTIGATION**

**SCI CASE NO.: CA09011**

**VEHICLE: 2000 DODGE CARAVAN  
LOCATION: FLORIDA  
DATE: JANUARY 2009**

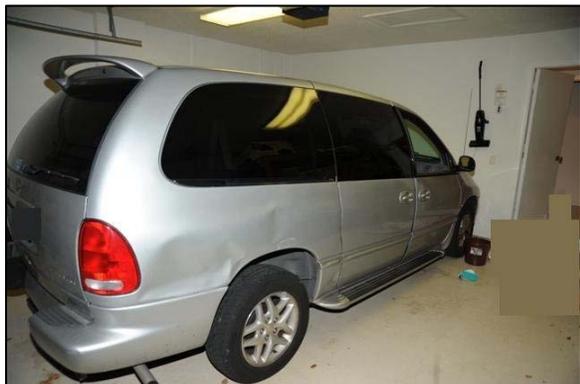
**Figure 2: Right rear oblique view of the Dodge.**

The involved vehicle was a 2000 Dodge Grand Caravan and was identified by the Vehicle Identification Number (VIN): 1B4GP44R2YB (production sequence deleted). The 4-door, front wheel drive vehicle was configured on a 303 cm (119.3 in) wheelbase and was equipped with a 3.3-liter V6 engine and a 4-speed automatic transmission. The rear bumper of the Dodge had been modified and an after-market wheelchair ramp had been installed in the vehicle. The manufacturer/installer of the wheelchair ramp was unknown. The son of the deceased reported that at the time of the incident, the ramp could only be operated manually. The electronic deployment of the ramp was inoperative. **Figures 2 and 3** are views of the parked vehicle within the garage.

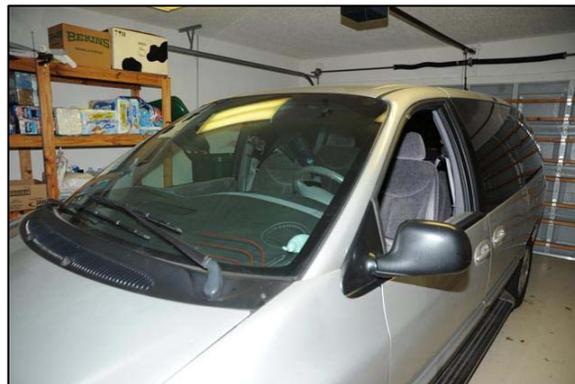
**Figure 3: Left front oblique view of the Dodge.**

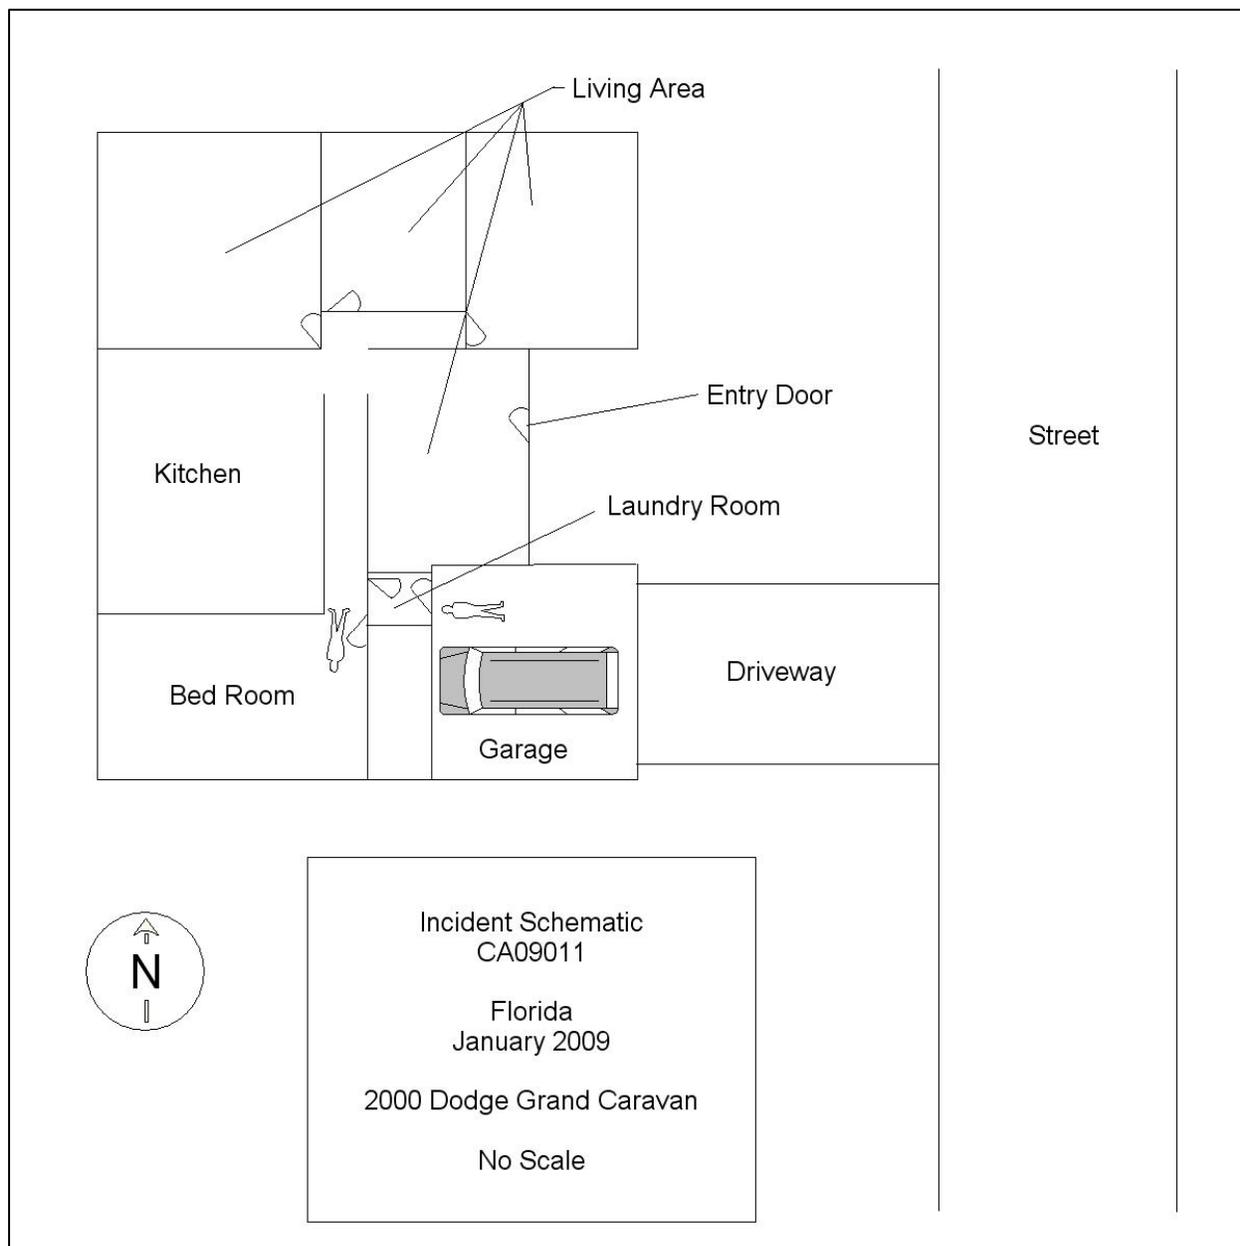
**Figure 4: Incident schematic.**

individual would first enter a laundry room. Passing through an interior door in the laundry room would place the individual in a hallway adjacent to the master bedroom and the kitchen area. A schematic of the incident site is attached to the end of this report as **Figure 4**.
