Remote Not-In-Traffic Surveillance Hyperthermia Investigation
Dynamic Science, Inc. (DSI), Case Number DS09025
1998 Honda Civic
Colorado
August 2008

| 4. Title and Subtitle Remote Not-In-Traffic Surveillance Hyperthermia Investigation | | 5. Report Date February 15, 2010 | |

Dynamic Science, Inc.
Crash Investigation
Case Number: DS09025

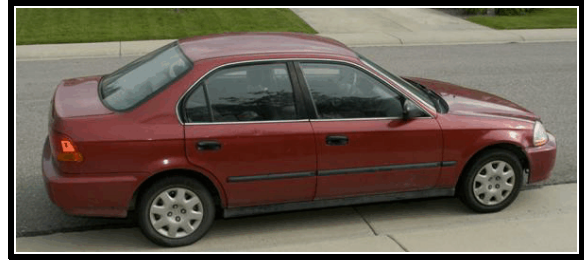
Figure 1. Subject vehicle, 1998 Honda Civic (police photo)

The 1998 Honda Civic 4-door sedan was identified by the Vehicle Identification Number (VIN): 1HGEJ657XWLxxxxxx. The Honda was equipped with a 4-cylinder, 1.6-liter engine and front wheel drive. The vehicle's exterior was red in color and the vehicle not configured with a sun roof. It does not appear that any of the glazing was tinted.

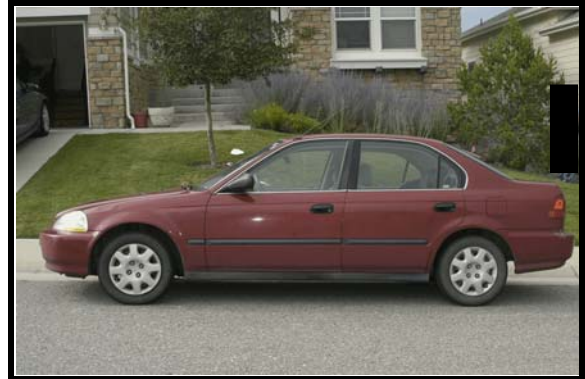
The incident occurred on a residential street in front of a private residence (**Figure 2**). The residence was a single story house on the north side of the street. The back yard was not fenced. The street was approximately 7.6 m (25 ft) south of the residence and the Honda was parked in front of the residence facing west. The left side doors were locked and the right side doors were unlocked. The child safety lock on the second row right door was not engaged and child safety lock on the second row left door was engaged. Two child seats were in the rear of the vehicle.

Figure 2. Incident site (police photo). Subject vehicle 1998 Honda Civic.
