**CALSPAN REMOTE HYPERTHERMIA DEATH INVESTIGATION
SCI CASE NO: CA09045**

VEHICLE: 1995 ISUZU RODEO

LOCATION: KENTUCKY

INCIDENT DATE: JUNE 2009

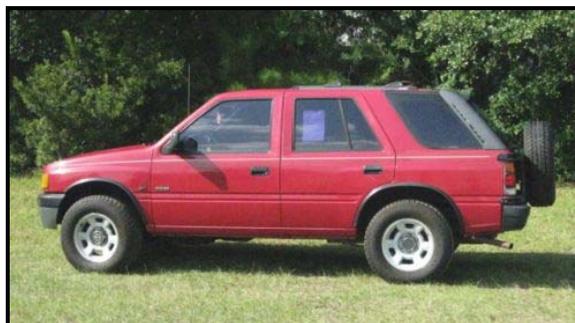
Figure 1: Left side view of an exemplar 1995 Isuzu Rodeo.

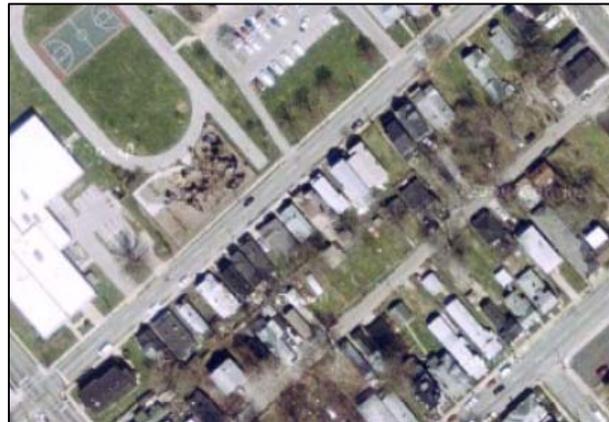
The incident occurred on a one-way, two-lane street outside the residence of the driver. The residence was located mid-block in an urban/residence setting. The street was oriented in a northeast/southwest direction. The one-way traffic flow was southwest in direction. Single family homes were located on the south roadside. The Isuzu rodeo was parked along the left curb outside the family's home. **Figure 2** is an aerial view of the incident site.

Figure 2: Aerial view of the incident site.

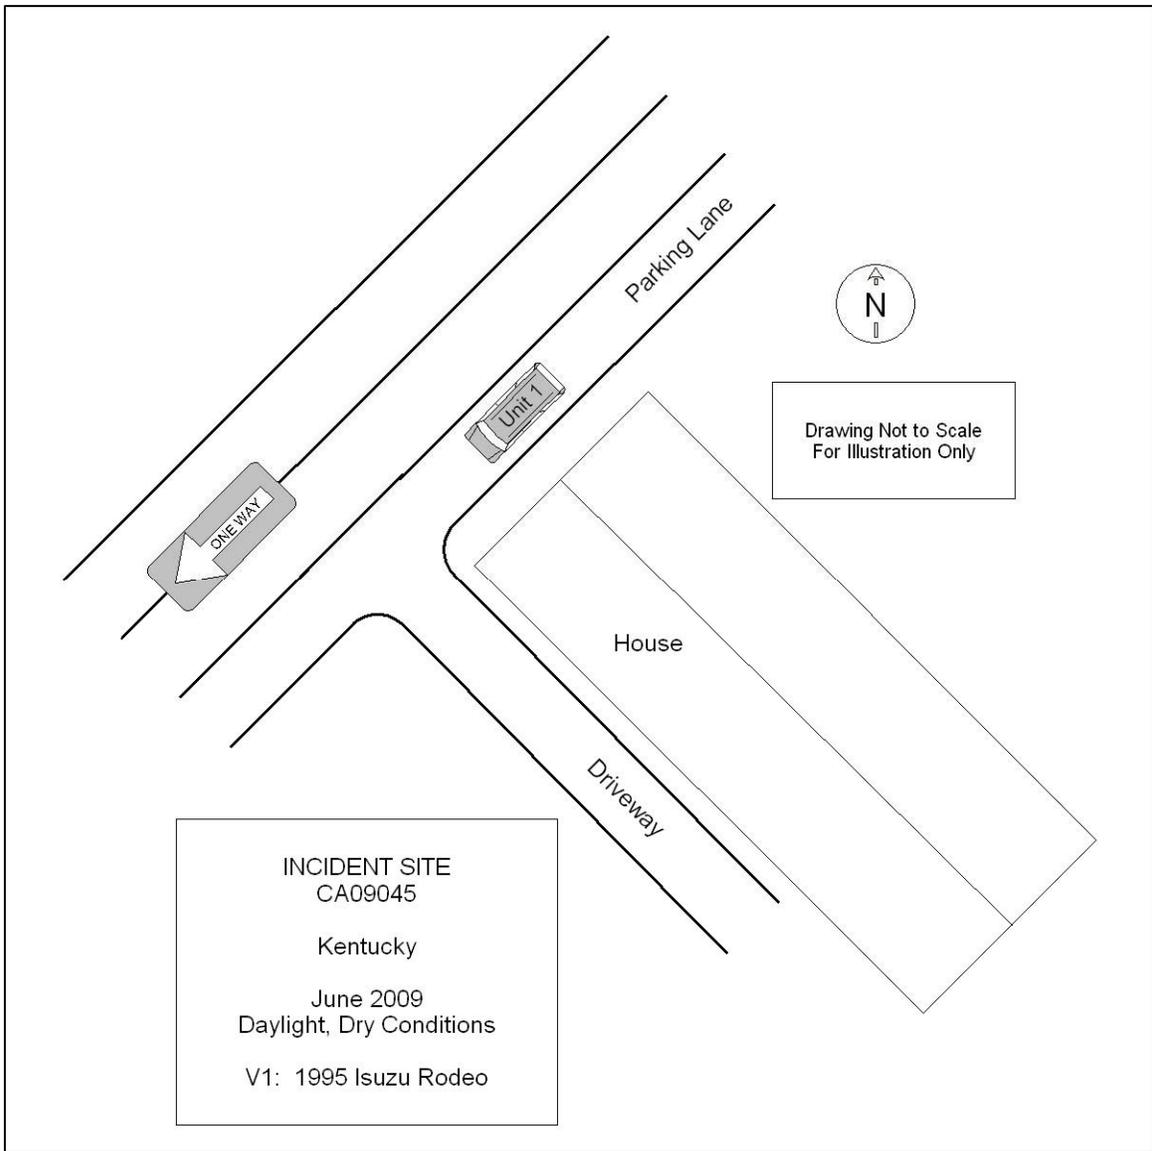
Figure 3: Incident Site Schematic.
