**CALSPAN ON-SITE CHILD RESTRAINT SYSTEM CRASH INVESTIGATION**  
**SCI CASE NO: CA09074**

**VEHICLE: 2007 SATURN ION**

**LOCATION: VIRGINIA**

**CRASH DATE: SEPTEMBER 2009**

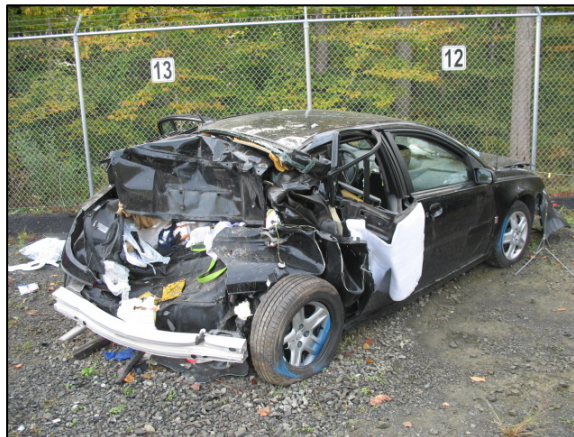
**Figure 1: Image of 2007 Saturn Ion right/rear oblique view displaying damage from Event 1.**

The 2007 Saturn Ion sustained severe damage to the back plane as a result of the impact with the 2004 Ford Explorer (Event 1). Maximum crush was 100 cm (39.3 in) and was located at edge of the trunk lid, inboard of the right corner. The damaged components included the bumper fascia, bumper beam, trunk, trunk lid, quarter panels, backlight, backlight header, right rear wheel and suspension components (**Figure 4**). The direct contact damage began 26 cm (10.2 in) left of center and extended 101 cm (39.3 in) to the right bumper corner. A crush profile was documented along the bumper beam and was as follows: C1 = 9 cm (3.2 in), C2 = 17 cm (6.7 in), C3 = 25 cm (9.8 in), C4 = 32 cm (13.4 in), C5 = 41 cm (16.1 in), C6 = 50 cm (19.7 in). Due to the height differences between the front bumper of the Ford and the rear bumper of the Saturn, the front plane of the

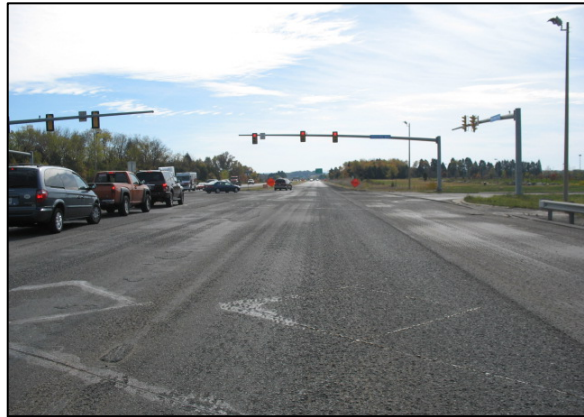
**Figure 2: Southbound view of intersection depicting pre-crash travel path for both vehicles.**

The crash occurred during nighttime hours in September 2009. At the time of the crash, the weather was clear and the bituminous roadways were dry. The crash occurred within a 4-leg intersection of a divided 6-lane north/south road and a 5-lane undivided east/west road, located within a rural commercial area. The intersection was controlled by multiple, 3-phase overhead traffic signals. Both vehicles shared the same pre-crash roadway environment which consisted of dedicated left and right turn lanes, two straight through lanes, and a depressed center grass median and was bordered by asphalt shoulders. The posted speed limit was 89 km/h (55 mph) in the north/south travel directions. The west side asphalt shoulder was bordered by a grass covered field. A wire fence was located 7.8 m (25.6 ft) west of the west edge line which paralleled the southbound roadway. A row of large rocks were located 37.6 m (123.4 ft) west of the referenced edge line which also paralleled the southbound roadway. At the time of the SCI scene inspection, an active work zone was in place and the asphalt road surface was removed to facilitate repaving of the travel lanes. As a consequence of this construction, any remaining physical evidence was destroyed during the repaving process. The on-scene police documentation of the physical evidence was used in the SCI scene diagram. A schematic of the crash is included at the end of this report as **Figure 12**. **Figure 2** is a southbound view of the intersection which depicts the pre-crash trajectory of the both the Saturn and the Ford.

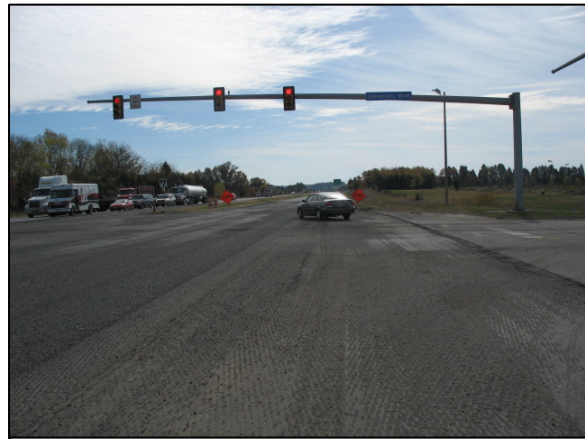
**Figure 3: Area of initial impact depicting post-crash roadway resurfacing**

The Saturn was traveling southbound on an approach to the controlled intersection in the second through lane (**Figure 3**). It is unknown whether the Saturn had come to a complete stop and was accelerating into the intersection, or had decelerated prior to entering the intersection. The specific pre-crash phase of the overhead traffic signal is unknown. The Ford was driven by a 26-year-old unrestrained male and occupied by three additional passengers. The male driver of the Ford was traveling southbound behind the

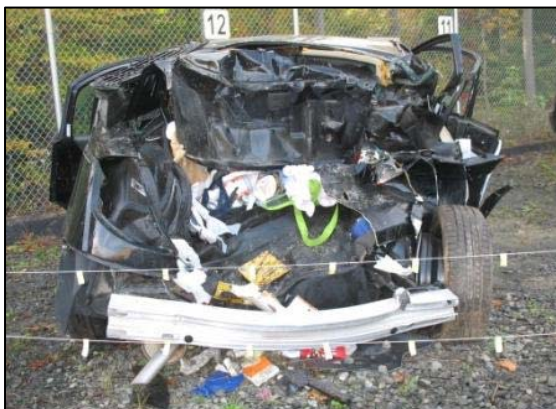
**Figure 4: Rear view of the impact damage to the Saturn.**

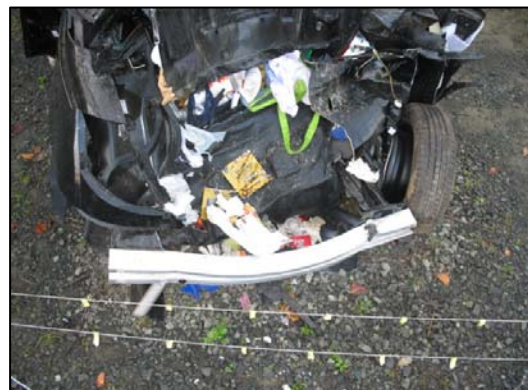
**Figure 5: Overhead view of the Saturn's crush at the bumper level and the above bumper level.**

Ford overrode the rear bumper of the Saturn. The override resulted in direct contact and significant crush above the bumper beam (**Figure 5**). A second crush profile was documented along the projected back plane of the trunk lid (latch released) in order to capture the above bumper damage. This crush profile was as follows: C1 = 7 cm (2.8 in), C2 = 56 cm (22 in), C3 = 70 cm (27.6 in), C4 = 74 cm (29.1 in), C5 = 100 cm (39.3 in), C6 = 92 cm (36.2 in). The average of the crush profiles was used to calculate the delta-V and was as follows: C1 = 9 cm (3.5 in), C2 = 37 cm (14.6 in), C3 = 48 cm (18.9 in), C4 = 53 cm (20.9 in), C5 = 71 cm (28.0 in), C6 = 71 cm (28.0 in). All four doors remained closed during the crash. The right rear door of the Saturn was jammed closed; however, the remaining three doors were operational post-crash.

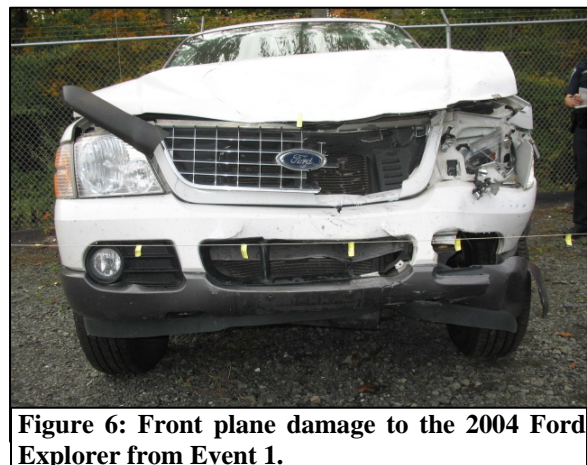
The 2004 Ford Explorer sustained moderate severity frontal damage (**Figure 6**) as a result of the impact with the Saturn. The direct contact damage began 34 cm (13.4 in) right of the centerline and extended to 111 cm (43.7 in) to the left bumper corner. The maximum crush measured 15 cm (5.9 in) and was located 50 cm (19.7 in) inboard of the left bumper corner. Six equidistant

**Figure 6: Front plane damage to the 2004 Ford Explorer from Event 1.**

crush measurements were documented along the bumper beam and were as follows: C1 = 12 cm (4.7 in), C2 = 8 cm (3.1 in), C3 = 15 cm (5.9 in), C4 = 9 cm (3.5 in), C5 = 0 cm, C6 = 0 cm. The CDC for the Ford's impact with the Saturn (Event 1) was 12FDEW1.

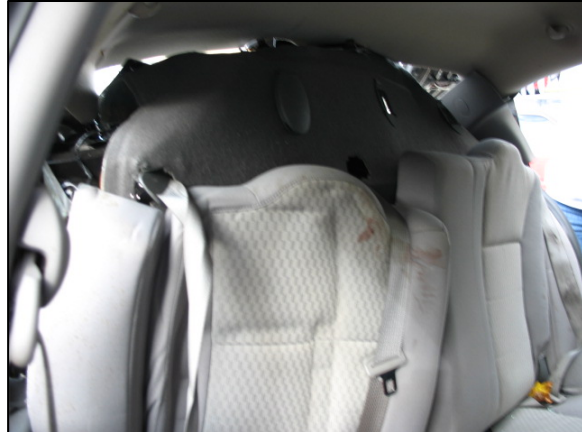
The interior damage to the Saturn consisted of occupant contact and passenger compartment intrusion on the rear seat area (**Figure 7**). The driver's contact points consisted of a scuff to the left side of the knee bolster and loading of the seatback. The seatback loading resulted in the outboard aspect of the seatback to rotate approximately 5 cm (2 in) rearward in a counterclockwise motion. The front right passenger's contact points consisted of body fluid transfers on the safety belt webbing.

**Figure 7: Depicts longitudinal intrusion of the second row seatback and rear shelf**

<b>Position</b>	<b>Component</b>	<b>Magnitude</b>	<b>Direction</b>
Rear right	Seatback	53 cm (20.9 in)	Longitudinal
Rear right	Rear shelf	51 cm (20.1 in)	Longitudinal
Rear center	Seatback	42 cm (16.5 in)	Longitudinal
Rear center	Rear shelf	40 cm (15.8 in)	Longitudinal
Rear left	Seatback	8 cm (3.1 in)	Longitudinal
Rear left	Rear shelf	5 cm (2.0 in)	Longitudinal

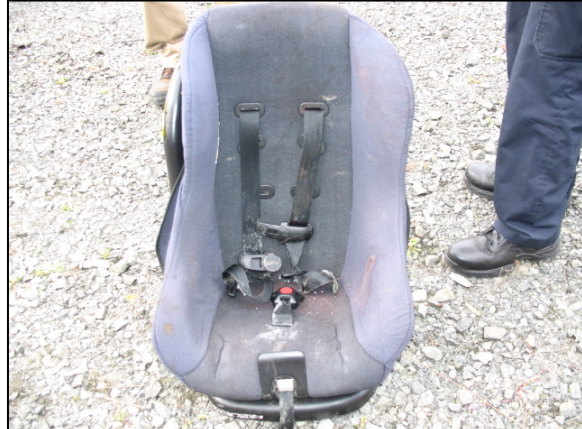
**Figure 8: Cosco Touriva convertible CRS restraint system.**

This CRS was designed with an integrated 5-point safety belt harness system in conjunction with three belt positioning slots. The belt webbing was found to be threaded through the top positioning slots. The CRS was comprised of a molded plastic shell with an adjustable lower foot used for forward-facing installations. A fabric cushion covered the seating area of the CRS.

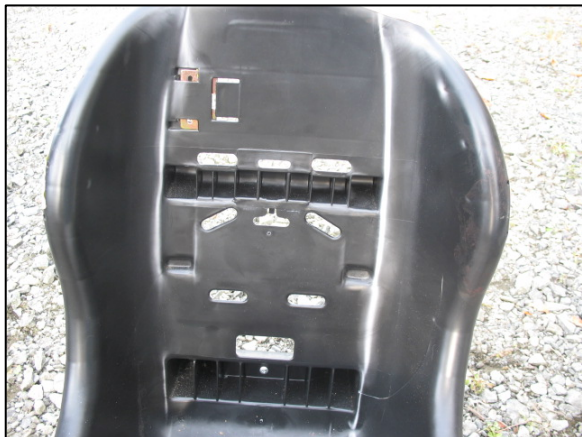
**Figure 9: Loading stress marks distributed throughout the plastic shell of the CRS.**

The inspection of this CSS revealed loading evidence (**Figure 9**) distributed across the entire plastic shell. A 21 cm (8.3 in) crack was located on the left side of the shell. Loading stress marks were

identified near the lower foot adjuster, top corners, both side wings, and bottom of the plastic shell, which was also deformed from the impact forces. Loading evidence was on the forward facing belt positioning slots which corresponded to the vehicle's belt webbing friction marks and stretching created by the second row seatback intrusion. Loading stress marks were also noted to the plastic structure, designed to reinforce the uppermost child seat harness strap slots, which was caused by the child occupant loading the 5-point harness. An examination of the 5-point harness system indicated that the two retainer clips, belt webbing and lower belt buckle were intact. The chest retainer clip was adjusted to below the level of the child's armpit. The left side was positioned 29 cm (11 cm) above the base of the CRS and the right was 36 cm (14 in) above the base. There was no significant loading evidence on the forward facing belt path of the CRS. The child seat locking clip was found in its original stowed shipping position located in the upper right side of the back of the plastic shell. It was not used during the crash.

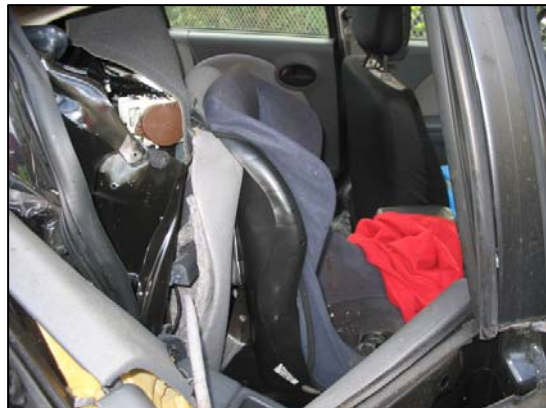
The intrusion displaced the CRS forward (**Figure 10**) into the front right seatback. The child loaded the integral harness system resulting in soft tissue injuries of the chest, abdomen and upper left thigh. He also sustained a left upper arm contusion and a left upper back abrasion from his impact with the anterior aspect of the plastic CRS shell which exhibited stress marks and loading evidence during the SCI inspection. His head translated forward and struck the upper aspect of the front right seat back resulting in multiple soft tissue injuries of the face, inclusive of a right eye abrasion with contusion, a nose abrasion/contusion, right cheek abrasion/contusion, lower lip laceration and a contusion to the right aspect of the chin (**Figure 11**). He also sustained unspecified head trauma, an atlanto-occipital dislocation, and an unspecified fracture of the fifth cervical vertebrae fracture from contact with the top of the posterior aspect of the front right seatback. The rear right child

**Figure 10: Post-crash position of the CRS.**

The CRS came to rest against the deformed second row seatback in a position slightly forward of vertical. The front third of its base was forward of the leading edge of the second row seat cushion. The Saturn's 3-point safety belt system remained engaged within the belt buckle with the webbing routed through the CRS forward facing belt path. The child was removed from the CRS and was pronounced deceased at the scene of the crash.

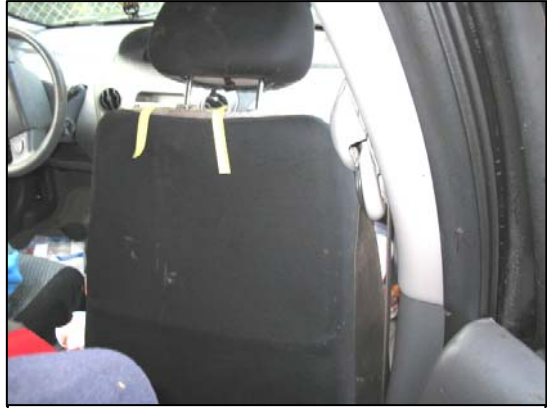
The rear right passenger's contact with the posterior aspect of the front right seat back consisted of dermal transfers and body fluid that measured 7 cm x 12 cm (2.8 in x 4.7 in) width x length located at the top of the seatback, slightly left of center. The second contact point to this seatback was located 18cm (7.1 in) below the top of the seat cushion and measured 7 cm x 6 cm (2.8 x 2.3) width x length which consisted of a irregular indentations in the seat fabric.

**Figure 11: Depicts the contact points to the rear aspect of the front right seatback.**
