On-Site Rollover Investigation
Dynamic Science, Inc. (DSI), Case Number DS10006
2010 Ford Fusion
California
February 2010

1. Report No. DS10006	2. Government Accession No.		3. Recipient Catalog No.	
4. Title and Subtitle On-Site Rollover Investigation			5. Report Date July 13, 2010

14. Sponsoring Agency Code	
15. Supplemental Notes				
16. Abstract This on-site investigation focused on a 2010 Ford Fusion that was involved in a frontal impact and subsequent rollover. This single vehicle crash occurred in February 2010 at 2120 hours in an unincorporated area of California. The crash site was the four-leg intersection of a north/south roadway and an east/west roadway. The subject vehicle was being driven south in the wrong direction in the northbound travel lanes approaching the intersection by a 48-year-old male. The Ford crossed through the intersection, impacted a concrete/gravel embankment, vaulted, and overturned end-over-end. The Ford came to rest on its roof facing north. The driver exited the vehicle under his own power and was transported to a local hospital where he was treated and released. The subject vehicle's Event Data Recorder (EDR) was supported by the Bosch Crash D

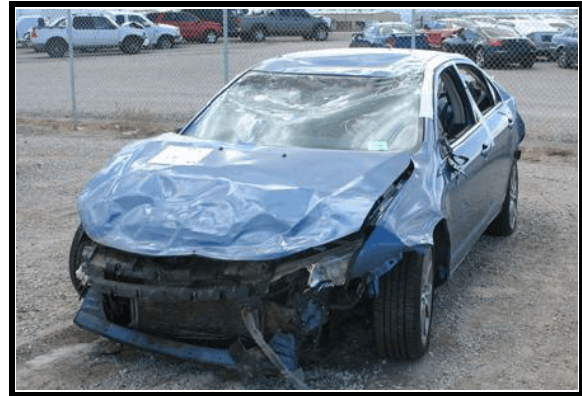
This on-site investigation focused on a 2010 Ford Fusion that was involved in a frontal impact and subsequent rollover (**Figure 1**). This single vehicle crash occurred in February 2010 at 2120 hours in an unincorporated area of California. The crash site was the four-leg intersection of a north/south roadway and an east/west roadway. The subject vehicle was being driven south in the wrong direction in the northbound travel lanes approaching the intersection by a 48-year-old male. The Ford crossed through the intersection, impacted a concrete/sand embankment, vaulted, and overturned end-over-end. The Ford came to rest on its roof facing north. The driver sustained minor head and leg injuries. He exited the vehicle under his own power and was transported to a local hospital for treatment.

Figure 1. Subject vehicle, 2010 Ford Fusion

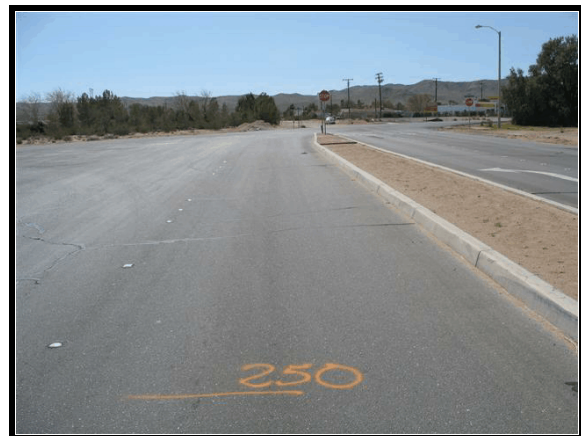
Figure 2. Southbound approach, 76.2 m (250 ft) from point of impact

speed limit for this roadway was 72 km/h (45 mph). The Ford was traveling south in the northbound travel lanes (**Figure 2**).

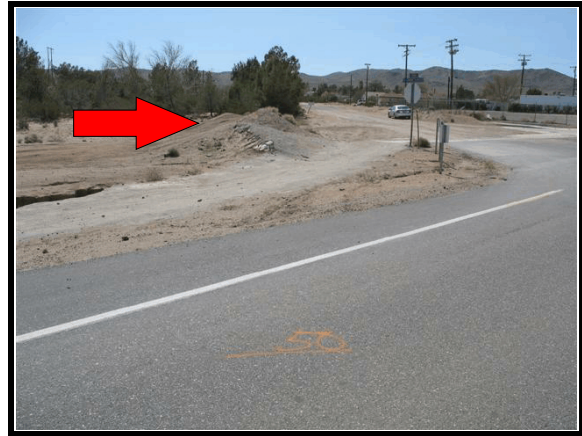
South of the southern edge of the east/west roadway there was a gravel shoulder and an approximately 4.5 m (15 ft) wide area of rough concrete that descended from north to south negative 7.4 percent. South of this area was a concrete/gravel embankment (**Figure 3**). The embankment was oriented in a north/south direction. The concrete portion was on the northern end of the embankment and was approximately 6.0 m (20.0 ft) in length. The northern end was 1.2 m (4.0 ft) wide and tapered until it was 2.7 m (9.0 ft) wide. The leading edge had an ascending angle of 25 degrees; the right side had an angle of 34 degrees and the left side had an angle of 20 degrees. The leading edge was 0.6 m (2.0 ft) high and ascended to approximately 1.2 m (4.0 ft) in height. South of the concrete embankment there was 8.2 m (27.0 ft) gravel embankment that was oriented in the same direction as the concrete embankment. To the right of the embankment, was a 6.0 m (20.0 ft) gravel covered roadway. Trees were planted parallel to this roadway. Approximately 54.8 m (180.0 ft) south of the east/west roadway there was an east/west oriented private driveway that measured 4.6 m (15.0 ft) in width.

Figure 3. Embankment

The front of the Ford struck the concrete embankment (Event 1). The impact resulted in sufficient longitudinal deceleration of the Ford to command the deployment of the driver's steering wheel mounted frontal air bag and actuated the driver's safety belt pretensioner.

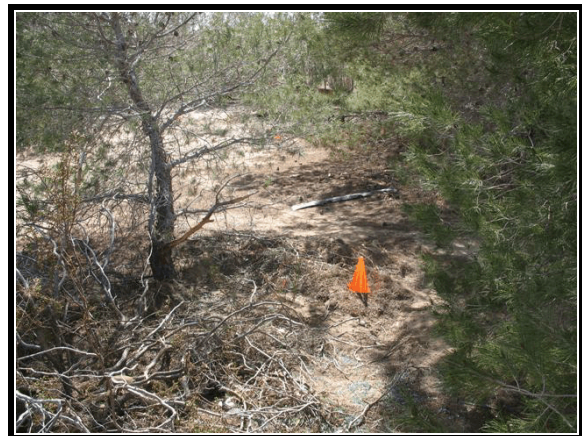
Figure 4. Contact with tree during rollover

Light scratching was located to the right side of the vehicle beginning 80.0 cm (31.4 in) aft of the rear axle and extending forward 300.0 cm (118.1 in). This was caused by contact to tree branches during the rollover. The CDC for this contact 00RDAS2. There was also a wood bark contact above the left rear wheel well. The CDC for this contact was 00LBMS1.

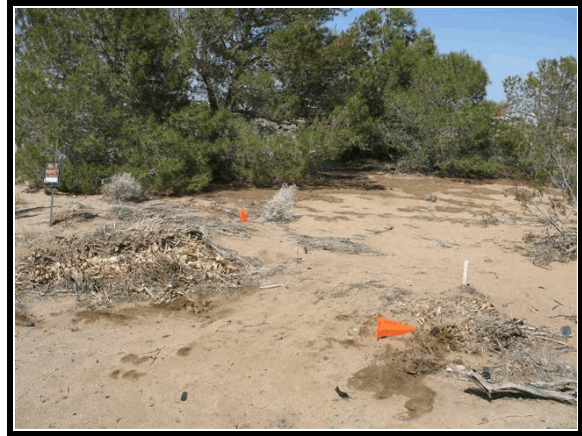
Figure 5. Area of final rest, looking north

The Ford traveled over the embankment, vaulted, and began an end-over-end rollover about its longitudinal axis. The vehicle first impacted the ground with its front end; a gouge was located on the ground 22.5 m (74.0 ft) south of the initial impact. The vehicle then impacted the ground with its back end; a gouge was located 24.7 m (81.0 ft) south of the initial impact. The vehicle continued the end-over-end rollover three more turns before coming to rest on its roof near the private roadway. The distance from the initial impact to final rest was 38.7 m (127.0 ft).

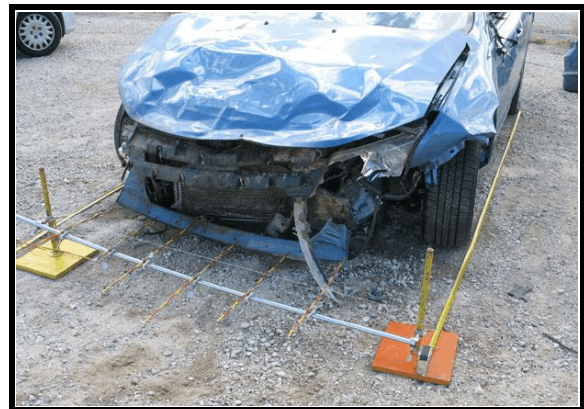
The Ford sustained moderate front end damage from the impact with the embankment (**Figure 6**). The direct damage began at the front left backing bar corner and extended 114.0 cm (44.8 in) to the right. The bumper fascia was displaced from the vehicle during the crash and there was 150.0 cm (59.0 in) of direct contact to the fascia. Six crush measurements were documented at the backing bar as follows: $C_1 = 24.0$ cm (14.9 in), $C_2 = 21.0$ cm (13.0 in), $C_3 = 22.0$ cm (13.7 in), $C_4 = 21.0$ cm (13.0 in), $C_5 = 18.0$ cm (7.0 in), $C_6 = 19.0$ cm (11.8 in). The backing bar was rotated downward and the crush measurements were taken to the middle of the backing bar face. The maximum crush was located at C_1 . The Collision Deformation Classification (CDC) for the frontal impact with the embankment was 12FDEW2.

Figure 6. Front of subject vehicle with contour gauge in place, 2010 Ford Fusion

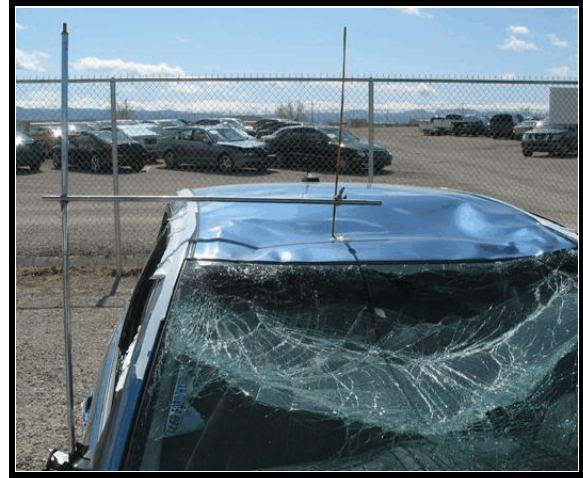
The Ford sustained moderate damage to the roof and back plane as a result of the rollover. The direct damage to the top extended from roof side rail to roof; it began 108.0 cm (42.5 in) forward of the rear axle and extended forward 247.0 cm (97.2 in) to include the entire hood. The maximum vertical crush was located 22.0 cm (8.7 in) aft of the windshield header, 41.0 cm (16.1 in) left of the right

roof rail, and measured 3.0 cm (1.2 in) (**Figure 7**). The CDC for the rollover was 00TDDO2. The direct damage to the back extended from bumper corner to bumper corner and included the trunk deck. The bumper fascia and spoiler had been displaced.

Figure 7. Maximum vertical crush, 2010 Ford Fusion

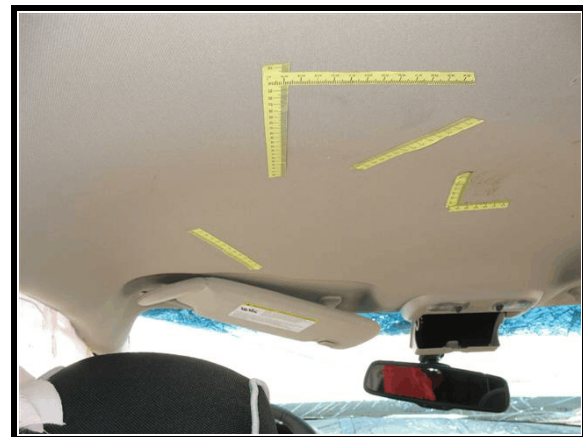
The Ford sustained moderate interior damage as a result of passenger compartment intrusion and occupant contacts. The vehicle sustained vertical intrusions to the windshield header and the roof, and longitudinal intrusions to C-pillar area and the second row seat back. The right rear door was jammed shut and the other doors remained closed and operational. There was integrity loss to the glazing at the left front, right front, left rear, right rear, and backlight locations. The windshield was cracked from the rollover but remained intact. There were possible occupant contacts to the left instrument panel to and to the roof. The scuff contact to the instrument panel was located along the lower edge and began 17.0 cm (6.7 in) to the right of the left aspect. There were three possible roof contacts (**Figure 8**). The first was located 5.0 cm (1.9 in) left of the centerline and 45.0 cm (17.7 in) rearward of the windshield header; it measured 5.0 cm (1.9 in) in width and was 8.0 cm (3.1 in) in length. The second was located 10.0 cm (3.9 in) left of the centerline and 55.0 cm (21.6 in) rearward of the windshield header; it was 12.0 cm (4.7 in) in width and 19.0 cm (7.5 in) in length. The third was 11.0 cm (4.3 in) in length and was located 38.0 cm (14.9 in) left of the centerline and 30.0 cm (11.8 in) rearward of the windshield header. The contacts may have been caused as the driver exited the vehicle.

Figure 8. Possible roof contacts

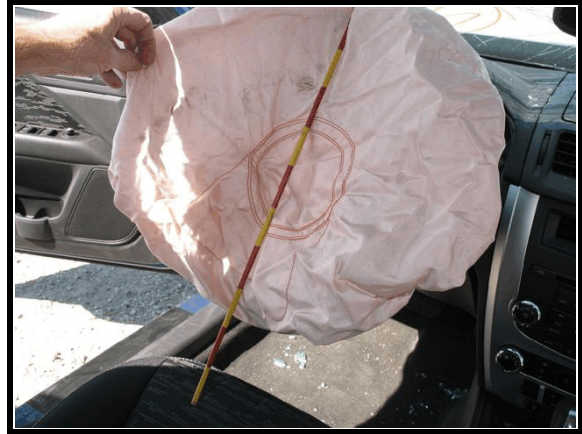
The driver's air bag deployed from the center of the steering wheel hub through H-configuration module cover flaps (**Figure 9**). The top flap measured 18.0 cm (7.0 in) in width and 8.0 cm (3.1 in) in height; the lower flap measured 18.0 cm (7.0 in) in width and 11.0 cm (4.3 in) in height. The deployed air bag measured 50.0 cm (19.7 in) in width in its deflated state. The air bag was tethered by a single internal strap. The tether was attached to a stitched 15.0 cm (5.9 in) diameter circle in the center of the front panel. Two X-shaped vent ports that measured 4.0 cm (1.6 in) were located at the 11 and 1 o'clock aspects on the rear panel. The air bag and module covers were not damaged. There were areas of grease and dirt located on the left upper and lower quadrants of the air bag face.

Figure 9. Driver's frontal air bag

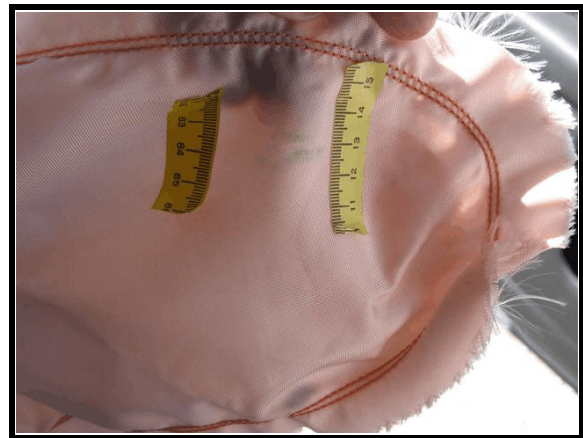
The driver's seat-mounted side air bag deployed from the triangular shaped module cover on the side of the seat back (**Figure 10**). The deployed air bag was semi-circular in shape and measured 29.0

Figure 10. Contact to inboard aspect of side air bag

cm (11.4 in) in length and 24.0 cm (9.4 in) in height. There was a single vent port on the outboard panel. A small green scuff was located on the inboard panel. The side IC air bags deployed through the roof rail cladding from a module located at the roof side rail (**Figure 11**). The air bags were generally rectangular and measured 183.0 cm (72.0 in) in length and 40.0 cm (15.7 in) in width. The forward aspect of the bags were attached to the A-pillar by tethers that measured 35.0 cm (13.7 in) in length; the rear aspect of the bags were attached to the D-pillar. The longitudinal area of coverage began near the A-pillar and extended to the D-pillar. The bag's vertical coverage began at the roof rail and extended to downward 5.0 cm (1.9 in) below the window frame. Portions of the left IC air bag had been cut away by unknown parties.

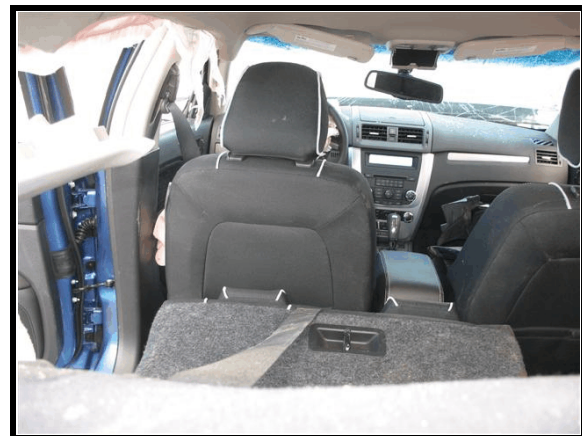
Figure 11. Left IC air bag (front cut away)

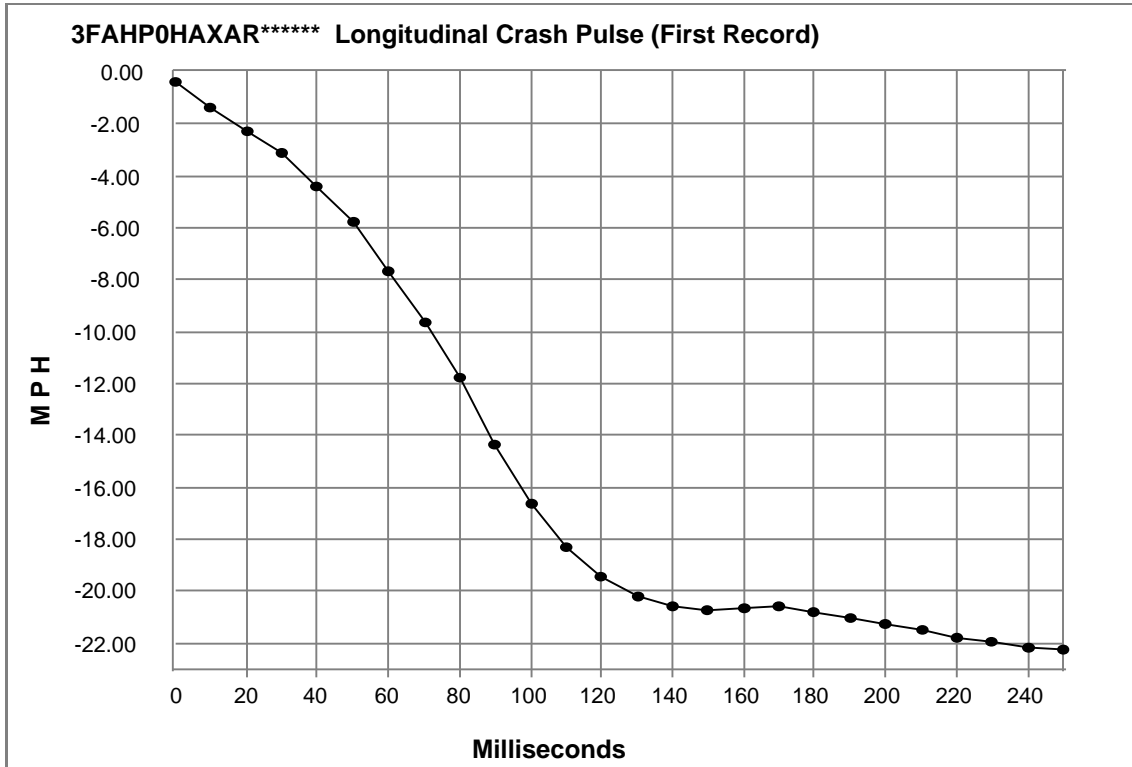
Longitudinal Crash Pulse (First Record)

Time (msec)	Delta-V, longitudinal (MPH)	Delta-V, longitudinal (km/h)
0	-0.37	-0.60
10	-1.34	-2.16
20	-2.24	-3.60
30	-3.12	-5.03
40	-4.38	-7.05
50	-5.78	-9.29
60	-7.63	-12.28
70	-9.67	-15.55
80	-11.76	-18.92
90	-14.36	-23.12
100	-16.64	-26.79
110	-18.28	-29.43
120	-19.46	-31.32
130	-20.22	-32.54
140	-20.59	-33.14
150	-20.73	-33.36
160	-20.61	-33.17
170	-20.58	-33.12
180	-20.80	-33.48
190	-21.03	-33.84
200	-21.29	-34.26
210	-21.50	-34.60
220	-21.77	-35.04
230	-21.95	-35.32
240	-22.14	-35.63
250	-22.26	-35.82

The EDR recorded the maximum longitudinal Delta-V as -35.73 km/h (-22.26 mph) at 250 milliseconds and the maximum lateral Delta-V as 10.35 km/h (6.43 mph) at 138 msec. The Damage Only algorithm of the WinSMASH program

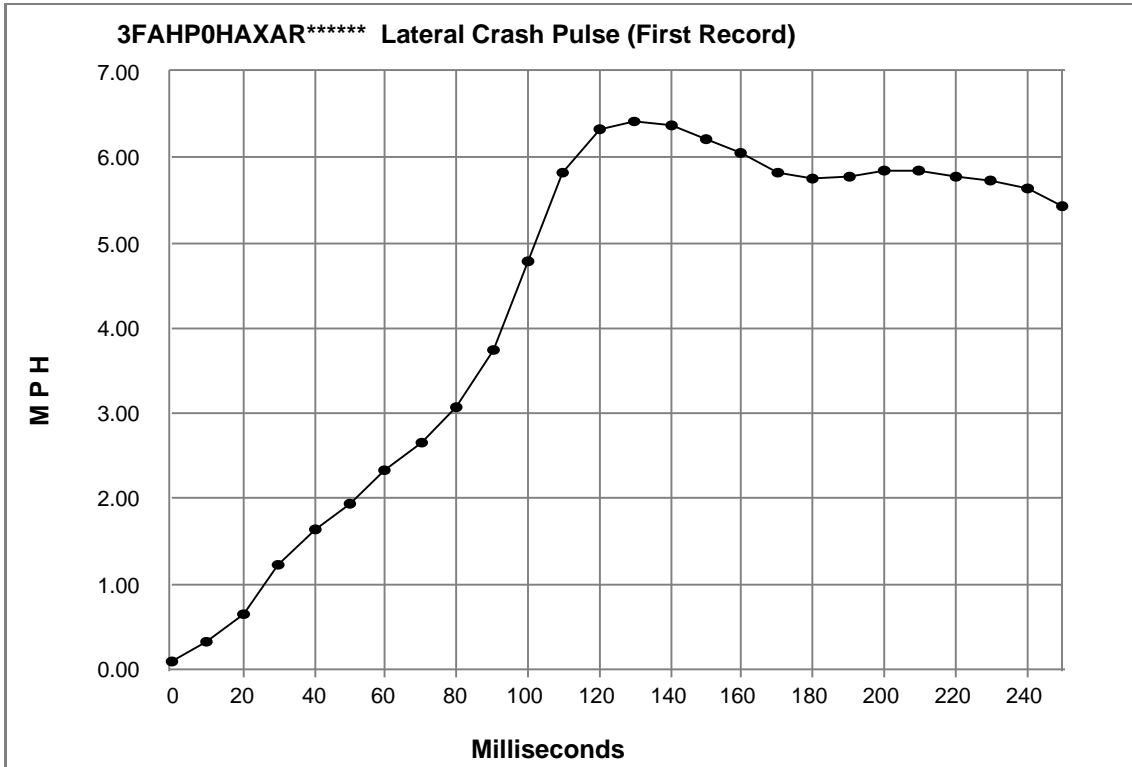
Lateral Crash Pulse (First Record)

Time (msec)	Delta-V, lateral (MPH)	Delta-V, lateral (km/h)
0	0.10	0.16
10	0.33	0.52
20	0.64	1.04
30	1.23	1.98
40	1.64	2.64
50	1.93	3.11
60	2.34	3.76
70	2.65	4.26
80	3.07	4.93
90	3.75	6.03
100	4.79	7.71
110	5.81	9.35
120	6.32	10.17
130	6.42	10.33
140	6.38	10.27
150	6.22	10.01
160	6.05	9.73
170	5.83	9.38
180	5.76	9.26
190	5.78	9.30
200	5.84	9.40
210	5.84	9.40
220	5.78	9.30
230	5.73	9.22
240	5.63	9.06
250	5.43	8.74

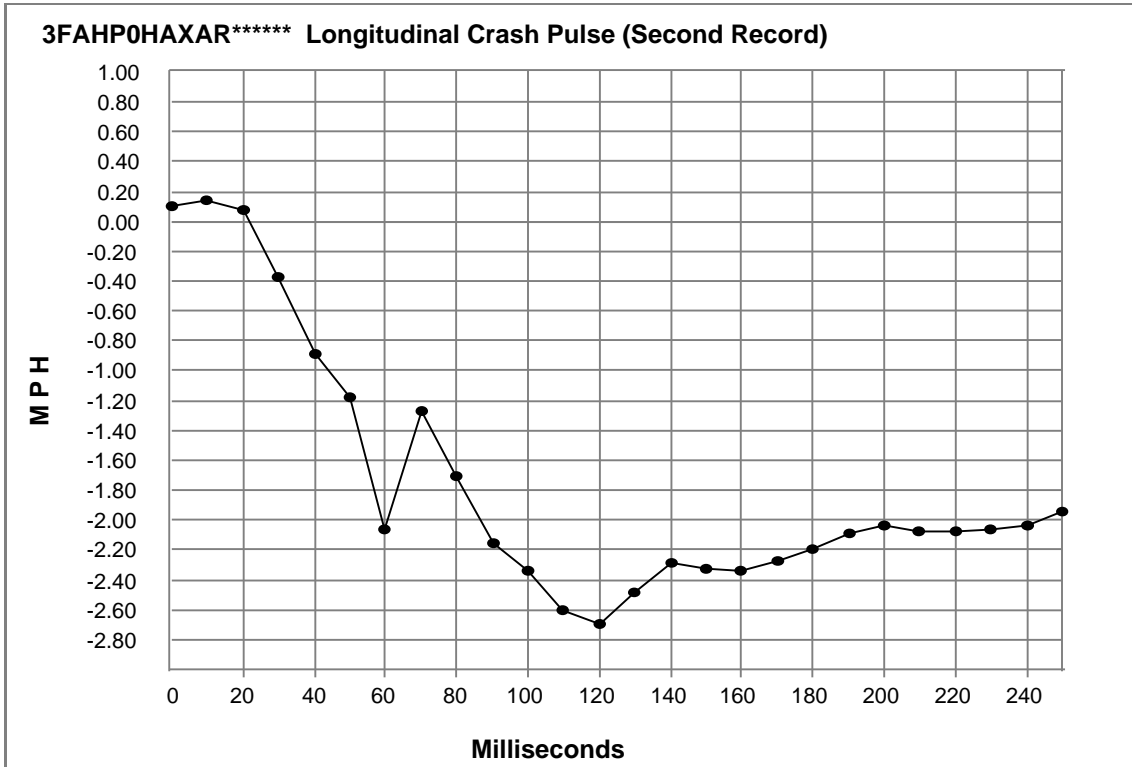
Longitudinal Crash Pulse (Second Record)

Time (msec)	Delta-V, longitudinal (MPH)	Delta-V, longitudinal (km/h)
0	0.10	0.16
10	0.14	0.22
20	0.07	0.12
30	-0.37	-0.59
40	-0.89	-1.43
50	-1.17	-1.89
60	-2.07	-3.33
70	-1.27	-2.05
80	-1.71	-2.75
90	-2.16	-3.48
100	-2.34	-3.77
110	-2.60	-4.19
120	-2.69	-4.33
130	-2.49	-4.01
140	-2.29	-3.69
150	-2.33	-3.75
160	-2.34	-3.77
170	-2.28	-3.67
180	-2.19	-3.53
190	-2.08	-3.35
200	-2.04	-3.29
210	-2.07	-3.34
220	-2.08	-3.35
230	-2.06	-3.31
240	-2.04	-3.28
250	-1.94	-3.13

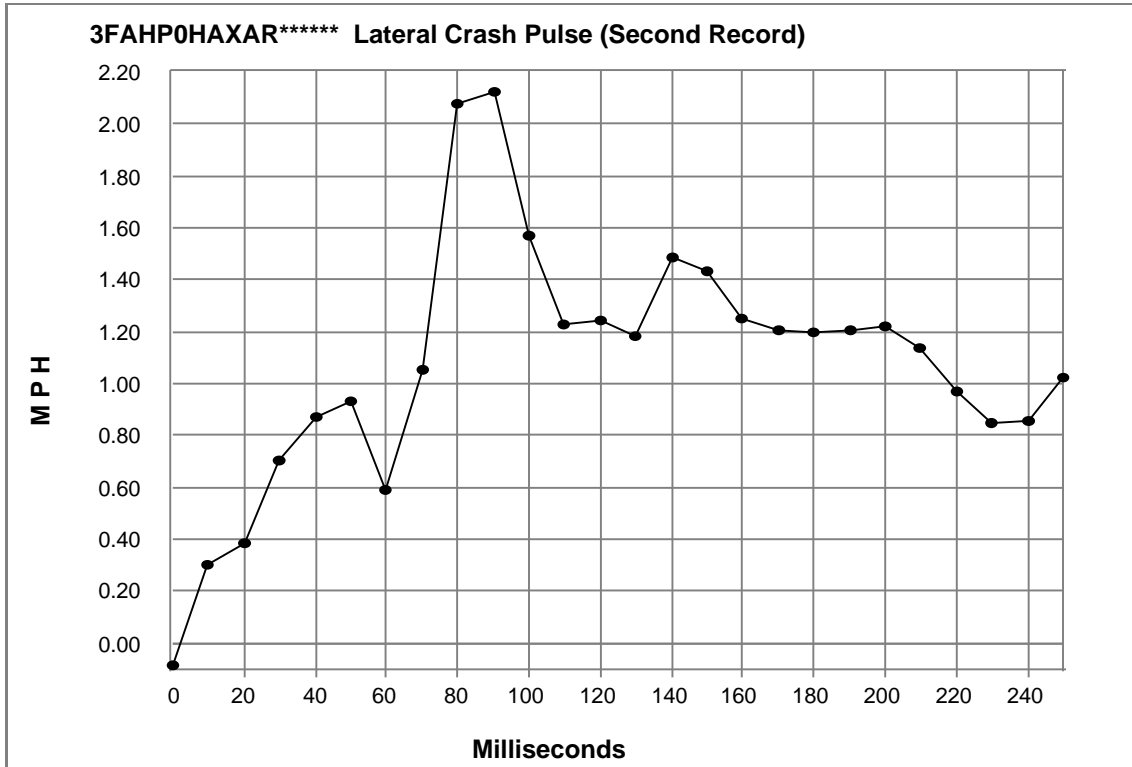
Lateral Crash Pulse (Second Record)

Time (msec)	Delta-V, lateral (MPH)	Delta-V, lateral (km/h)
0	-0.08	-0.14
10	0.30	0.49
20	0.39	0.62
30	0.70	1.13
40	0.87	1.41
50	0.93	1.50
60	0.59	0.96
70	1.05	1.69
80	2.08	3.35
90	2.12	3.42
100	1.57	2.53
110	1.23	1.98
120	1.24	2.00
130	1.18	1.90
140	1.49	2.39
150	1.43	2.31
160	1.25	2.01
170	1.21	1.94
180	1.20	1.93
190	1.21	1.94
200	1.22	1.96
210	1.14	1.83
220	0.97	1.56
230	0.85	1.36
240	0.86	1.38
250	1.03	1.65
