ON-SITE CERTIFIED ADVANCED 208-COMPLIANT VEHICLE INVESTIGATION

CASE NUMBER - IN10013

VEHICLE - 2007 Ford Mustang Convertible

CRASH DATE - January 2010

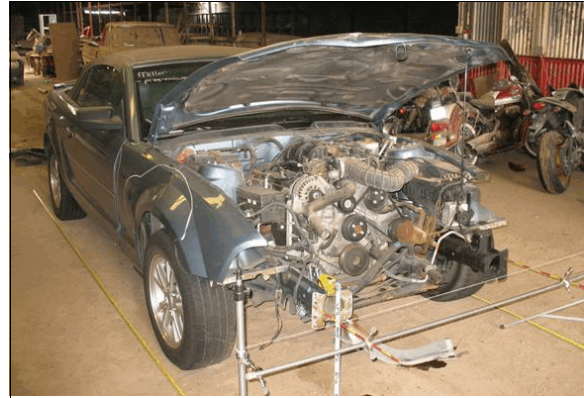
Figure 1: The damaged and partially repaired 2007 Ford Mustang convertible

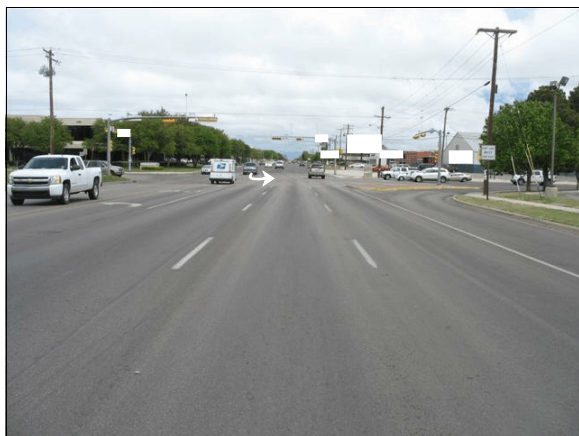
Figure 2: Approach of the Mustang to the intersection; arrow shows approach of the Focus

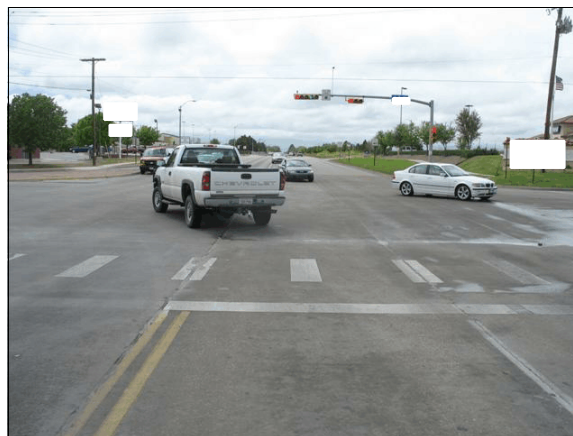
Figure 3: Approach of the Focus turning left from the left turn lane

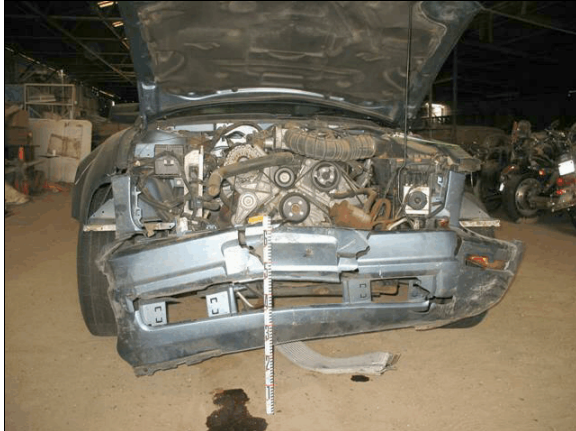
Figure 4: Front of Mustang; vehicle was under repair; bumper fascia placed on end of frame rails; bumper bar had been salvaged

Exterior Damage: The Mustang sustained front plane damage during the impact with the Focus. The front bumper fascia, both headlamp/turn signal assemblies, hood, and left fender were directly damaged. The direct damage began at the left corner of the front bumper fascia and extended 156 cm (61.4 in) across the bumper fascia. It was not possible to measure a front crush profile since the vehicle was under repair.

Damage Classification: The Collision Deformation Classification (CDC) for the front impact was 11FDEW1 (340 degrees). The Missing Vehicle algorithm of the WinSMASH program calculated the total Delta V as 12 km/h (7.5 mph). The longitudinal and lateral velocity changes were -11 km/h (-6.8 mph) and 4 km/h (2.5 mph), respectively. The results were borderline, since they were based only on the crush on the Focus.

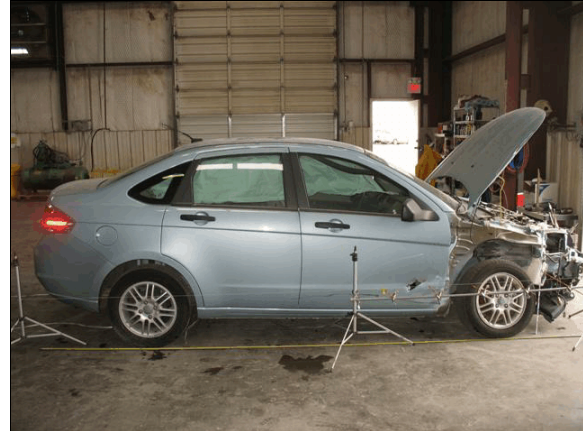
Figure 5: The Focus sustained impact damage on the right fender and right front door

Exterior Damage: The Focus sustained right side plane damage during the impact with the Mustang. The right fender, front wheel, and right front door were directly damaged. The direct damage began 169 cm (66.5 in) forward of the right rear axle and extended 162 cm (63.8 in) forward along the right side. A crush profile was estimated based on the damaged components remaining on the vehicle. The maximum residual crush was estimated to be 17 cm (6.7 in), which occurred at C₅. The table below presents the estimated crush profile.

Damage Classification: The CDC for the right side plane damage was 02RYEW2 (50 degrees). The Missing Vehicle algorithm of the WinSMASH program calculated the vehicle’s total Delta V as 15 km/h (9.3 mph). The longitudinal and lateral velocity changes were -10 km/h (-6.2 mph) and -11 km/h (-6.8 mph), respectively. The results appeared reasonable.

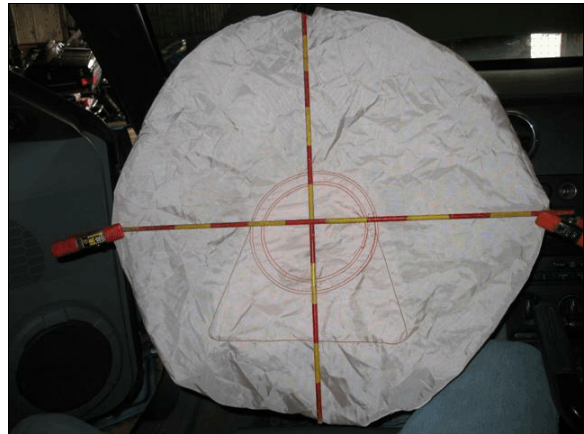
The driver's frontal air bag was located within the steering wheel hub and the module cover was a two flap configuration constructed of pliable vinyl. Each flap was 6.5 cm (2.6 in) in width and 17 cm (6.7 in) in height. A circular Mustang logo 6 cm (2.4 in) in diameter was mounted on the right flap. An inspection of the air bag module cover flaps revealed that they opened at the designated tear points and were undamaged. The deployed air bag (**Figure 6**) was 57 cm (22.4 in) in diameter and had two 7 cm (2.8 in) wide internal tethers. Two cross-shaped vent ports 4

cm 1.6 in) in width and height were located on the back of the air bag at the 11 and 1 o'clock positions. Inspection of the deployed air bag revealed no discernable evidence of occupant contact and no damage.

Figure 6: The driver's deployed frontal air bag

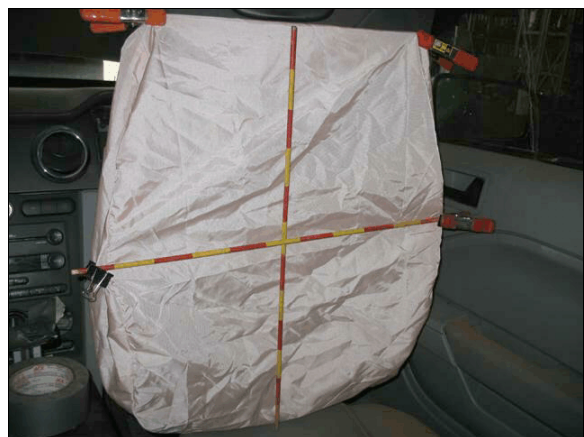
The front right passenger's frontal air bag was located within the middle of the instrument panel. The module cover consisted of two horizontal flaps constructed of medium gauge vinyl. Each flap was 41 cm (16.1 in) in width and 7 cm (2.8 in) in height. An inspection of the module cover flaps revealed that they opened at the designated tear points and were undamaged. The deployed air bag (**Figure 7**) was rectangular with a width of 51 cm (20.1 in) and a height of 65 cm (25.6 in) and had two cross-shaped vent ports 6 cm (2.4 in) in width and height. The vent ports were located on the left and right sides near the top of the air bag. Inspection of the air bag revealed no discernable evidence of occupant contact and no damage.

Figure 7: The deployed front passenger's frontal air bag

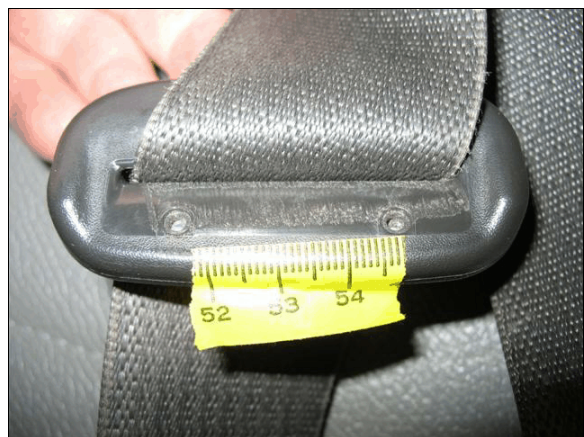
The inspection of the driver's safety belt assembly revealed that the pretensioner actuated. The retractor was jammed with a length of belt webbing extending out of the retractor consistent with usage. The belt webbing was 103 cm (40.6 in) in length as measured from the stop button to the upper anchor. A load abrasion was present on the latch plate belt guide (**Figure 8**). This evidence indicated that the driver was restrained in this crash.

Figure 8: Load abrasion on the driver's latch plate belt guide

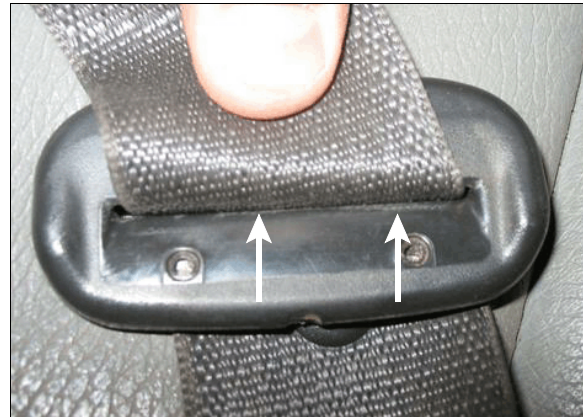
The inspection of the front right passenger’s safety belt assembly revealed a small load abrasion on the latch plate belt guide (**Figure 9**). While the pretensioner probably actuated, there was no evidence to confirm it. The retractor was not jammed and the belt webbing freely extended and retracted. The load mark evidence on the latch plate belt guide indicated that the front right passenger was restrained in this crash.

Figure 9: Load abrasion on front passenger’s latch plate belt guide

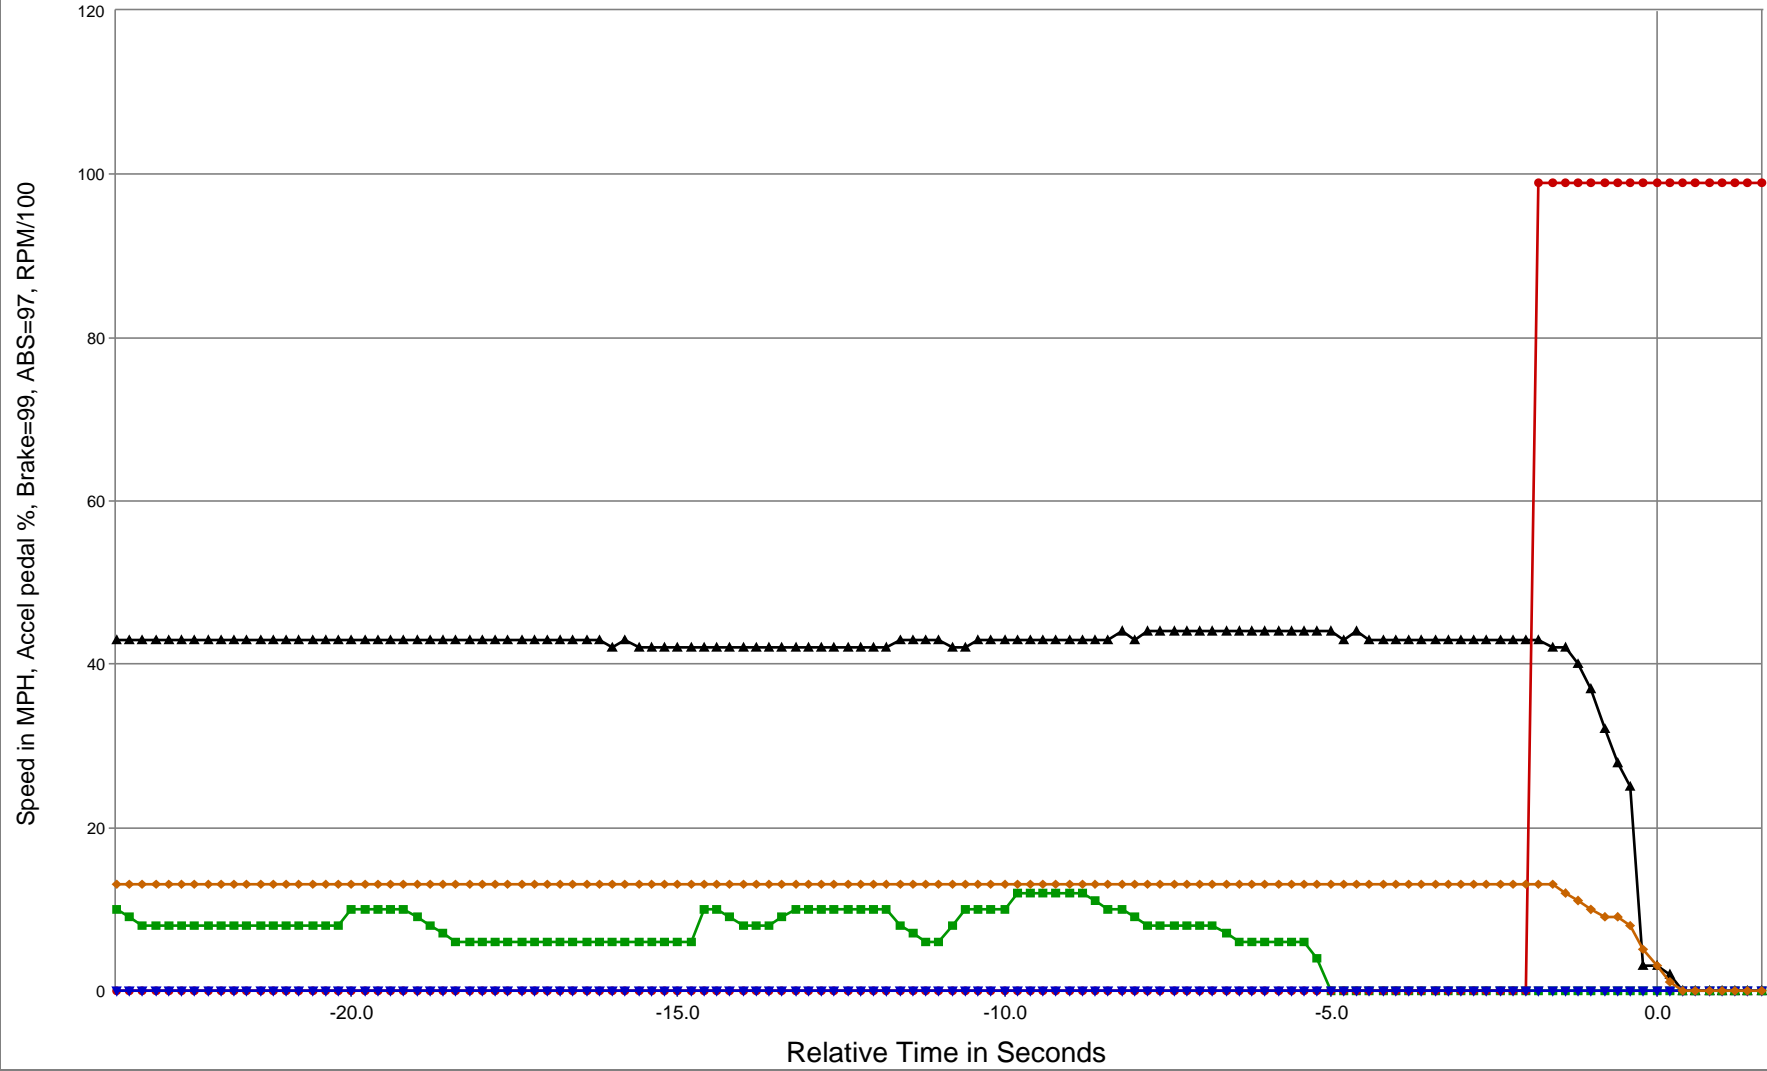
1ZVFT84NX75***** PCM EDR Crash Data - RDS Received

▲ Vehicle Speed (MPH) ■ Accelerator Pedal (%) ● Brake Switch (0=Off/99=On) ▼ ABS (0=Inactive/97=Active) ◆ RPM/100
