On-Scene / Vehicle to Fixed Object  
Dynamic Science, Inc. / Case Number: DS9712  
1996 Infiniti I30  
California  
November, 1996

1. Report No. DSI9712		2. Government Accession No.		3. Recipient Catalog No.	
4. Title and Subtitle <b>In-Depth Accident Investigation</b>				5. Report Date July/1997

Description: This case was initiated in response to a report of an airbag-related fatal injury to a driver. Vehicle 1 was a 1996 Infiniti I30 driven by a 58-year-old female.

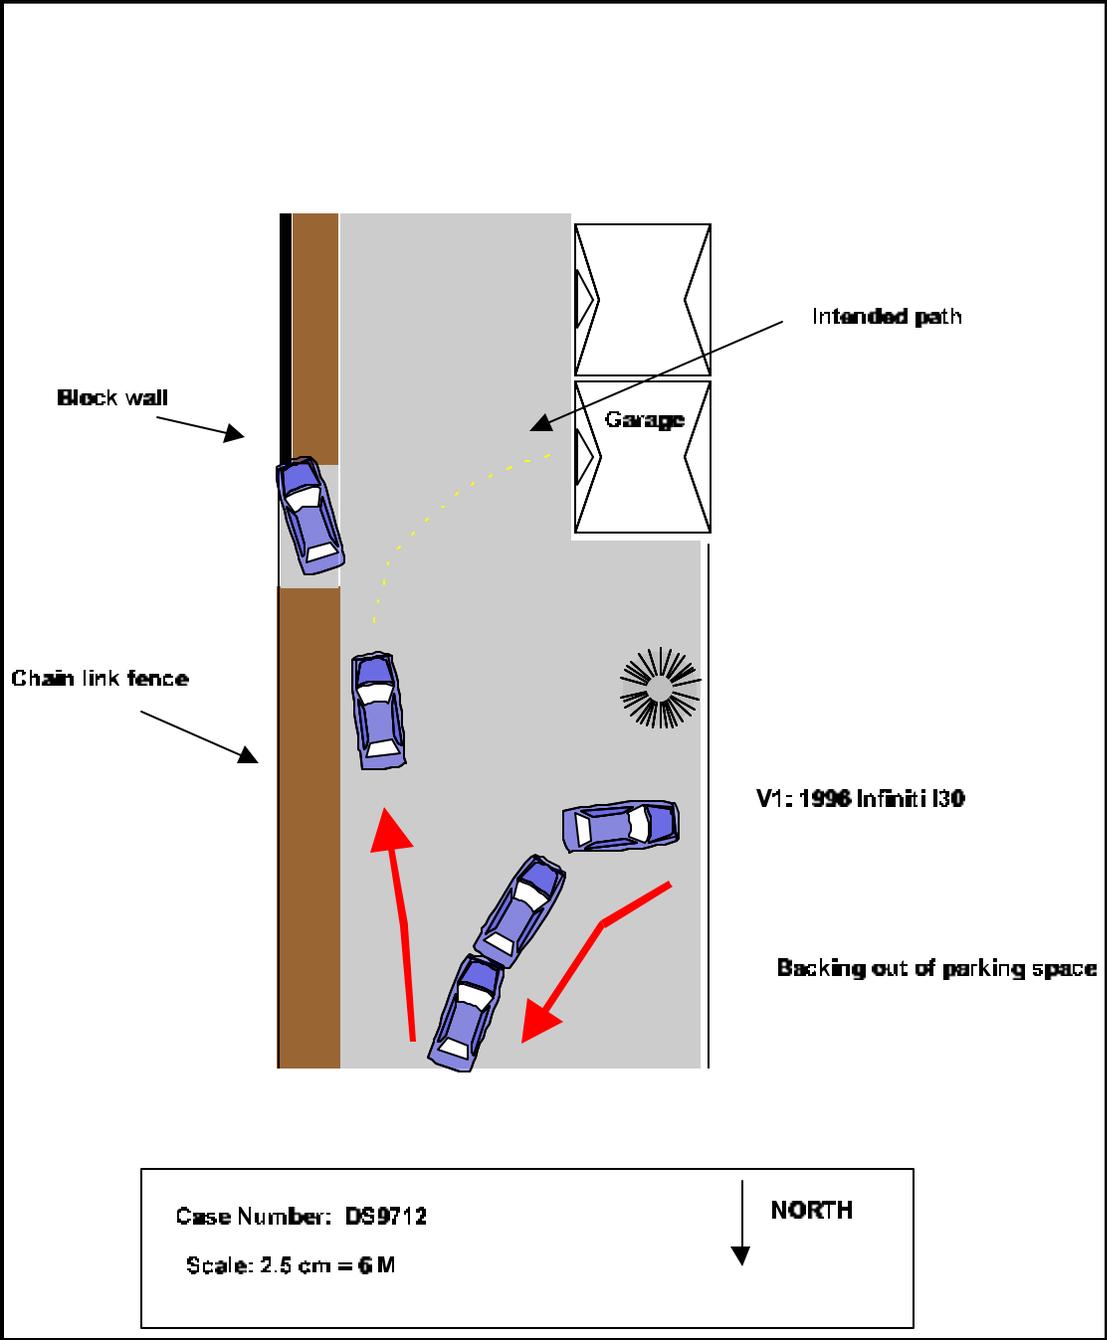
Scene Diagram

This collision occurred in California in November 1996 at 1359 hours. The weather was clear and there were no unusual road conditions. Vehicle 1, a 1996 Infiniti I30 driven by a 58-year-old female (160 cm/63 in., 68 kg/150 lbs.), had originally backed out of a parking space going north and then began traveling southbound down an alley at approximately 18.5 km/h (11.5 MPH)<sup>1</sup>. Police arriving on scene indicate that the driver was using the lap and shoulder belts. It appears that it was the driver's intent to park the case vehicle in her garage--which is to the right in Figure 1. According to the engineer who notified the NHTSA, the driver had pressed the button on the garage door opener and the garage door had opened to some small extent.

For reasons which may never be known (the driver has a history of seizures), the vehicle went to the left and struck a concrete wall which was parallel to the roadway. Both air bags deployed. Vehicle 1 sustained moderate damage (12FLEN1) with a delta V of 18.2 km/h (11.3 MPH). Investigating police officers did not see any indications of skid marks on the roadway or on the dirt shoulder leading to the impact area.

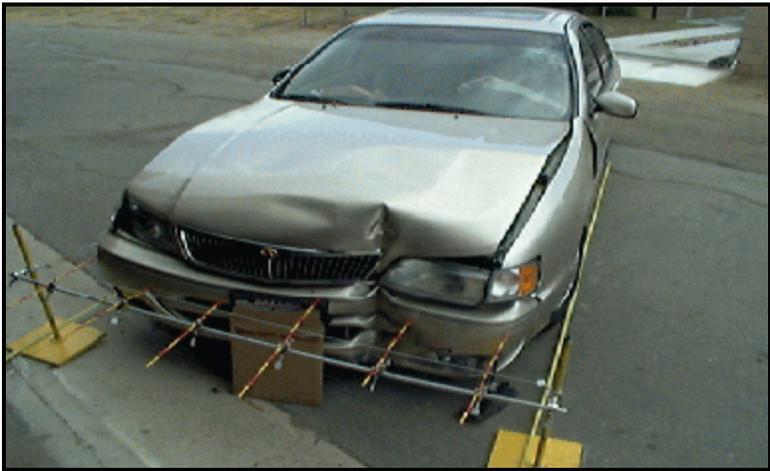
Description:	1996 Infiniti I30 4-door	
VIN:	JNKCA21D5TTxxxx	
Odometer:	8364 km (5197 miles)	
Engine:	Unknown	
Reported Defects:	None	
Cargo:	None	
Damage Description:	Moderate rearward crush of the front bumper; primarily to the left side.	
CDC:	12FLEN1	
Delta V: <sup>2</sup>	Total	18.2 km/h (11.3 MPH)
	Longitudinal	-18.2 km/h (-11.3 MPH)
	Latitudinal	0 km/h (0 MPH)
	Energy	20,764 joules (15314 ft-lb)

Figure 2. Exterior, Vehicle 1

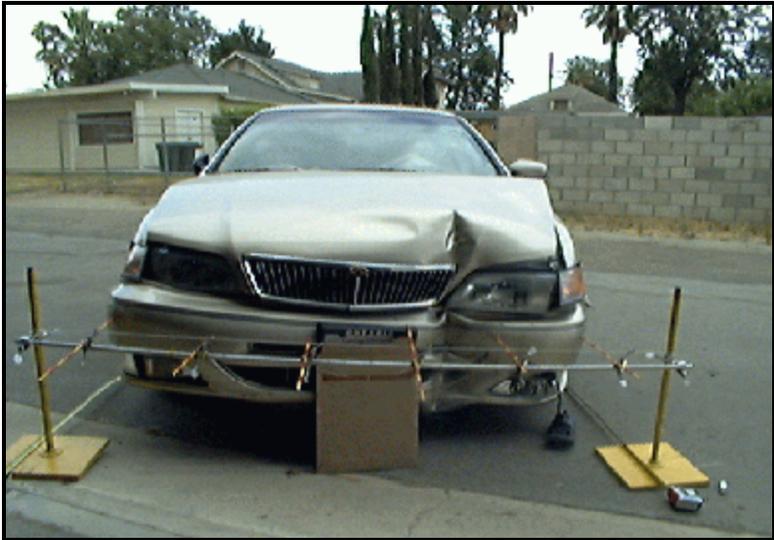
Figure 3. Exterior, Vehicle 1

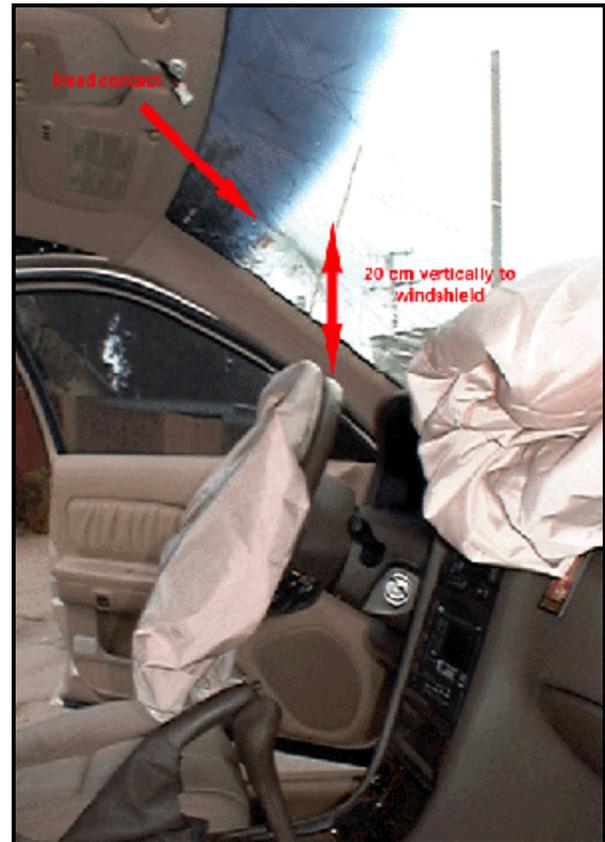
This vehicle is equipped with bucket seats in the front and a bench seat in the rear. The left front seat was farther back than the right. Both seats are controlled electronically. The driver's seat was slightly reclined. The driver's side airbag had a single tether and two vents. It had a maximum deployed excursion of 32 cm (12.5 in.). The passenger side airbag was enclosed in a mid-mount module. The airbag had no tethers and two vents. Neither airbag sustained any damage. There were faint indications of facial contact to the back side of the driver's airbag in the area near the vent holes. There was no intrusion nor any integrity loss to the interior of the vehicle.

Figure 4. Vehicle Interior, side view

It appears that all the injuries sustained were as a result of the airbag deployment. The driver likely leaning forward. At impact, the driver would have gone further forward. At deployment the driver's head was driven upward and to the left into the windshield, causing the frontal scalp contusion and the contusions to the right chin and neck (note the relationship between the windshield strike and the steering wheel rim shown in Figure 4). The deploying airbag then struck the driver in the chest causing the rib fractures and aorta laceration and drove the driver backwards into the seatback where she came to rest.

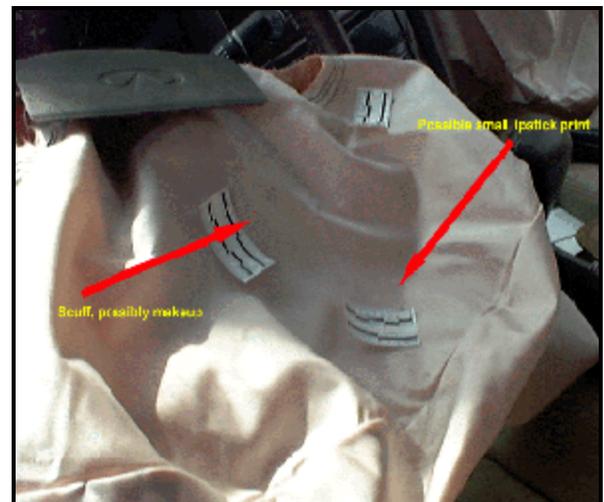
Figure 5. Back side of driver airbag
