Remote / Vehicle to Vehicle / Front to Front  
Dynamic Science, Inc. / Case Number: DS97015  
1994 Nissan Sentra  
Washington  
August 1994

1. Report No. DSI9715		2. Government Accession No.		3. Recipient Catalog No.	
4. Title and Subtitle In-Depth Accident Investigation				5. Report Date November/1997

Dynamic Science, Inc.  
Accident Investigation  
Case Number: DS97015

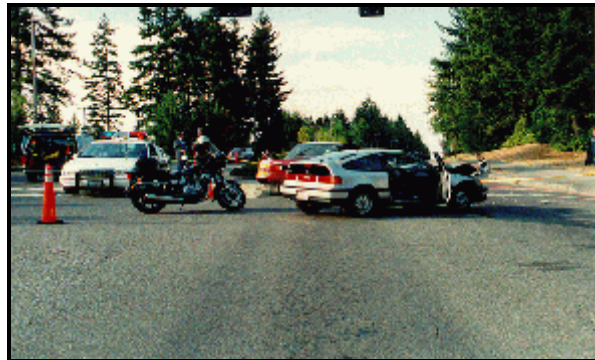
**Figure 1.** Final rest - Vehicle 2 can be seen in the foreground and Vehicle 1 is behind Vehicle 2.

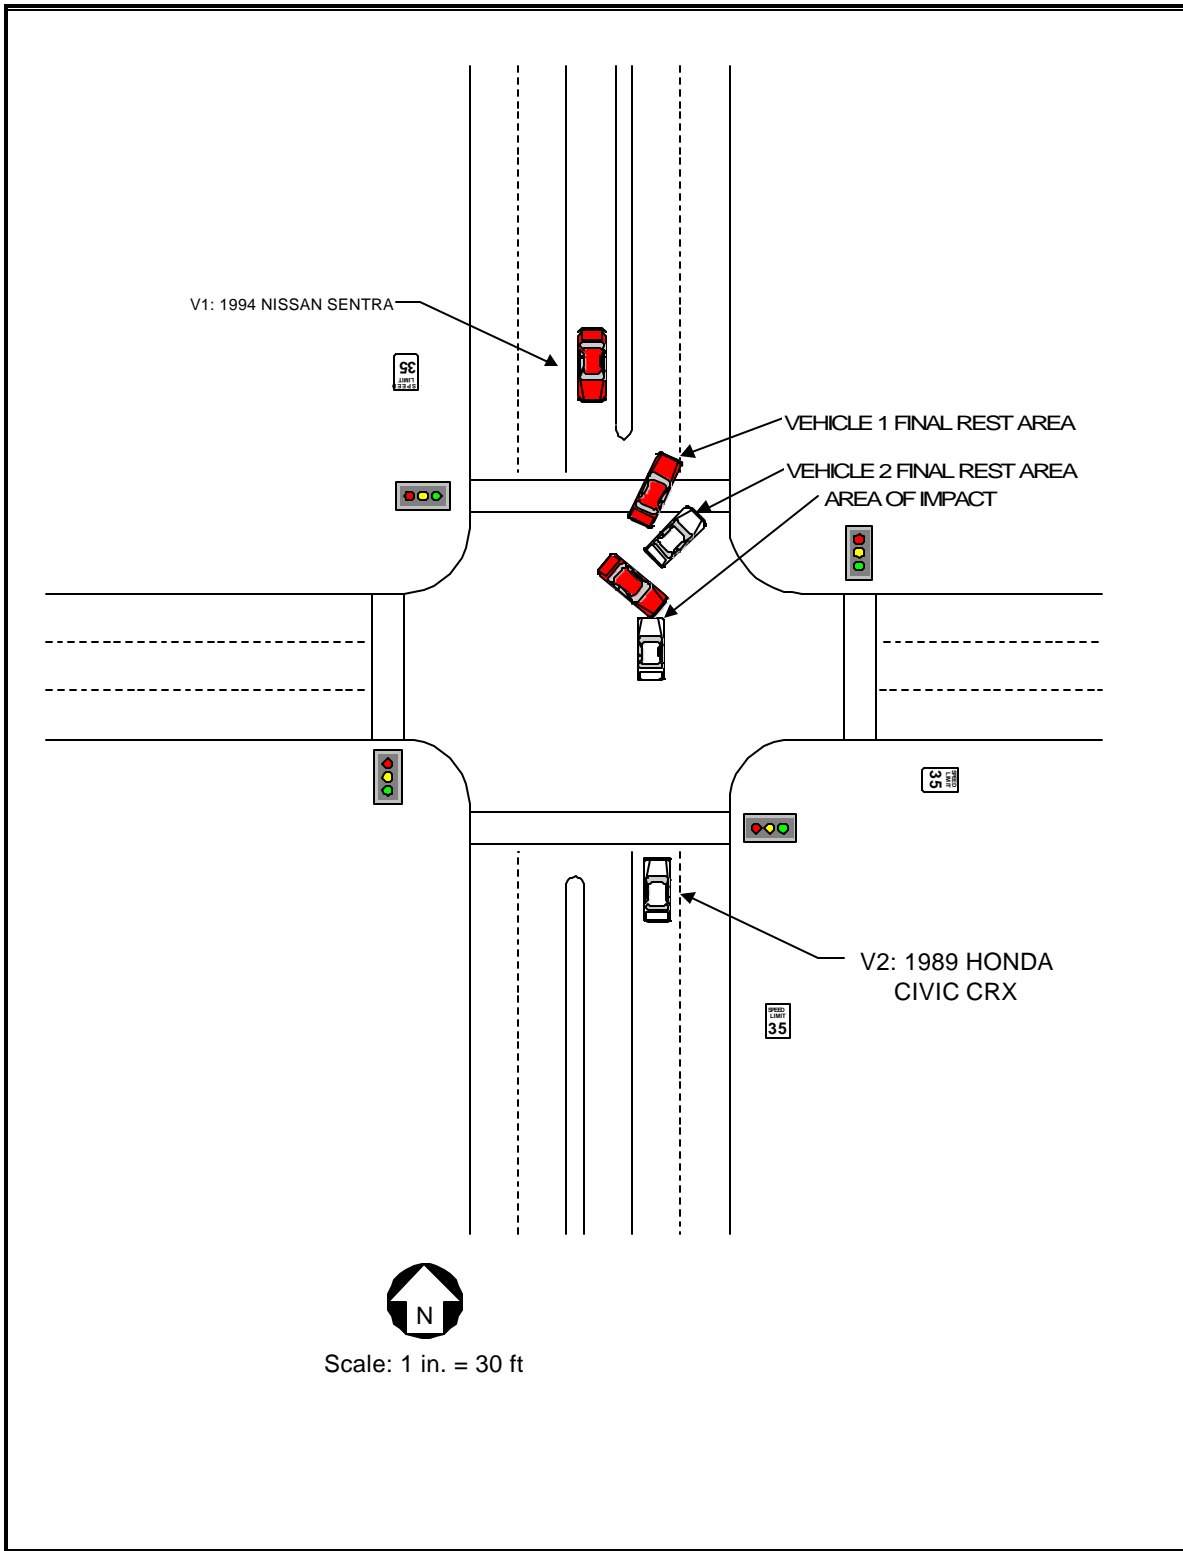
Figure 2. Scene diagram

This collision occurred in Washington in August, 1994 at 1552 hours. Vehicle 1, a 1994 Nissan Sentra driven by a 58 year-old male (163 cm / 64 in., 52 kg / 115 lbs.), was traveling southbound approaching a four-leg intersection. The driver shoulder belt was in use, but the driver lap belt was not in use. Vehicle 2, a 1989 Honda Civic CRX driven by a 51 year-old female was traveling northbound at a police estimated speed between 51 km/h (32 mph) and 56 km/h / (35 mph), also approaching the intersection. As Vehicle 2 entered the intersection, Vehicle 1 began a left-hand turn. The front-right of Vehicle 1 was struck by the front of Vehicle 2. Vehicle 1 sustained a longitudinal  $\Delta v$  of -17 km/h (10.5 mph). The airbag in Vehicle 1 was deployed by the longitudinal force of this impact. Vehicle 1 was pushed into a counterclockwise rotation and came to rest in the roadway facing south-southwest. Vehicle 2 was pushed into a clockwise rotation and also came to rest in the roadway facing southwest, a short distance south of Vehicle 1.

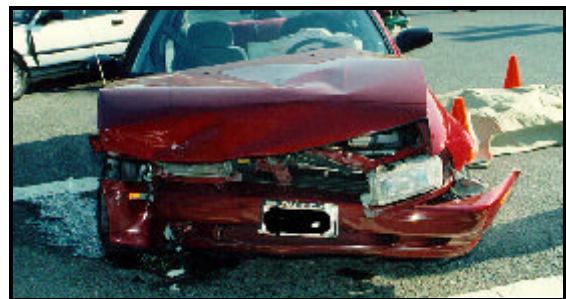
**Figure 3.** Vehicle 1 - Exterior

Description:	1994 Nissan Sentra four-door sedan
VIN:	1N4EB31F1RCXXXXXX
Odometer:	Unknown
Engine:	Four cylinder 1.6 L
Reported Defects:	None
Cargo:	None reported
Damage Description:	Moderate damage to front and front-right with bumper shifted to the left.
CDC:	01FZEW2 (Impact #1)
Delta V: (Impact #1)	Total            22.2 km/h (14.4 mph)  Longitudinal    -17.0 km/h (-11.0 MPH)  Latitudinal    -14.3 km/h (-9.2 MPH)  Energy          39,536 joules (29,160 ft-lb)

This vehicle is equipped with two rows of seats. The front seats are both bucket seats. The driver's seat back appears to be reclined slightly rearward from its full upright position. There does not appear to be any intrusion or integrity loss. This case was initiated in response to a report of an airbag-related driver fatality. This case is being conducted as a remote investigation.

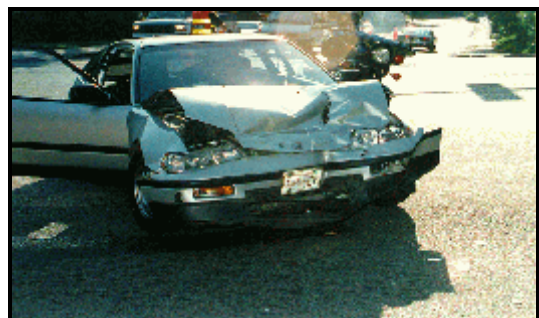
**Figure 4.** Vehicle 2 - Exterior

Description:	1989 Honda Civic CRX
VIN:	JHMED8358KSXXXXXX
Odometer:	Unknown
Engine:	Unknown
Reported Defects:	None
Cargo:	None reported
Damage Description:	Moderate damage to front and front-left with bumper shifted slightly to the right.
CDC:	12FYEW2 (Impact #1)
Delta V: (Impact #1)	Total            26.8 km/h (16.7 mph)
	Longitudinal    -37.0 km/h (-22.9 MPH)
	Latitudinal      2.0 km/h (1.2 MPH)
	Energy            31,433 joules (23,183 ft-lb)

This vehicle is equipped with two rows of seats. The front seats are both bucket seats. The driver's seat back appears to be inclined slightly rearward from its full upright position. There does not appear to be any intrusion or integrity loss. The 51 year-old female driver of Vehicle 2 was transported for medical treatment.

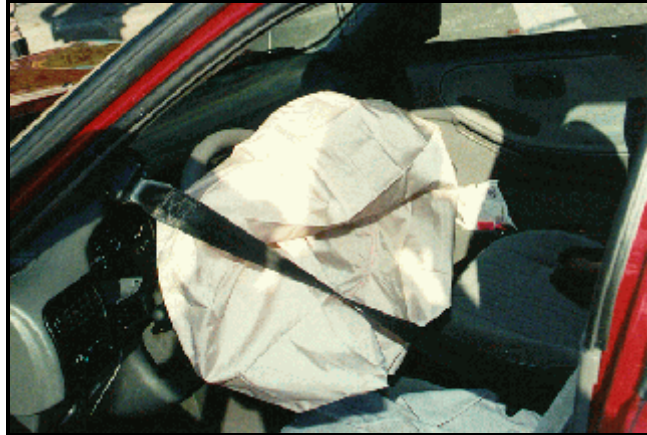
**Figure 5.** Vehicle 1 - Interior

The driver of Vehicle 1 was apparently seated with his seat adjusted to a position where the lower rim of the steering wheel was slightly rearward of the front edge of the seat cushion. The seat cushion was covered with what appears to be a terrycloth towel. The driver was restrained by the motorized shoulder harness, but was not wearing the manual lap belt in conjunction with the shoulder harness. During the impact, the driver likely moved forward and to his right, with his lower torso submarining to some extent. With his left shoulder restrained by

the shoulder harness, his upper body twisted in a counterclockwise direction, allowing the right side of his chest to strike the airbag as it deployed, resulting in the right anterior rib fractures, sternal fracture, and right side hemothorax. The force of the deploying airbag may have projected him rearward with his back left striking the driver's seatback, resulting in the left posterior rib fractures and left side hemothorax. The primary cause of his injuries appears to be his interaction with the deploying airbag. Abrasions on his forehead may have been caused by the interaction of eyewear to the deploying airbag, but it is unknown if eyewear was worn.
