Remote Investigation, Vehicle v. Animal
Dynamic Science, Inc. (DSI), Case Number (DS97026)
1995 Ford Windstar GL 4x2 van
Colorado
October, 1997

Dynamic Science, Inc.
Accident Investigation
Case Number: DS97026

Description: This case was initiated in response to a report of an air bag related seriously injured right front passenger. The case is being conducted as a remote investigation. The NHTSA was notified by the vehicle owner via the Office of Safety Defects.

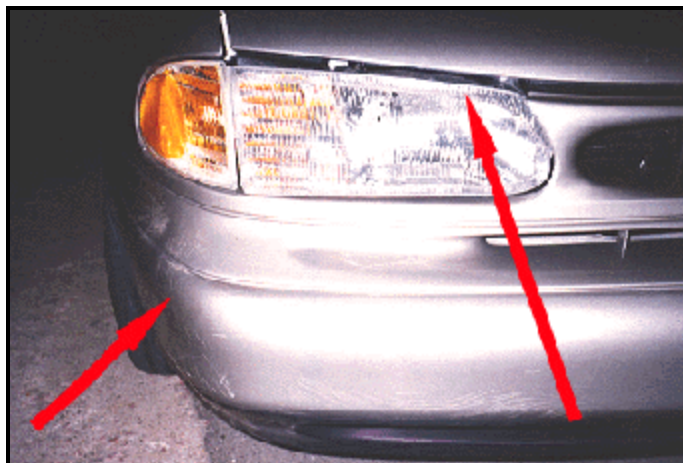
Figure 2. Right front bumper, case vehicle

Description:	1995 Ford Windstar GL 4x2 van	
VIN:	2FMDA5146SBxxxxxx	
Odometer:	38,212 km (23,745 miles)	
Engine:	3.8 L EFI V-6	
Reported Defects:	None	
Cargo:	None	
Damage Description:	Scratches and fragments of hair were found on the right front bumper	
CDC:	12FREW1	
Travel Speed	32.9 km/h (20.5 mph)	
Delta V:	6.2 km/h (3.9 mph)	Estimated. Based on a coefficient of restitution of 0.01, and a closing velocity of 5.86 fps.

The vehicle was towed from the scene and has subsequently been repaired. Scratches and fragments of hair were found on the right front bumper. Both air bag modules were replaced, the front bumper was aligned, and the fascia was refinished. In addition, both rear window latches were replaced. According to the driver, both of these had somehow been damaged as a result of the crash. The nature of the damage is not known. In addition, the right front seat belt was replaced. According to body shop personnel, the seat belt was replaced solely to reassure the driver. Prior to its replacement, it was tested by body shop personnel and seemed to function correctly.

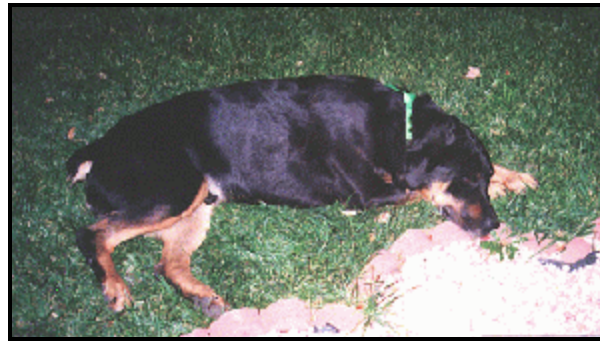
Figure 4. Struck dog

The dog was injured and was later taken to the Humane Society by the local animal control department.

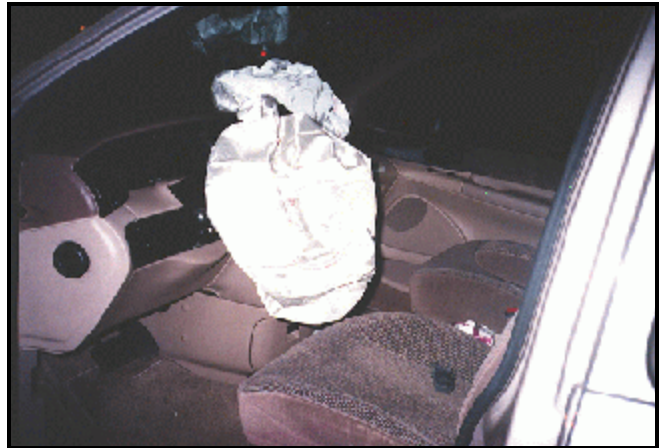
Figure 6. Vehicle interior, left front

The driver (178 cm / 70 in., 95 kg / 210 lbs.) was seated in a normal upright fashion in the front left bucket seat. Both hands were on the steering wheel at the 10 and 2 o'clock positions. According to the driver, the seat was positioned to the rear-most position. The driver states that he was wearing the lap and shoulder belt in a proper fashion. The driver saw the dog prior to the collision and braked hard with his right foot. The driver went forward during braking. According to the driver, the air bags deployed as the front right bumper struck the dog. As the air bag deployed, the bag struck the inside of both arms, causing minor abrasions. The driver does not recall his hands leaving the wheel.

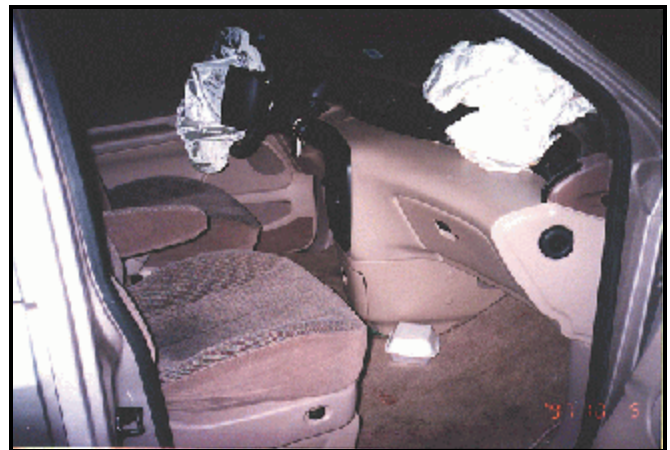
Figure 7. Vehicle interior, right front

The glasses worn by the right front occupant were knocked off during the air bag deployment and were later recovered in the rear of the vehicle. The glass had been knocked out of the frame.

The right front occupant (152 cm /60 in.) was seated in a normal upright fashion in the front right bucket seat. According to the driver, the seat was positioned in the rear-most position. She may have been holding leftovers in a Styrofoam container. According to the driver, she was wearing the lap and shoulder belt in the proper fashion. Prior to the collision with the dog, the driver braked. This occupant likely pitched forward to some degree. At impact, the air bag deployed and contacted this occupant's face, as evidenced by the general abrasions to the face and the eyeglass contact to the bridge of the nose. The glasses were knocked off the occupant's face during the deployment. The occupant's head was forced backwards causing the flexion/extension injury to the neck. The blow to the face appears to have been the cause of the frontal brain contusions.
