**CALSPAN REMOTE INADVERTENT SIDE AIR BAG DEPLOYMENT
INVESTIGATION**

CALSPAN CASE NO. CA97-27

SUBJECT VEHICLE - 1995 VOLVO 850

INCIDENT DATE - MAY, 1997

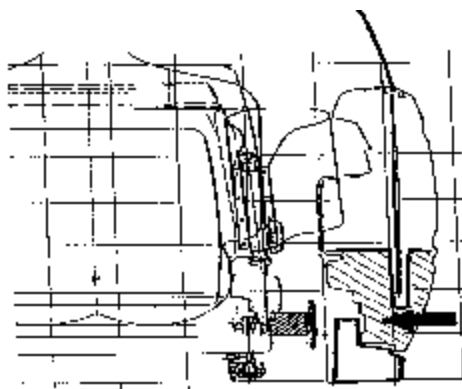
Volvo's Sipsbag Seat Installation

The Sipsbag's sensor was located on the outboard aspect of the lower seat frame and the module was contained in the outboard seat back. The ventilated Sipsbag was made of polyamide with an internal coating of silicone rubber. It was designed to deploy when an impact triggers a mechanical sensor and drives a firing pin into a percussion cap. Speed, force, and deformation equivalent to a side impact at a minimum of approximately 18 km/h (11 mph) is required to initiate the deployment of the side air bag system. The conditions required to trigger the Sipsbag are:

- Speed > 2 m/s
- Force > 500 N
- Stroke > 2 mm

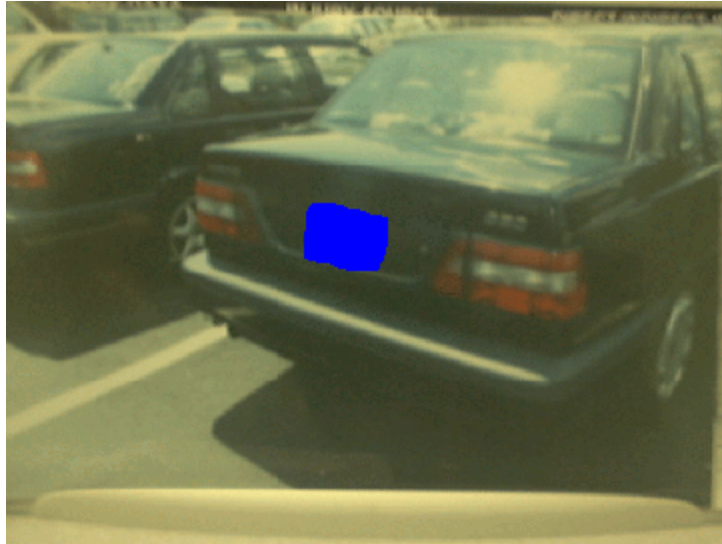
1. Identification of the subject vehicle

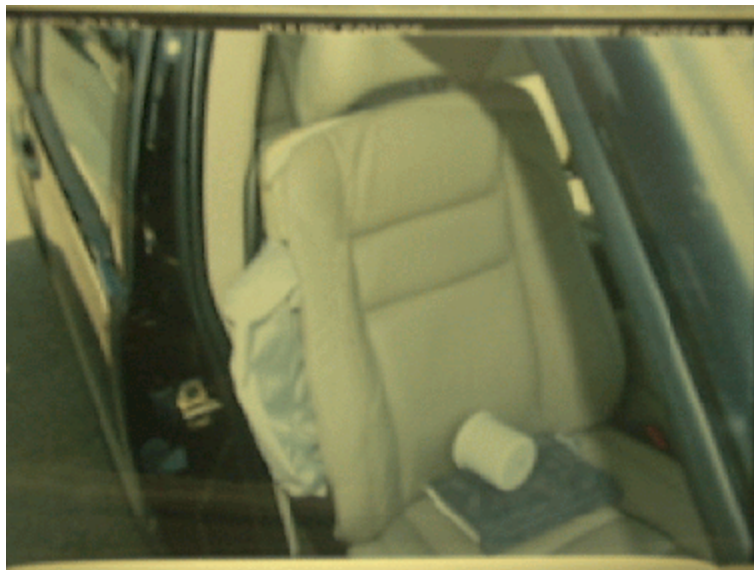
2. View of the deployed passenger side Sipsbag and the separated stitching on the outboard and superior aspects of the right front seat back.

On the date of the incident, the adult male driver of the Volvo drove to pickup the four teenage occupants from playing street hockey. Three of the males took positions in the rear seat of the Volvo while the remaining male was seated in the right front position of the vehicle. This occupant did not have adequate room to place his hockey stick in front of him and, therefore he positioned the stick between the right front sill area and the right front seat at the location of the Sipsbag's sensor unit. The right front door was still open at this time. This occupant then closed the door which compressed the hockey stick against the seat frame and the triggering mechanism subsequently initiated the Sipsbag's deployment sequence. The deployment of the passenger side Sipsbag caused the stitching of the leather seat back on the outboard and superior aspects to separate. A safety report from Volvo Car Corporation (Paper No. 94 S6 O 13) indicates that this is normal on the outboard side of the seat back. The cost incurred to replace the Sipsbag and repair the seat back was \$1300.00.

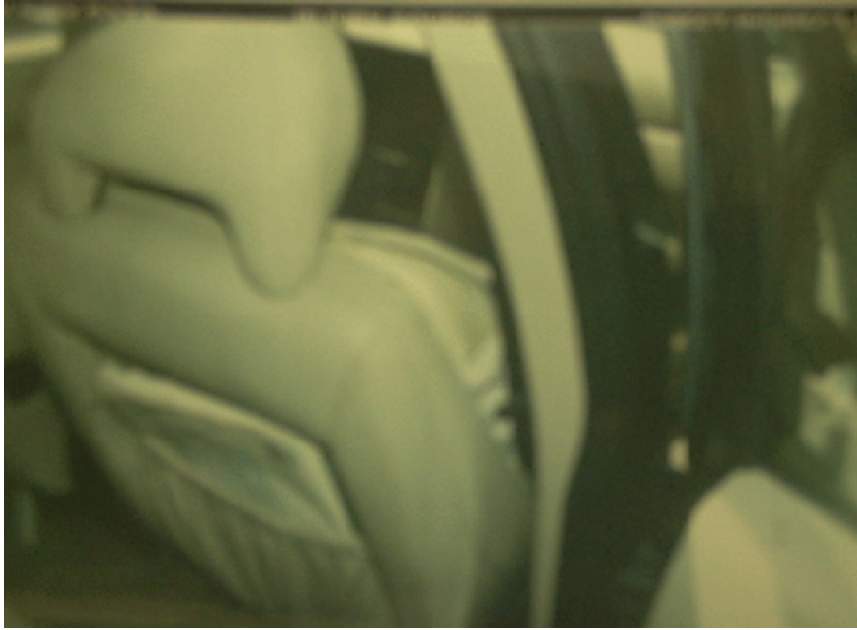
3. Posterior view of the separated stitching on the right front seat back.
