**TRANSPORTATION SCIENCES
CRASH RESEARCH SECTION**

**CALSPAN REMOTE DEPOWERED AIR BAG DEPLOYMENT INVESTIGATION
CALSPAN CASE NO. CA97-34
SUBJECT VEHICLE - 1998 PONTIAC GRAND AM GT
VEHICLE #2 - 1994 OLDSMOBILE CUTLASS SUPREME S**

**LOCATION: STATE OF MICHIGAN
CRASH DATE: SEPTEMBER, 1997**

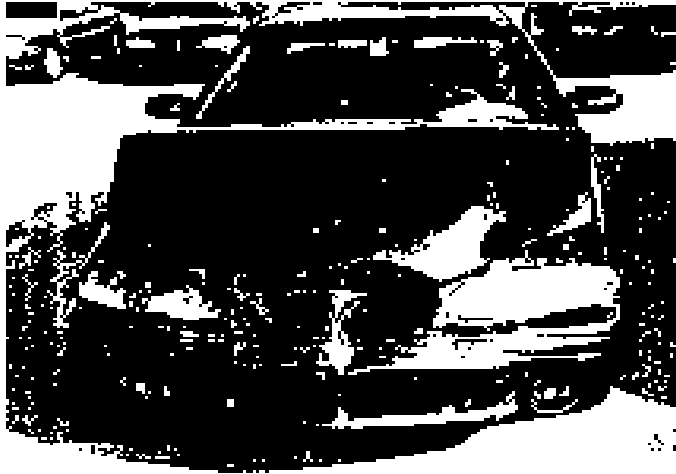
1. View of the damaged frontal plane of the 1998 Grand Am.
