**REDESIGNED AIR BAG SPECIAL STUDY (RABSS)
SCI TECHNICAL SUMMARY REPORT**

NASS CDS CASE 1998 - 11-135J

VEHICLE - 1998 DODGE DAKOTA PICKUP TRUCK

LOCATION - MICHIGAN

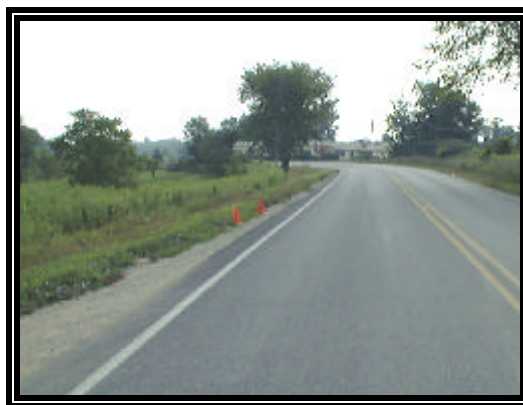
Figure 1: Trajectory view prior to roadside departure.

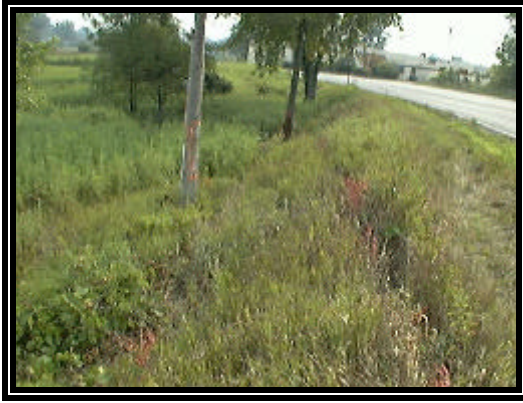
Figure 2: Trajectory view approaching the sideswipe impact.

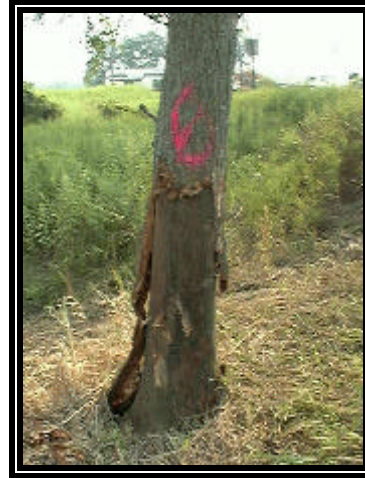
Figure 3: View of the point of impact.

Immediately beyond the sideswiping impact, the negative grade to the north began to level and the negative grade increased to the east. The vehicle listed right to a more level attitude. Approximately 19 m (62 ft) beyond the first impact, the Dodge struck a 30 cm (12 in) tree with the front right center aspect of the vehicle. The maximum deformation measured 110 cm (43 in) and was located 30 cm (12 in) right of the vehicle centerline. The force of the impact caused a forward weight shift and negative pitch of the vehicle. The rear wheels probably left the ground. The Dakota then rotated approximately 30 degrees clockwise and rebounded from the tree. The pickup came to rest facing southeastward approximately 5 m (15 ft) from the tree. The delta V of the impact was 56+ km/h (35+ mph). The vehicle's SRS deployed as a result of the impact.

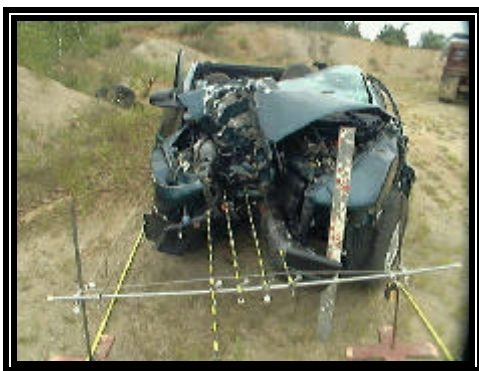
Figures 4 and 5 are the front and right side views of the Dodge Dakota. The Dodge sustained 36 cm (14 in) of direct contact damage to the right center aspect of the frontal plane. The damage began 18 cm (7 in) right of center and extended to the right. The direct contact damage occurred in-board of the right frame rail and was directed longitudinally rearward. The measured crush profile was as follows: C1=23 cm (9 in), C2=118 cm (46 in), C3=119 cm (47 in), C4=116 cm (46 in), C5=112 cm (44 in), C6=69 cm (27 in), L=35 cm (14 in). The 12 o'clock direction of the impact force deformed the frontal structure of the pickup rearward into engine compartment. The magnitude of the force caused buckling of the truck frame rearward of the B pillar. The back of the cab contacted the forward edge of the pickup bed due the compressive forces of the crash. Both doors remained closed and were buckled. The right wheelbase was fore-shortened 49 cm (19 in).

Figure 4: Front view of the Dodge Dakota.

The Collision Deformation Classification (CDC) of this impact was 12-FREN-05. Forensic analysis of the vehicular damage and SCI experience indicated the delta V of this crash was above 56 km/h (35 mph). Reconstruction of this crash through the use of the WINSMASH model calculated a barrier equivalent delta V of 63 km/h (39 mph) using pole impact parameters.

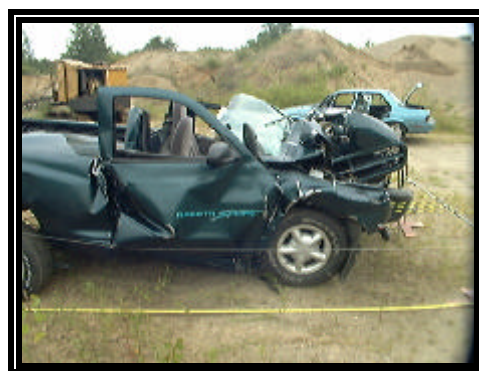
Figure 5: Right side view of the Dodge.

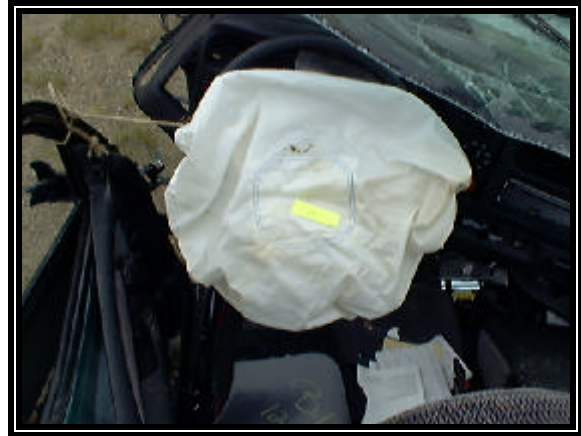
The vehicle was equipped with a Supplemental Restraint System that consisted of redesigned driver and right front passenger air bags. The air bags had deployed as a result of the crash. The driver air bag was housed in the typical manner in the center hub of the steering wheel. There was no contact evidence on the exterior surfaces of the module cover flaps. The driver air bag measured 48 cm (19 in) in its deflated state. The bag was tethered by 2 internal straps and vented internally back through the inflator. A blood smear was identified on the face of the air bag, **Figure 6**. Linear gray/black scuffs were noted in the 10 o'clock sector of the back side of the bag. These scuffs were indicative of an impeded deployment and developed from frictional contact with the interior surface of the upper cover flap.

Figure 6: View of the driver air bag.

The vehicle's SRS deployed due to the force of the impact, however deployment probably occurred late in the collision sequence as referenced above. The forward position of the driver caused the driver to contact the driver air bag prior to full inflation. His forward kinematic pattern loaded the steering column through the inflating air bag evidenced by the full displacement of the column from the shear capsules. The sudden deceleration of the driver's upper torso caused by the combined 3-pt restraint and air bag loading resulted in violent flexion of the head/neck complex. The linear and angular acceleration of the head/neck resulted in the cerebral sub-arachnoid hemorrhages, the right inferior fronto-temporal cortical contusions, the diffuse axonal cerebral injury and a C6/C7 cervical fracture. The expansion of the air bag abraded the driver's face and chin. The driver then rebounded, striking his occipital scalp on an unknown source.
