**REDESIGNED AIR BAG SPECIAL STUDY (RABSS)
SCI TECHNICAL SUMMARY REPORT**

NASS CDS CASE NO. 1998-13-182E

RABSS VEHICLE - 1998 CHEVROLET CAVALIER

CRASH DATE - AUGUST, 1998

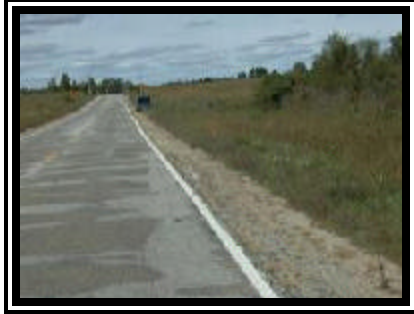
Figure 1. Northbound approach for the 1998 Chevrolet Cavalier.

The 36 year old male driver of the 1998 Chevrolet Cavalier was operating the vehicle northbound (**Figure 1**) when he became involved in an argument with the front right passenger. During the argument, the passenger reportedly grabbed the steering wheel which redirected the vehicle towards the right (east) pavement edge (**Figure 2**). The NASS researcher reported no brake marks at the scene indicative of driver avoidance maneuvers.

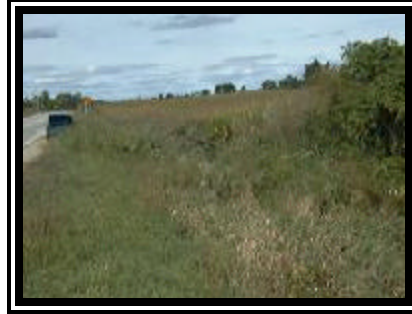
Figure 2. Northeast approach to ditch impact.

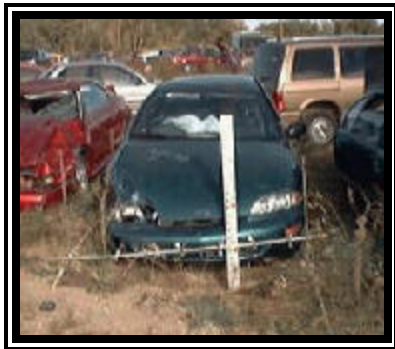
The 1998 Chevrolet Cavalier sustained minor frontal damage as a result of the impact with the ditch (**Figure 3**). The (*SCI revised*) direct contact damage began at the front right bumper corner and extended 52.0 cm (20.5 in) inboard. The impact deformed the full frontal width resulting in a combined direct and induced damage length (Field L) of 129.0 cm (50.8 in). Six crush measurements

were documented at the level of the bumper: C1= 0 cm, C2= 0 cm, C3= 0 cm, C4= 2.0 cm (0.8 in), C5= 3.0 cm (1.2 in), C6= 8.0 cm (3.1 in). The (*SCI revised*) Collision Deformation Classification (CDC) for this impact to the Chevrolet was 12-FZEW-1 with a principal direction of force of 0 degrees. The grille and right headlight assembly fractured and separated from the vehicle during the collision sequence. The right front wheel/tire was deflated (not restricted). The right fender was displaced rearward as the hood was displaced up and rearward from the impact force. No windshield damage was sustained from exterior impact forces. Direct contact damage was also documented to the left side surface attributed to the rollover impact (**Figure 4**). This damage pattern consisted of surface scratching, mud/dirt deposits and small areas of (lateral) sheet metal deformation. A maximum crush value of 9.0 cm (3.5 in) was identified at the left rear side surface area (left rear wheel/tire deflated not restricted). The CDC for this second and final impact was 00-LDAO-2.

Figure 3. Frontal damage to the 1998 Chevrolet Cavalier.

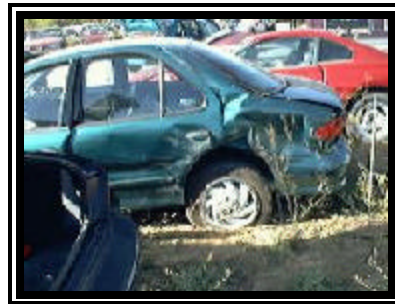
Figure 4. Rollover damage to the left side surface.

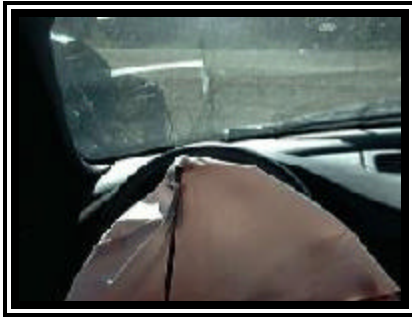
The 1998 Chevrolet Cavalier was equipped with redesigned frontal air bags for the driver and front right passenger positions. The air bags had deployed as a result of the ditch impact. The driver air bag was housed in the center of the steering wheel with a vertically oriented flap tear seam (I-configuration). No contact evidence was identified on the air bag or exterior surface of the module cover flaps. The flaps were symmetrical in shape and measured 10.0 cm (7.9 in) square. The NASS researcher measured the diameter of the driver air bag at 54.0 cm (21.3 in) in its deflated state (**Figure 5**). No internal straps were present. The bag was vented by two ports located at the 9 o'clock and 3 o'clock sectors on the rear aspect of the air bag.

Figure 5. 1998 Chevrolet Cavalier redesigned driver air bag.

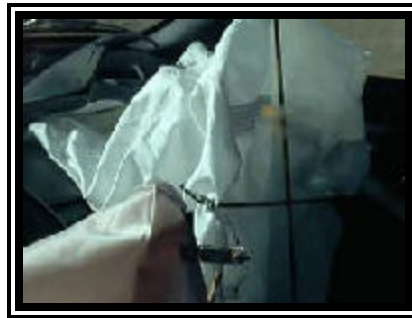
The front right passenger air bag deployed from the right top instrument panel area with a single cover flap design hinged at the forward aspect. No contact evidence was identified on the air bag or exterior surface of the module cover flap. The cover flap was rectangular in shape and measured 32.0 cm (12.6 in) in width and 17.0 cm (6.7 in) in height. The cover flap fractured the right mid-windshield area during the air bag deployment. The NASS researcher measured the passenger air bag at 55.0 cm (21.7 in) in width and 50.0 cm (19.7 in) in height in its deflated state (**Figure 6**). No vent ports or internal tether straps were present. No cutoff switch was found for the front right air bag.

Figure 6. 1998 Chevrolet Cavalier redesigned passenger air bag.
