**REDESIGNED AIR BAG SPECIAL STUDY (RABSS)
SCI TECHNICAL SUMMARY REPORT**

NASS CDS CASE NO. 1998-43-171E

RABSS VEHICLE - 1998 FORD MUSTANG CONVERTIBLE

CRASH DATE - JUNE, 1998

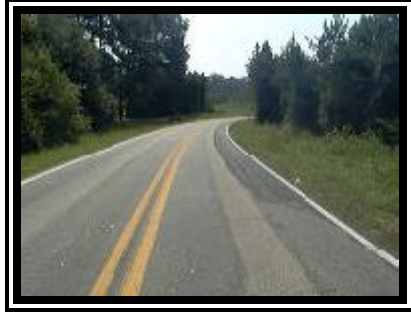
Figure 1. Southbound approach for the 1998 Ford Mustang.

The 36 year old female driver of the 1998 Ford Mustang was operating the vehicle southbound (**Figure 1**) at a (police reported) speed of 97 km/h (60 mph) and negotiating a right curve when she allowed the vehicle to cross the centerline into the path of the northbound Nissan. The Ford driver reported no avoidance actions in anticipation of the impending crash. The 22 year old male driver of the 1991 Nissan pickup was operating the vehicle northbound (**Figure 2**) at a (police reported) speed of 80 km/h (50 mph) and negotiating a left curve when he observed the southbound Ford cross his path of travel. The front right seating position of the Nissan was occupied by a 22 year old female. The NASS researcher reported no skid marks at the scene indicative of driver avoidance maneuvers.

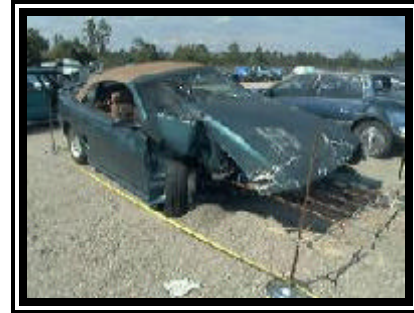
The 1998 Ford Mustang sustained moderate frontal damage as a result of the impact with the Nissan pickup (Figure 3). The direct contact damage encompassed the entire frontal width resulting in a combined direct and induced damage length (Field L) of 115.0 cm (45.3 in). Six crush measurements were documented at the level of the reinforcement bar (*bumper fascia separation*): C1= 0 cm, C2= 5.0 cm (2.0 in), C3= 50.0 cm (20.0 in), C4= 69.0 cm (27.2 in), C5= 60.0 cm (23.6 in), C6= 87.0 cm (34.3 in). The Collision Deformation Classification (CDC) for this impact to the Ford was 12-FDEW-4 with a principal direction of force of (+)10 degrees. The grille and headlight assemblies fractured and separated from the vehicle during the collision sequence. The right fender was displaced rearward which restricted/deflated the right front wheel/tire and jammed the right door (tempered window glazing disintegrated). The hood was deformed slightly up and rearward from the impact force. Reduction in the right side wheelbase measured 38.0 cm (15.0 in). The left side wheelbase was elongated 6.0 cm (2.4 in). The windshield was fractured by exterior impact forces (only).

Figure 3. Frontal damage to the 1998 Ford Mustang convertible.

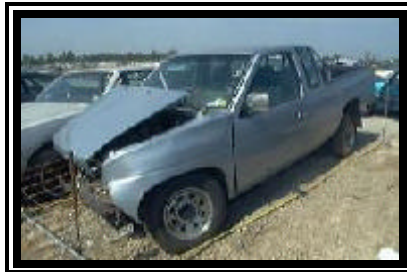
Figure 4. Frontal damage to the 1991 Nissan pickup truck.

The 1991 Nissan King Cab pickup truck sustained moderate frontal damage as a result of the impact with the Ford Mustang (Figure 4). The direct contact damage encompassed the entire frontal width resulting in a combined direct and induced damage length (Field L) of 122.0 cm (48.0 in). A maximum crush value of 75.0 cm (29.5 in) was documented at the C4 position. The (*SCI revised*) CDC for this impact to the Nissan was 11-FDEW-4 with a principal direction of force of (-)20 degrees. The bumper assembly (only) shifted slightly to the right. Bed to cab contact was noted to the right side. The right fender was displaced rearward as the hood was deformed up and rearward from the impact force. The windshield was fractured from exterior impact forces (only). Reduction in the right side wheelbase measured 19.0 cm (7.5 in).

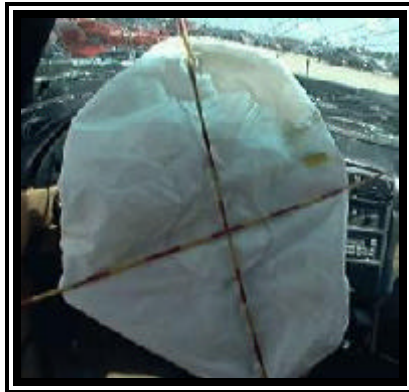
The 1998 Ford Mustang was equipped with redesigned frontal air bags for the driver and front right passenger positions. The air bags had deployed as a result of the crash. The driver air bag was housed in the center of the steering wheel with a horizontally oriented flap tear seam (H-configuration). The flaps were nearly symmetrical in shape as the upper flap measured 15.0 cm (5.9 in) in width and 7.0 cm (2.8 in) in height while the lower flap measured 15.0 cm (5.9 in) in width and 6.0 cm (2.4 in) in height. Although no contact evidence was identified on the exterior surface of the module cover flaps, a smudge mark was documented at the upper right quadrant of the air bag. The NASS researcher measured the diameter of the driver air bag at 48.0 cm (18.9 in) in its deflated state (**Figure 5**). The bag was tethered by two internal straps and vented by two ports located at the 11 o'clock and 1 o'clock sectors on the rear aspect of the air bag.

Figure 5. 1998 Ford Mustang redesigned driver air bag.

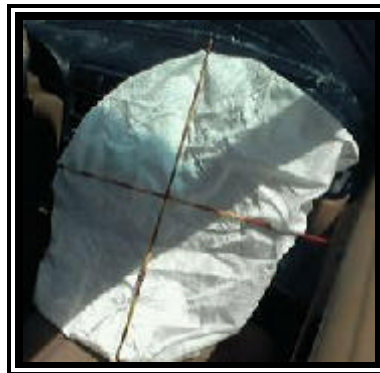
The front right passenger air bag deployed from the right mid-instrument panel area with a horizontally oriented flap tear seam (H-configuration). The flaps were nearly symmetrical in shape as the upper flap measured 42.0 cm (16.5 in) in width and 8.0 cm (3.1 in) in height while the lower flap measured 42.0 cm (16.5 in) in width and 7.0 cm (2.8 in) in height. Although no contact evidence was identified on the exterior surface of the module cover flap, blood spattering was noted across the face of the air bag. The NASS researcher measured the passenger air bag at 62.0 cm (24.4 in) square in height in its deflated state (**Figure 6**). No vent ports or internal tether straps were present. No cutoff switch was found for the front right air bag.

Figure 6. 1998 Ford Mustang redesigned passenger air bag.
