Remote, Redesigned Air Bag Special Study

Dynamic Science, Inc., Case Number (1998-74-152F)

1998 Dodge Stratus

December/1998

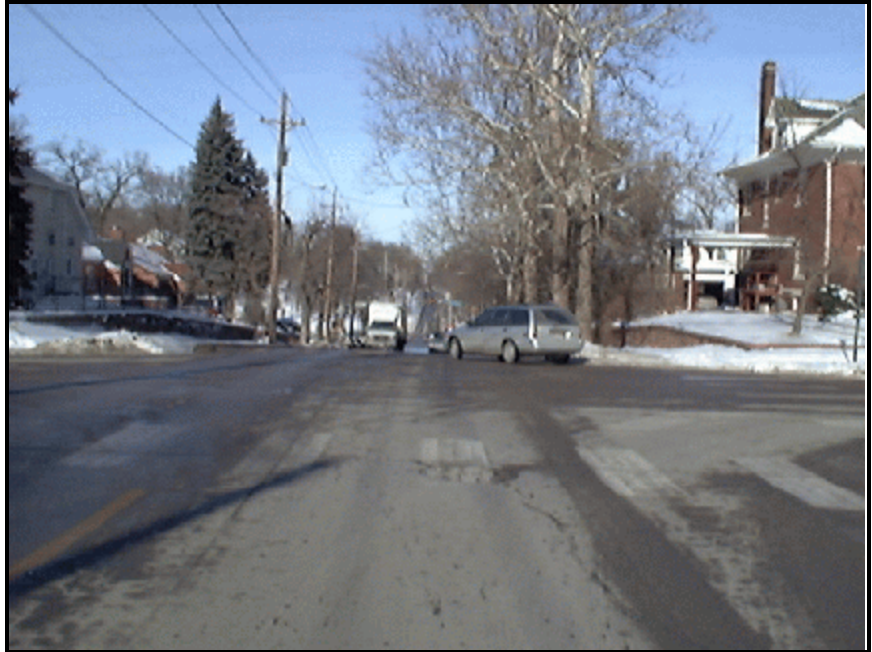
Figure 1. Approach of Vehicle 1 to area of impact.

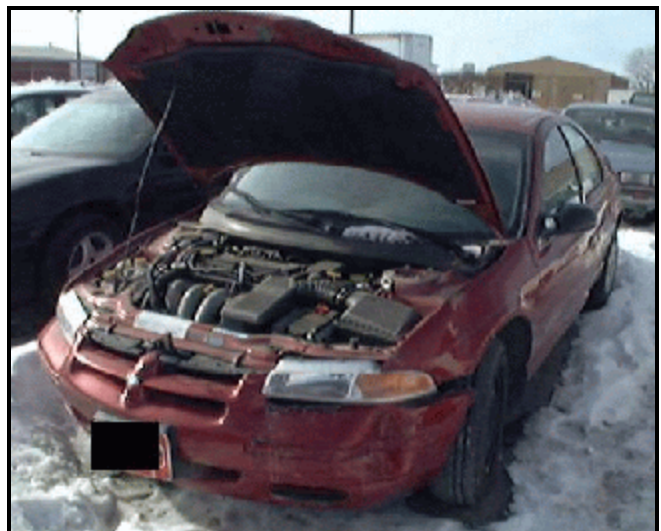
Figure 2. Exterior, Vehicle 1 (case vehicle)

As the vehicles approached the intersection, the driver of Vehicle 2 initiated a left turn (to go east) in the path of Vehicle 1. The driver of Vehicle 1 swerved to the right and braked but was unable to avoid the impact. The front right of Vehicle 1 (11FLEW1) struck the front right of Vehicle 2 (01FZEW2). Vehicle 1 sustained a longitudinal delta V of -24 km/h (-14.9 mph). Both front air bags in Vehicle 1 deployed at this point.

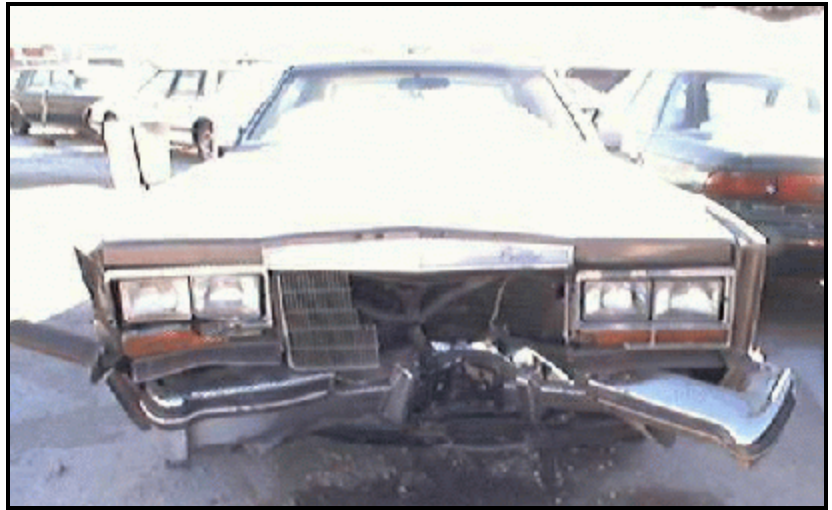
Figure 3. Exterior, Vehicle 2.

Vehicle 1 was not towed. Vehicle 2 became disabled due to damage sustained in the crash and was towed from the scene.

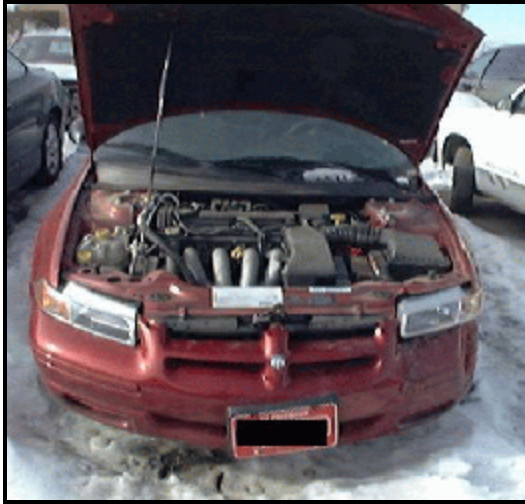
Figure 4. Exterior, Vehicle 1

Plane of Impact	Field L cm/in.	C1 cm/in.	C2 cm/in.	C3 cm/in.	C4 cm/in.	C5 cm/in.	C6 cm/in.
Bumper	160	15	2	0	0	0	0
	63	5.9	0.8	0	0	0	0

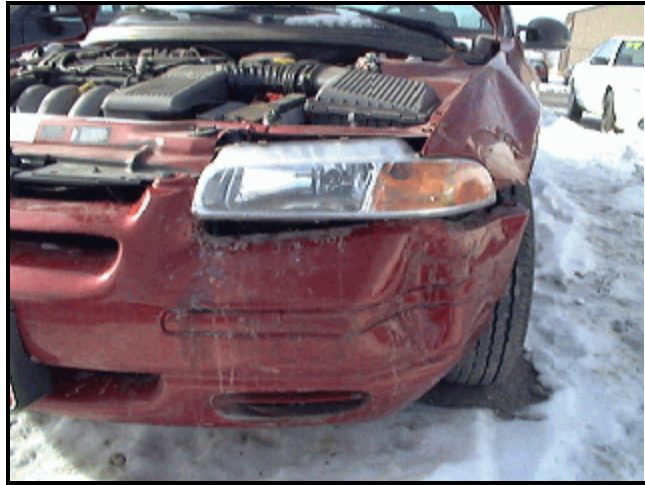
Figure 5. Exterior, Vehicle 1

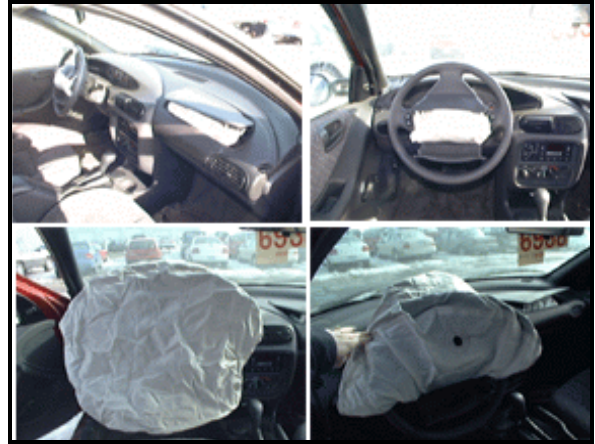
The front left air bag was housed in the steering wheel hub and was concealed by an “H” pattern cover flap that was not damaged. The circular air bag was equipped with two tether straps and a single vent port. The bag was not damaged in the crash, nor were there any occupant contacts.

Figure 6. Front left air bag
