Remote, Redesigned Air Bag Special Study
Dynamic Science, Inc., Case Number (1998-079-009K)
1998 Oldsmobile Intrigue
California
February/1998

Summary

This remote investigation focused on the redesigned air bag system deployment of a 1998 Oldsmobile Intrigue 4-door sedan. This moderate injury crash occurred in February, 1998 in the morning. The weather was clear and the bituminous roadway was dry. The crash occurred on a two-way undivided roadway. The roadway contains five travel lanes; two eastbound lanes, two westbound lanes, and one center turn lane. The speed limit for this road is 64 kmph (40 mph). There are no traffic controls and the road is level at the area of impact.

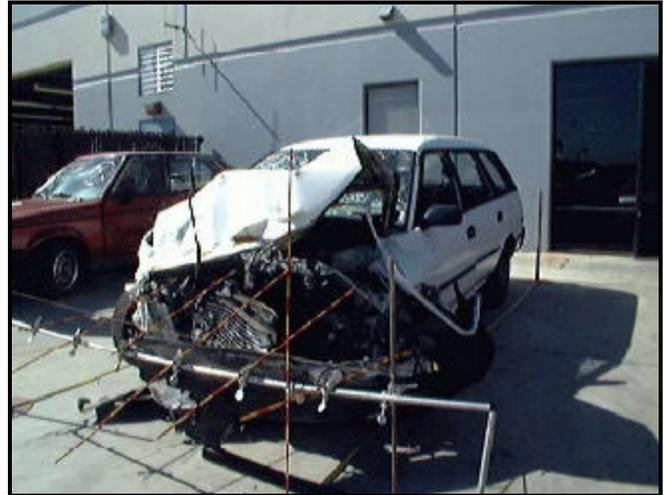
Figure 1. Exterior, Vehicle 1 (Toyota Corolla)

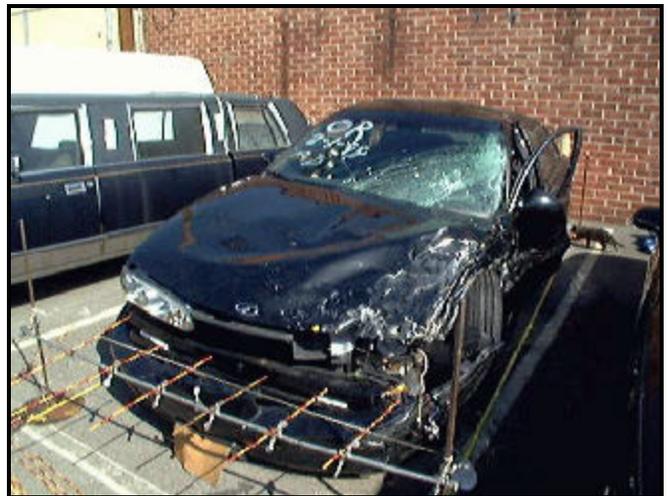
Figure 2. Exterior, Vehicle 2 (Oldsmobile Intrigue)

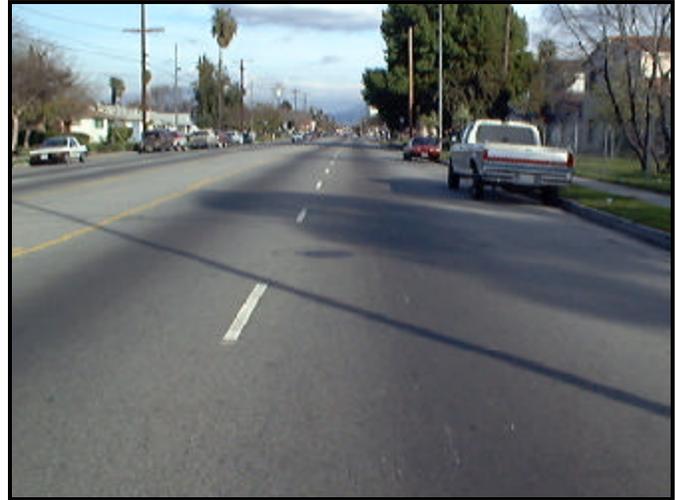
Figure 3. Crash scene. Vehicle 2 approach path.

The driver of Vehicle 1 reported that he “changed lanes pretty fast” and “lost control” of the vehicle. Vehicle 1 crossed from the right westbound travel lane completely across the roadway and entered the path of Vehicle 2 in the right eastbound travel lane. The front plane of Vehicle 2 (12FLEE9) struck the front plane of Vehicle 1 (02FDEW3) in the right eastbound travel lane (event 1). Vehicle 2 then impacted the south curb (event 2) with its right-front wheel (02RFWN3) before coming to rest back in the original lane facing east. Vehicle 1 rotated counter-clockwise approximately 90 degrees after impact and came to rest straddling the two eastbound lanes facing southeast.

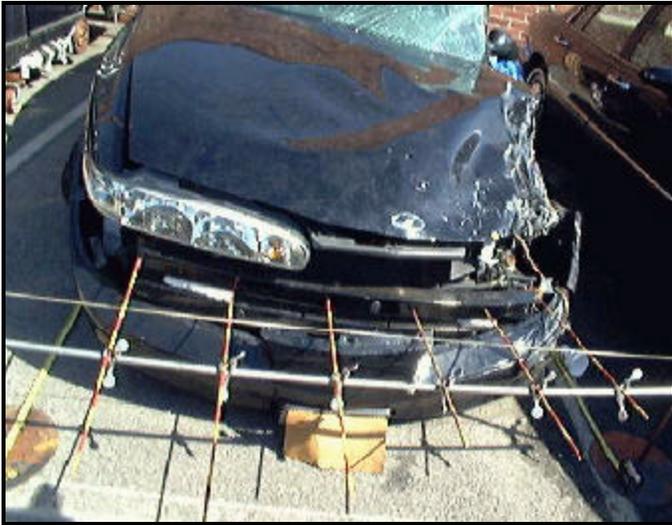
Figure 4. Exterior, Vehicle 2 (1998 Oldsmobile Intrigue)

Plane of Impact	Field L cm/in.	C1 cm/in.	C2 cm/in.	C3 cm/in.	C4 cm/in.	C5 cm/in.	C6 cm/in.
Bumper	125	15	5	1	0	0	0
	49.2	5.9	2	0.4	0	0	0

¹SCI altered. Direct damage <16 inches

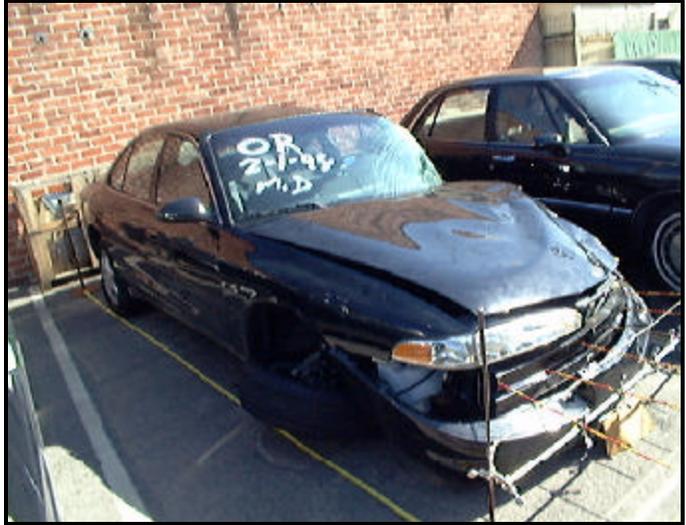
Figure 5. Exterior, Vehicle 2 (1998 Oldsmobile Intrigue)

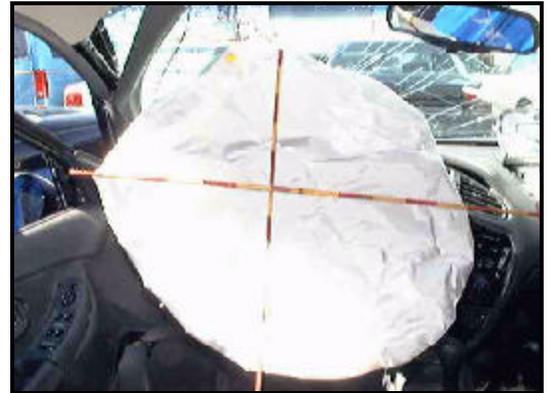
The front left air bag was housed in the steering wheel hub and was concealed by symmetrical I-configuration cover flaps which were not damaged. The circular air bag was equipped with two tether straps and two vent ports. Contact evidence consisting of a small scuff was found on the front of the bag. The bag was not damaged in the crash.

Figure 6. Driver's frontal air bag.

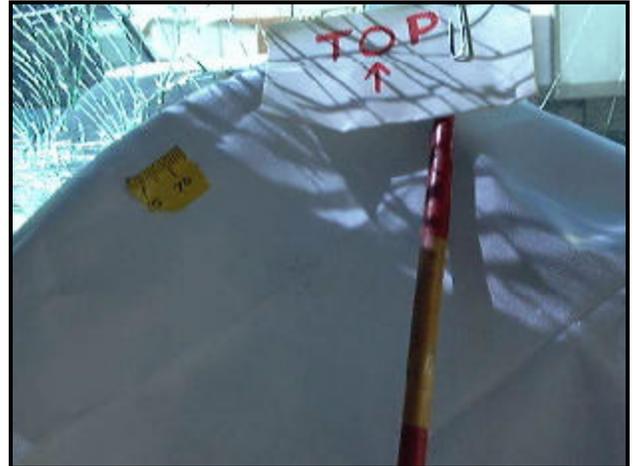
At impact, the occupants reacted to the 350 degree principle direction of force by moving forward and slightly left. As the restraints locked, further forward movement of the occupants was prevented. The driver contacted the deploying front left air bag-causing the loss of consciousness and facial skin laceration. Impact with the locked shoulder belt caused the thorax skin contusion. It appears that the cervical and lumbar strains were caused by impact forces rather than contact with a component of the vehicle's interior. The front right passenger also impacted the locked shoulder belt-causing the thorax skin contusion. Impact with the locked lap belt caused the abdominal skin contusion and abrasion. The back center occupant sustained a facial skin abrasion from an unknown source. All three occupants of Vehicle 2 were transported by land from the scene to a trauma center where they were treated and released.

Figure 7. Driver's frontal air bag contact (scuff).
