Remote, Redesigned Air Bag Special Study

Dynamic Science, Inc., Case Number (1998-079-803E)

1998 Toyota Corolla

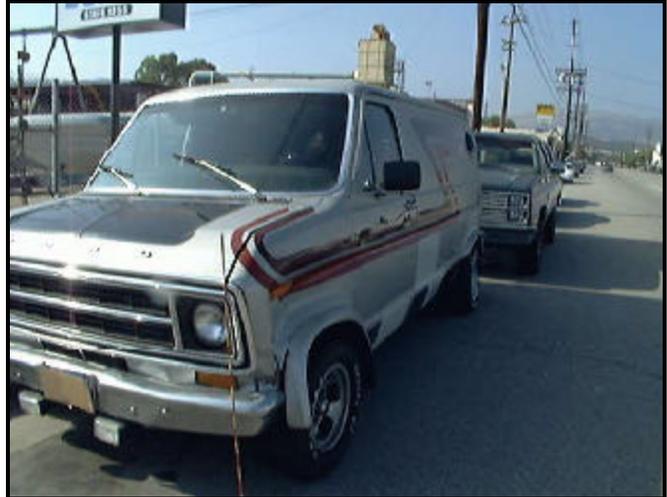
Figure 1. Exterior, Vehicle 1 (Ford E-Series)

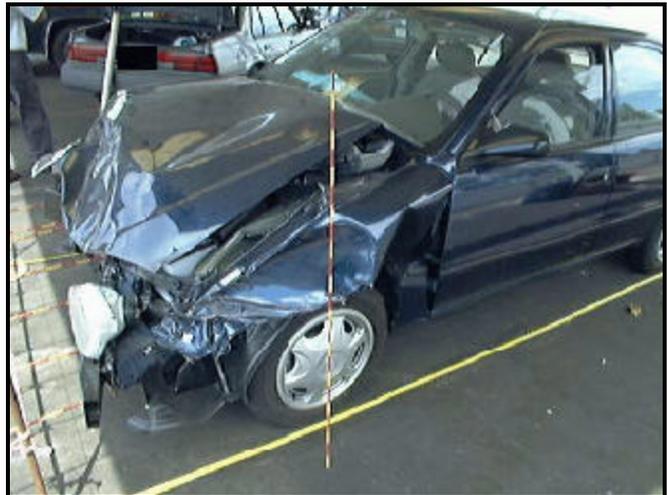
Figure 2. Exterior, Vehicle 2 (Toyota Corolla)

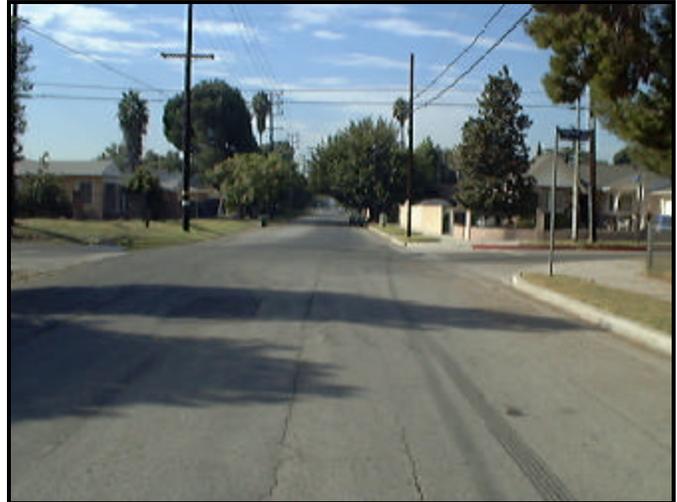
**Figure 3.** Crash scene. Vehicle 2 approach path.

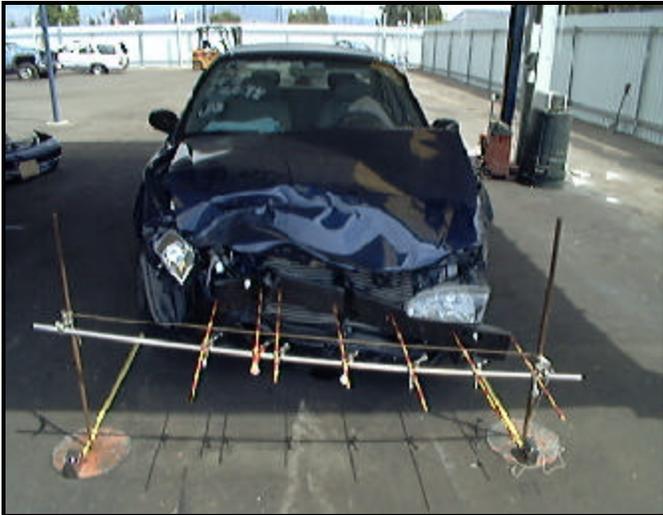
**Figure 4.** Exterior, Vehicle 2 (1998 Toyota Corolla)

Plane of Impact	Field L cm/in.	C1 cm/in.	C2 cm/in.	C3 cm/in.	C4 cm/in.	C5 cm/in.	C6 cm/in.
Bumper	117	2	16	27	35	34	12
	46.1	0.8	6.3	10.6	13.8	13.4	4.7

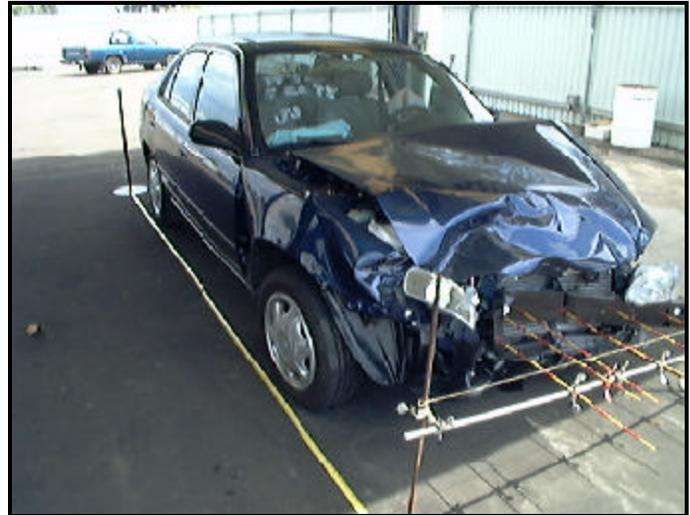
**Figure 5.** Exterior, Vehicle 2 (1998 Toyota Corolla)

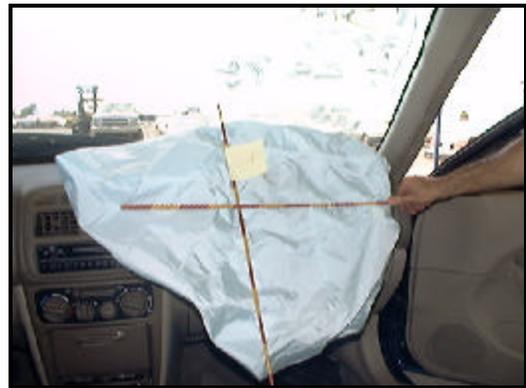
The front right air bag was housed in the top-instrument panel position and was concealed by a single rectangular configuration cover flap which was not damaged in the crash. The rectangular air bag was equipped with two vent ports and no tether straps. No contact evidence was found on the air bag and the bag was not damaged.

**Figure 7.** Passenger's frontal air bag.

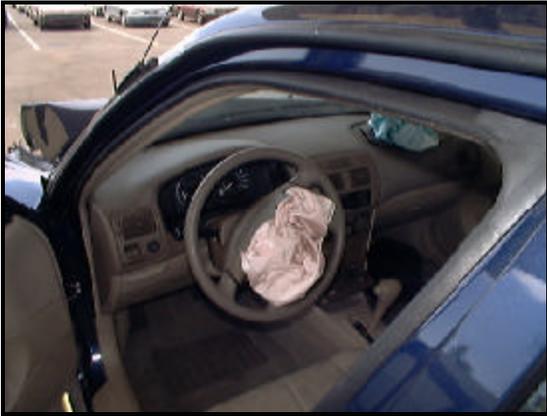
The interior of the Toyota Corolla sustained no damage from occupant contact. There were no areas of intrusion into the passenger compartment. No evidence of occupant contact was found in the vehicle.

**Figure 8.** Interior, case vehicle.

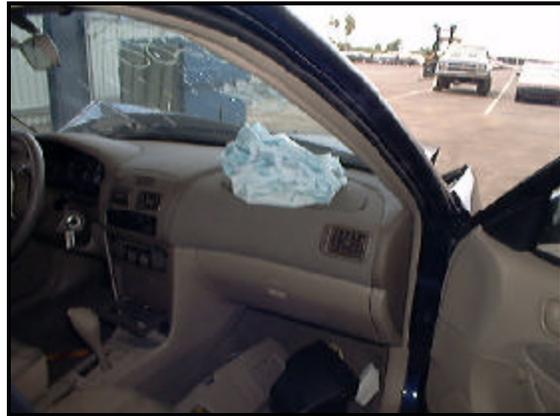
**Figure 9.** Interior, case vehicle.

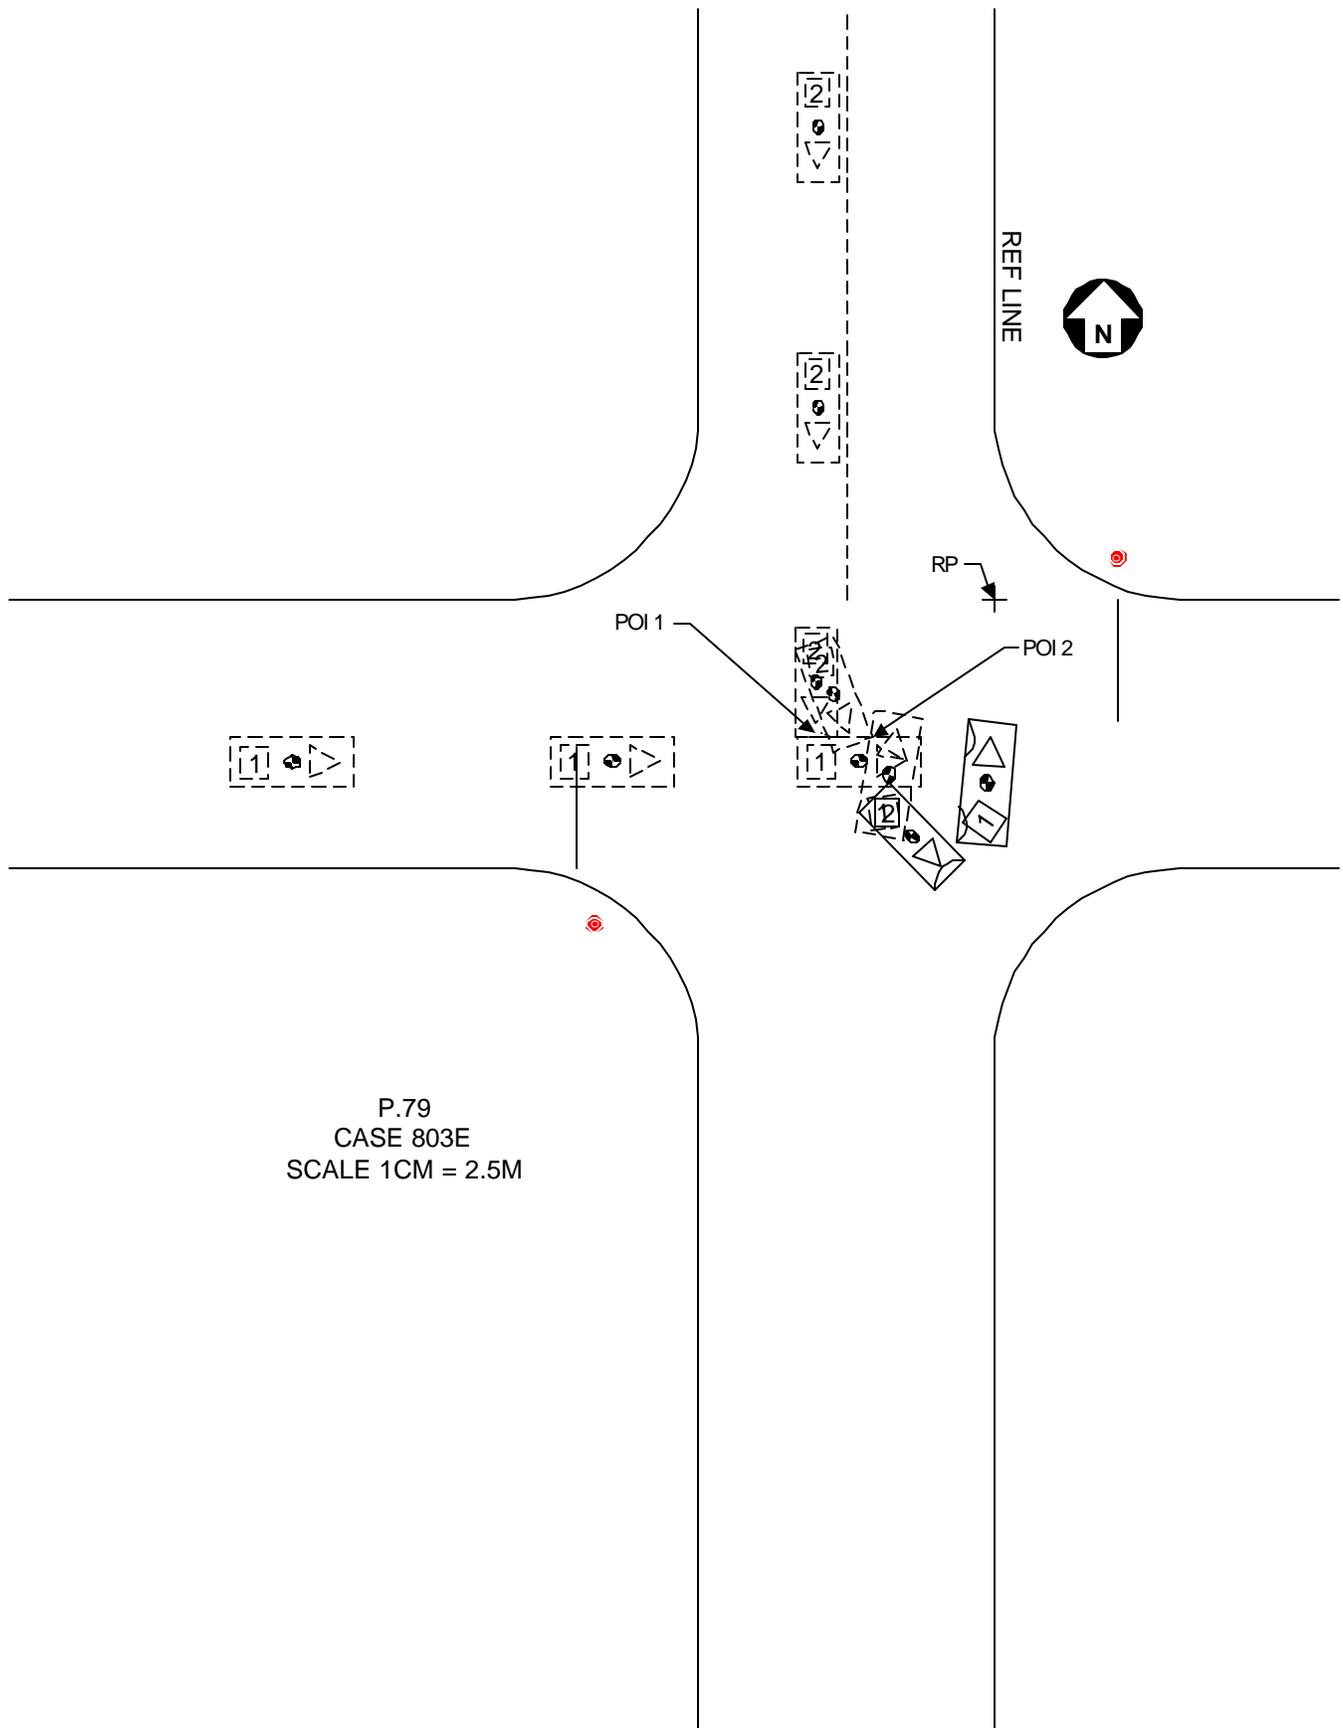
*Scene Diagram*

Vehicle 1 entered the intersection and crossed the path of Vehicle 2. The front plane of Vehicle 2 (01FDEW2) impacted the left plane of Vehicle 1 (10LBEW99) in the intersection (event 1). The vehicles then impacted a second time due to rotation (event 2) with the left plane of Vehicle 2 (09LFEW3) contacting the left plane of Vehicle 1 (09LFEW99).

Vehicle 1 rotated counter-clockwise approximately 90 degrees after impacts and came to rest in the intersection facing north. Vehicle 2 rotated counter-clockwise approximately 40 degrees and came to rest in the intersection facing southeast.
