Remote Investigation / Vehicle to Vehicle
Dynamic Science, Inc. / Case Number: DS98014
1994 Plymouth Voyager
Kentucky
March 1996

| 4. Title and Subtitle In-Depth Accident Investigation | | | | 5. Report Date | |

Dynamic Science, Inc.
Accident Investigation
Case Number: DS98014

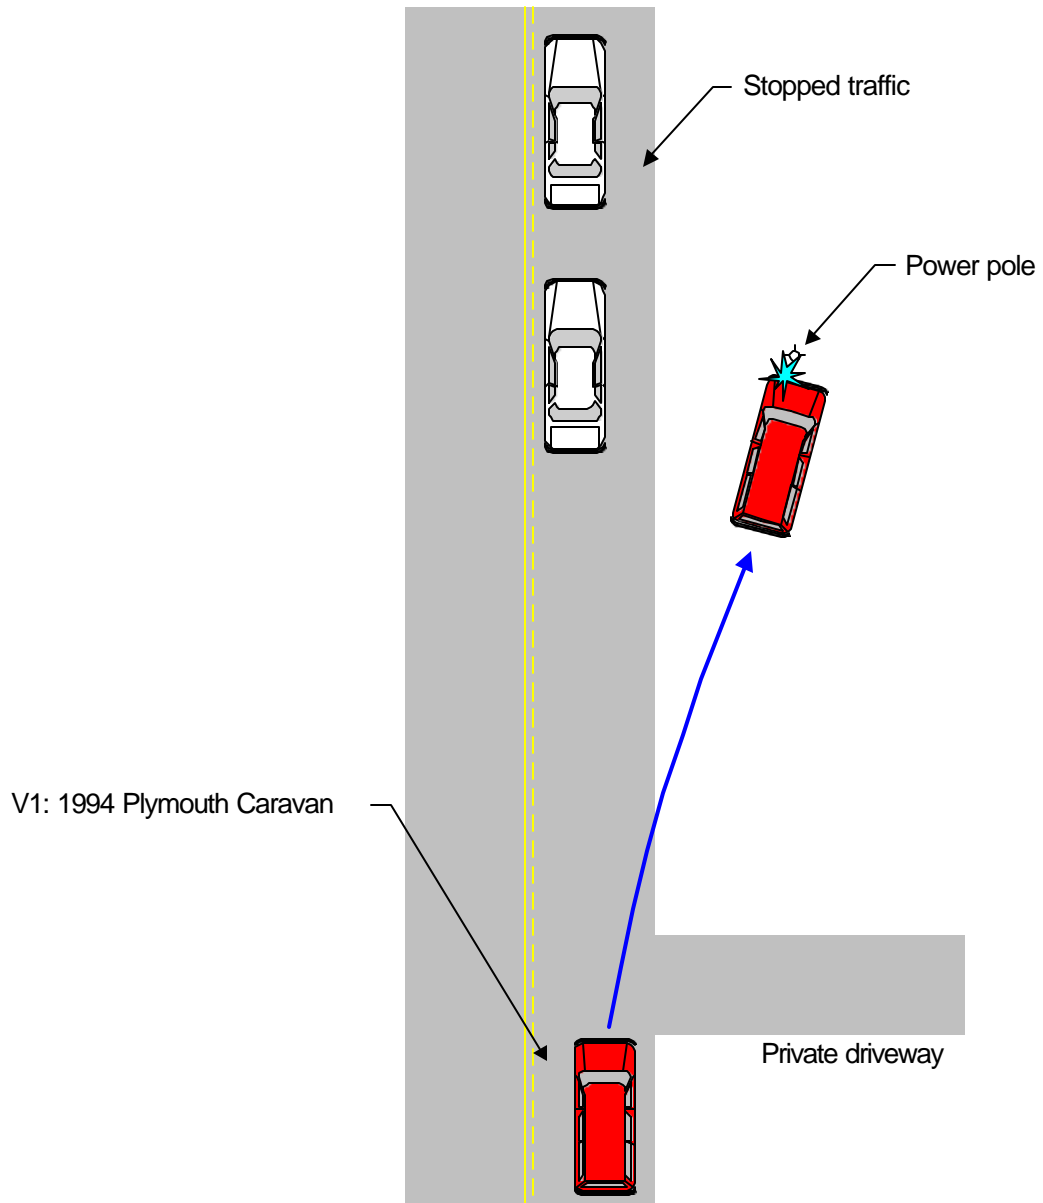
Scene Diagram

Vehicle 1, a 1994 Plymouth Voyager van driven by a pregnant 28-year-old female, was traveling eastbound on a state highway at a speed reported to be between 56-72 km/h (35-45 MPH). The front right of Vehicle 1 was occupied by an unrestrained 4-year-old (30 kg) female. The left rear was occupied by a 7-year-old female. The driver of Vehicle 1 stated that vehicles in front of her had stopped and she tried to avoid them by steering to the right and leaving the roadway.

There is no explicit statement indicating that the driver braked, but this seems likely given the collision type. After leaving the roadway Vehicle 1 struck a power pole. A CDC-only barrier run produced a longitudinal delta v of -14.8 km/h (-9.2 mph). Both air bags deployed at this point. In other reports the driver indicated that she was trying to place the right front occupant back into her restraint when she ran off the road.

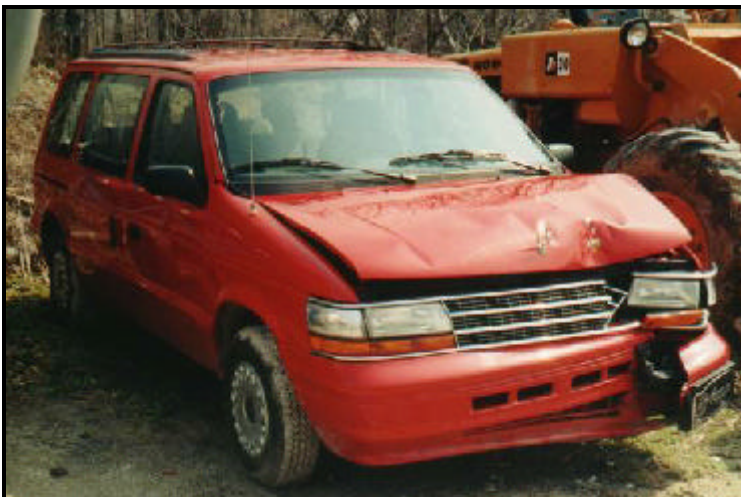
Figure 2. Exterior, Vehicle 1

| Damage Description: | Minor crush damage to left bumper and grille area. | |
| CDC: | 12FLEN1 | |

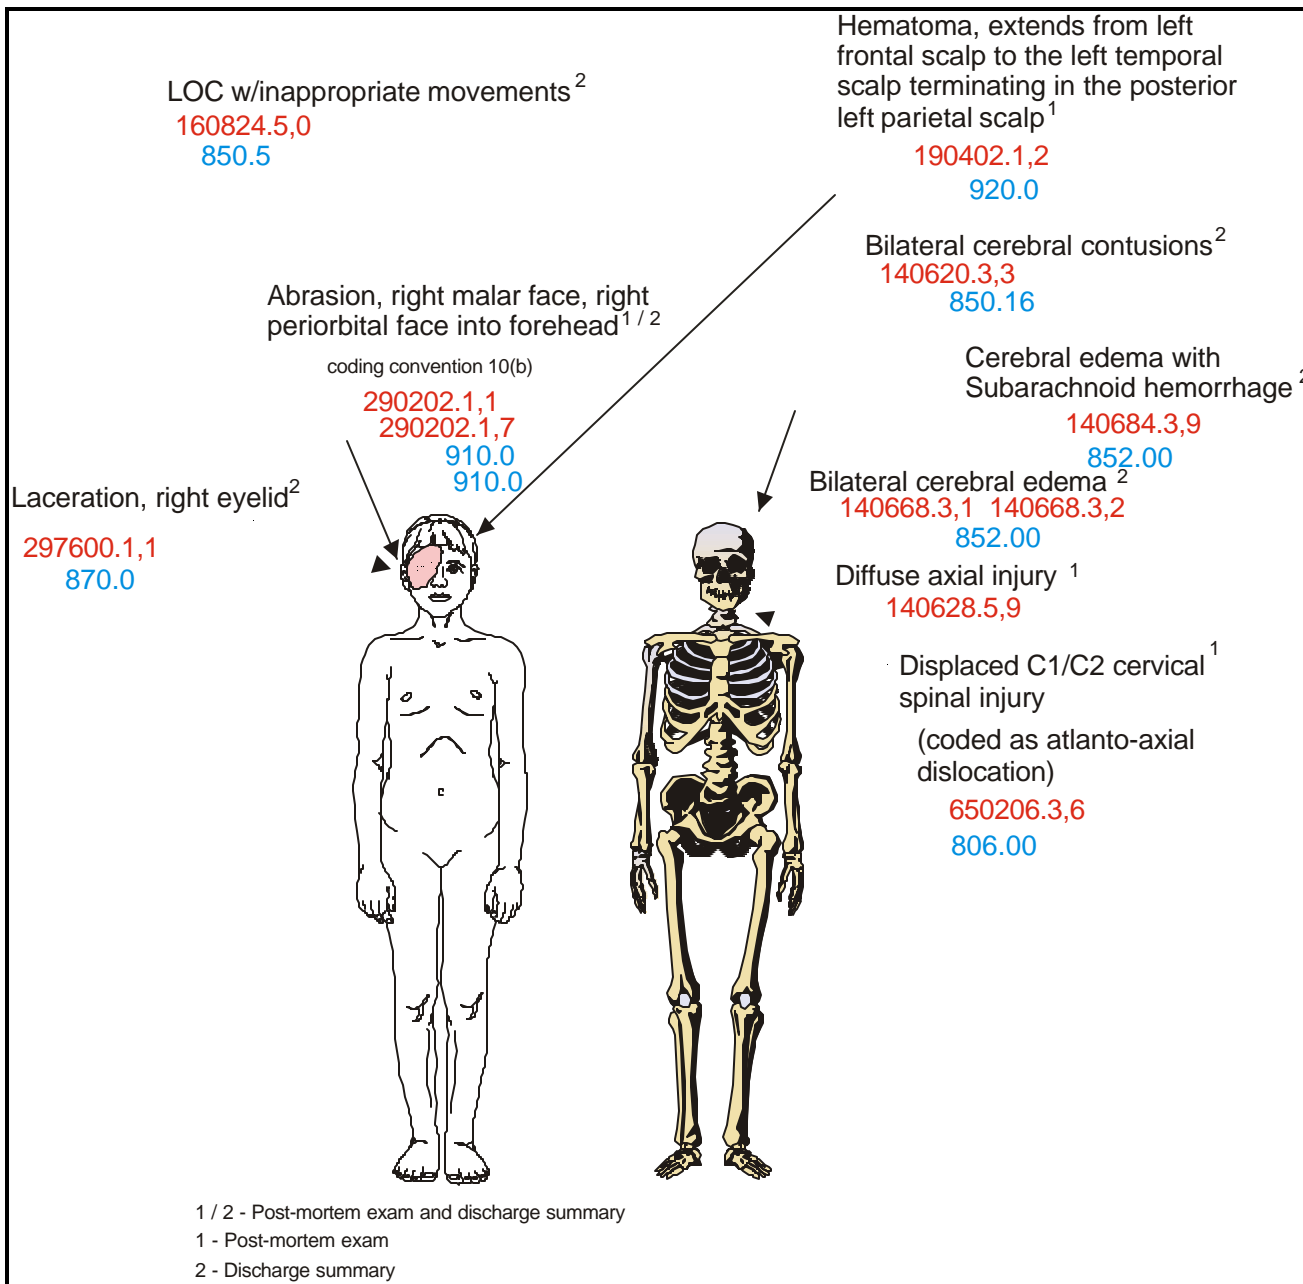
Figure 3. Front right occupant injuries

| | <u>INJURY</u> | <u>OIC CODE</u> | <u>ICD-9</u> | <u>SOURCE</u> |
|---|--|---|---|---|
| | Displaced C1/C2 cervical spinal injury | 650206.3,6 | 806.00 | Air bag |
| | Abrasion, right malar face, right periorbital face into forehead | 290202.1,1 290202.1,7 | 910.0 910.0 | Air bag |
| | Laceration, right eyelid | 297600.1,1 | 870.0 | Air bag |
| | Hematoma, extends from left frontal scalp to the left temporal scalp, terminating in the posterior left parietal scalp | 190402.1,2 | 920.0 | Windshield |

The front right occupant appears to have been seated in a forward facing fashion. She was unrestrained. In one report there is an indication that she was restrained at one time, but had gotten out of the restraints. As Vehicle 1 departed the roadway and the driver braked, this occupant was pitched forward with the right side of her face in a downward position. At impact, the air bag deployed and struck this occupant on the right side of her face. She was lifted upward and the left side of her head struck the windshield. The impact with the windshield likely caused the brain injuries. The combination of the air bag on one side and the windshield on the other likely caused the C1/C2 injury. Post impact, this occupant was found on the floor of the vehicle.
