Remote Investigation / Vehicle to Vehicle  
Dynamic Science, Inc. / Case Number: DS98015  
1998 Chevrolet van  
Connecticut  
December 1997

1. Report No. DS98015		2. Government Accession No.		3. Recipient Catalog No.	
4. Title and Subtitle Remote Accident Investigation				5. Report Date .February 2, 1999

**Dynamic Science, Inc.**  
**Accident Investigation**  
**Case Number: DS98015**

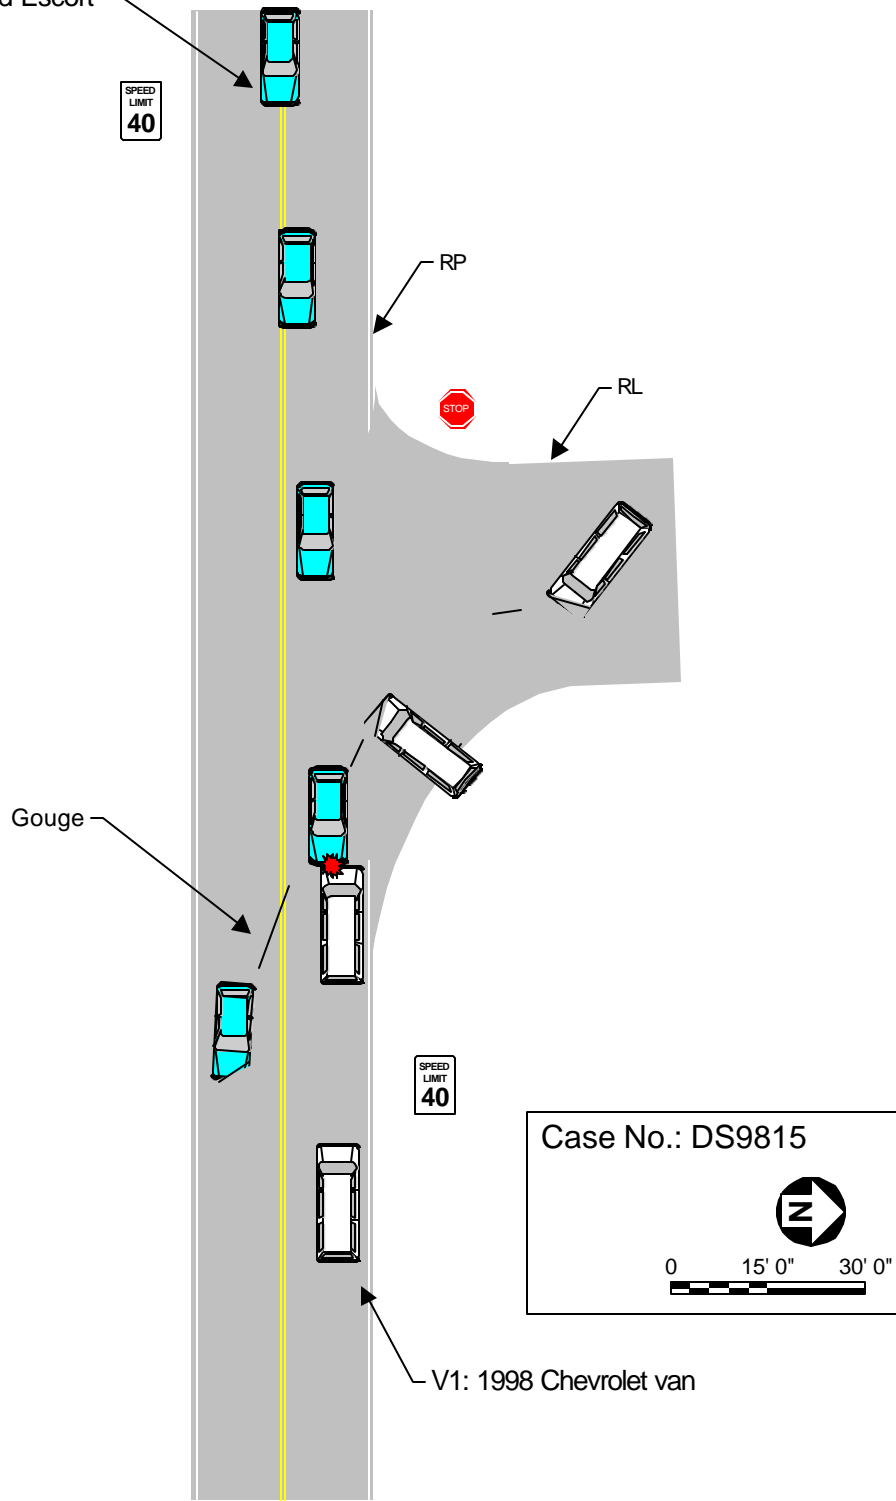
Scene Diagram

automatic shoulder belt. It is unknown if the separate lap belt was used. The vehicle was traveling eastbound on the roadway, just coming out of the curve at a police calculated speed of 56-64 km/h (35-40 mph). As the other vehicle came out of the curve it appears that the vehicle drifted into the on-coming lane of travel. The front of the other vehicle struck the front of the case vehicle in a head-on configuration. The case vehicle sustained a longitudinal delta V of -43.6 km/h (-27.2 mph)<sup>3</sup> using a CDC of 12FYEW6. The other vehicle sustained a longitudinal delta V of -77.0 km/h (-47.8 mph) using a CDC of 12FYAW6. The case vehicle rotated counterclockwise and came to rest in the southbound leg of the intersection. The other vehicle was redirected to the right and came to rest nearly parallel to the right hand shoulder at some point east of the intersection.

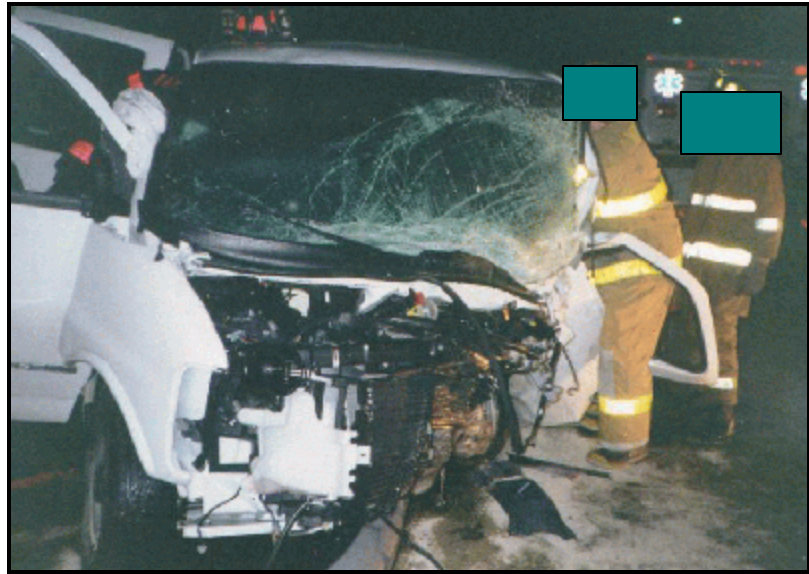
**Figure 2.** Exterior, case vehicle

Description:	1998 Chevrolet 3/4 ton van	
VIN:	1GCGG25ROW1XXXXXX	
Odometer:	Unknown	
Engine:	5.7L V8	
Reported Defects:	None noted	
Cargo:	None	
Damage Description:	Extensive front end and left side damage. Direct contact extends from the middle right to the left of the bumper. Crush extends to a point below the A-pillar. There is human tissue on the brackets below the A-pillar (this came from the driver of Vehicle 2). There is extensive intrusion to the left front along the toe pan and the left side instrument panel.	
CDC:	12FYEW6	
Delta V:	Total	43.8 km/h (27.2 mph)
	Longitudinal	-43.6 km/h (-27.1 mph)
	Latitudinal	3.8 km/h (2.4 mph)
	Energy	221,586 joules (163,539 ft-lbs)

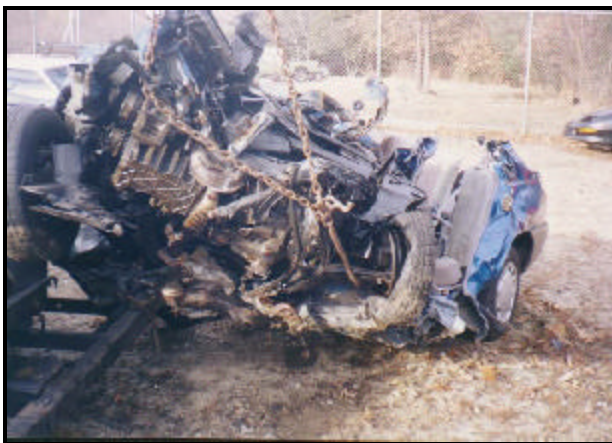
**Figure 4.** Exterior, other vehicle

Description:	1991 Ford Escort	
VIN:	1FAPP14JGMWXXXXXX	
Odometer:	Unknown	
Engine:	1.9L EFI I4	
Reported Defects:	None noted	
Cargo:	None noted	
Damage Description:	Vehicle totaled. Extensive rearward crushing through front. Damage extends to A-pillar and includes direct contact to the A-pillar area.	
CDC:	12FYAW6	
Delta V:	Total	77.3 km/h (48.0 mph)
	Longitudinal	-77.0 km/h (-47.8 mph)
	Latitudinal	6.7 km/h (4.2 mph)
	Energy	236,163 joules (174,317 ft-lbs)

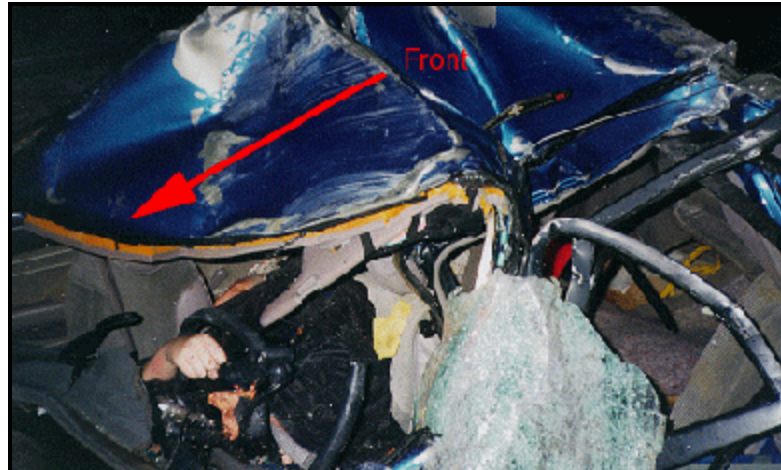
**Figure 6.** Driver, other vehicle

The driver of the other vehicle was fatally injured. She sustained the following injuries: blunt trauma of head with fracture of the skull and lacerations and transection of the brain and midbrain, blunt trauma to chest with bilateral rib fractures, heart/aorta lacerations, and liver and spleen lacerations; fracture/dislocation of pubic symphysis, left upper/lower arms, left upper/lower leg, right lower leg, and fracture/dislocation of the first thoracic vertebra with transection of the spinal cord.

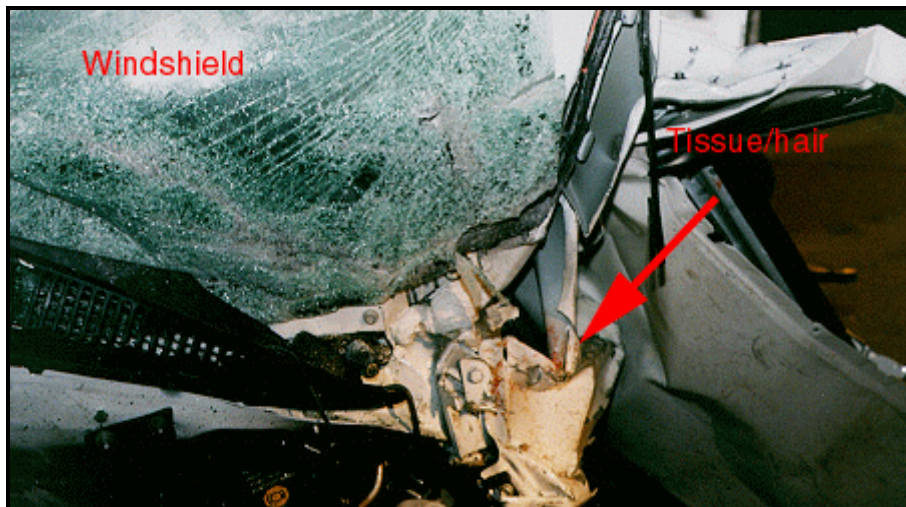
Puncture wound to right chest	790800.1,1	875.0	Unknown
“L” shaped laceration to forehead, 4 x 2-1/2 in.	290604.2,7	873.42	Exterior, V1
Abrasion, left hand	790202.1,2	914.0	Unknown
Extensive facial lacerations	290600.1,0	873.49	Exterior, V1

**Figure 7.** Contact between exterior of case vehicle and driver of the other vehicle

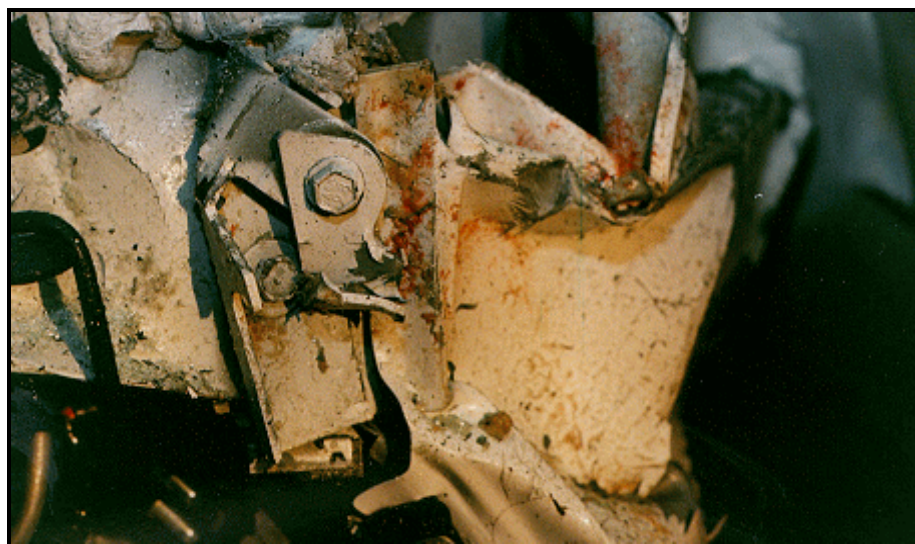
**Figure 8.** Contact between exterior of case vehicle and driver of the other vehicle (closeup)

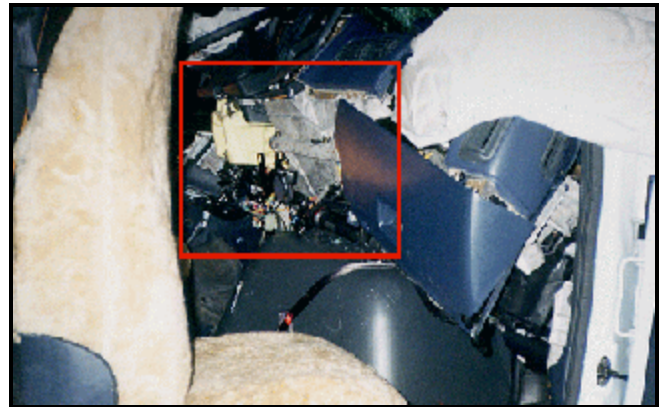
The center occupant of the case vehicle, a 7-year-old male, was seated in a child seat which had been placed in a rear-facing position between the two front seats. The seat was not attached to the vehicle. The child was not restrained in the child seat. Even though the type of child seat is not known, it should be noted that there are no child seats which would be appropriate for a child of this age and likely size (29 kg, 64 lbs./130.5 cm, 51.3 in.). At impact, the child and the child seat were projected forward and slightly to the left. Given the size characteristics and weight distribution of a larger child in the child seat, the child seat likely would have tipped toward the front of the vehicle. It is likely that this occupant's head struck the center portion of the instrument panel. The case vehicle rotated violently in a counterclockwise direction and was airborne for a short time. This occupant was flung toward the front right of the vehicle and he engaged the right lower side of the instrument panel—where he came to rest.

**Figure 9.** Interior Vehicle 1, damage to center instrument panel

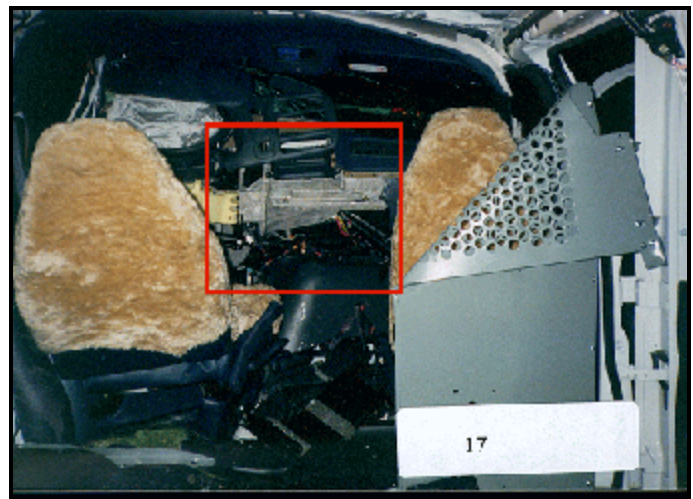
**Figure 10.** Interior Vehicle 1, damage to center instrument panel
