On-Scene / Vehicle to Vehicle / Front to Right Side
Dynamic Science, Inc. / Case Number: DS98019
1997 Nissan Quest XE Minivan
Colorado
May, 1998

| 4. Title and Subtitle In-Depth Accident Investigation | | | | 5. Report Date | |

**Dynamic Science, Inc.
Accident Investigation
Case Number: DS98019**

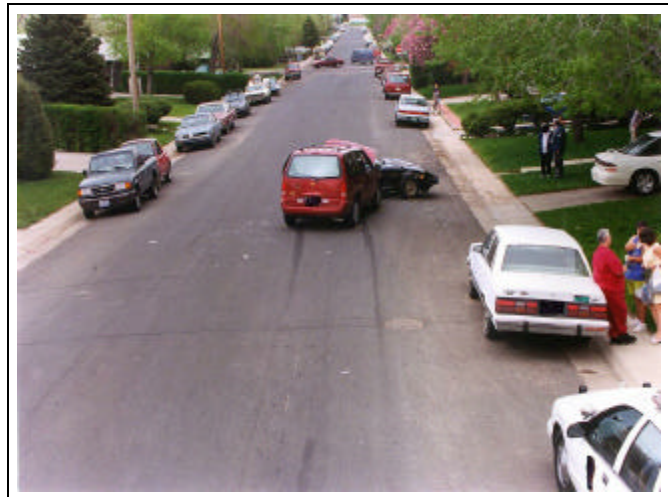
The crash occurred in the state of Colorado in May, 1998 at 1502 hours. At the point of impact, the roadway is an east-west, two-way, undivided, asphalt, straight residential street. The roadway has a negative slope for the case vehicle direction of travel. The weather was clear, the road was dry and clear of defects. There are no traffic controls present, and the posted speed limit is 40 km/h (25 mph).

Figure 1. Crash scene—heading east.

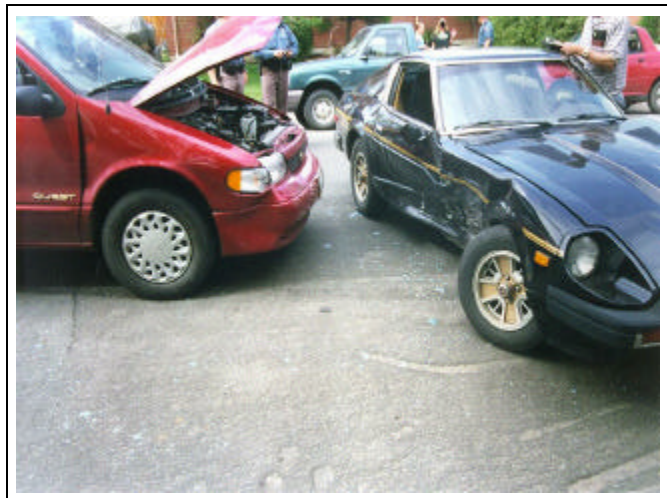
Figure 2. Damage and final rest positions.

After impact, the case vehicle rotated slightly clockwise and came to final rest heading east. The 280 ZX was pushed counterclockwise and came to final rest heading south. The case vehicle sustained minor damage to its front end. The case vehicle was towed from the scene, but was driveable. The 280 ZX sustained major damage and intrusions to the right side and was towed from the scene.

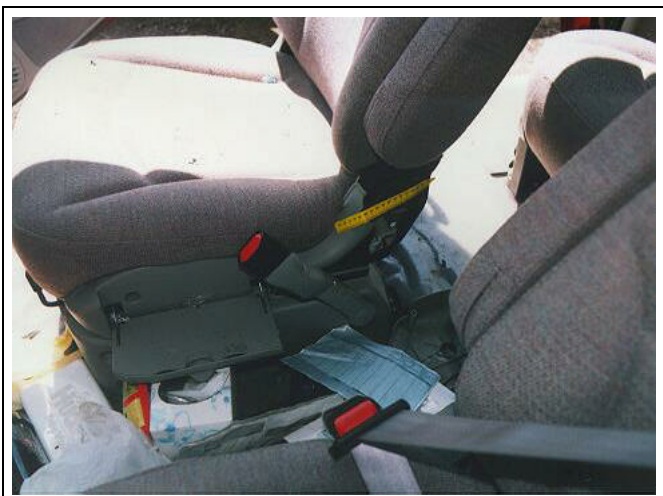
Figure 5. Lower left seat cushion of front right seat.

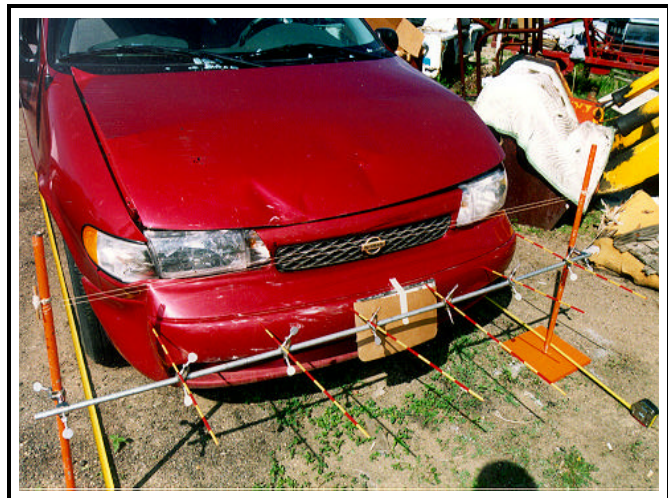
| Damage Description: | Minor damage across the front bumper, hood, grille area, front right fender, and windshield. | |
| CDC: | 12FDEW1 | |

Figure 6. Exterior damage to case vehicle.

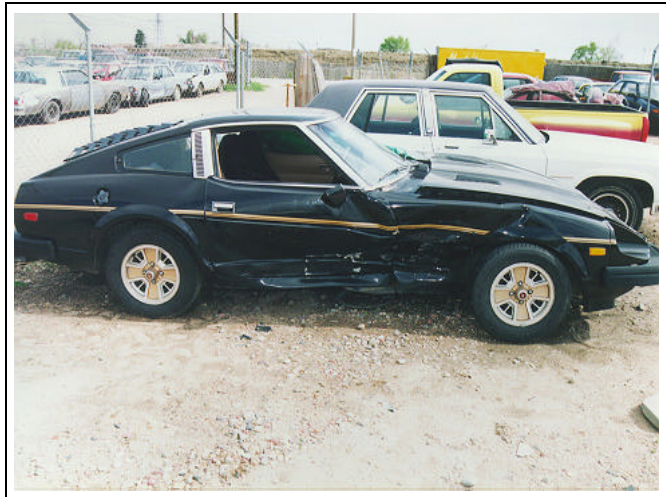
| Damage Description: | Moderate damage to the right side, right side glazing, and windshield. | |
| CDC: | 02RYEW3 | |

Figure 7. Exterior damage to 280 ZX.
