Remote Investigation / Vehicle to Vehicle
Dynamic Science, Inc. / Case Number: DS98026
1995 Plymouth Voyager
Oregon
June 1998

1. Report No. DS98026		2. Government Accession No.		3. Recipient Catalog No.	
4. Title and Subtitle In-Depth Accident Investigation				5. Report Date February 9, 1999

Dynamic Science, Inc.
Accident Investigation
Case Number: DS98026

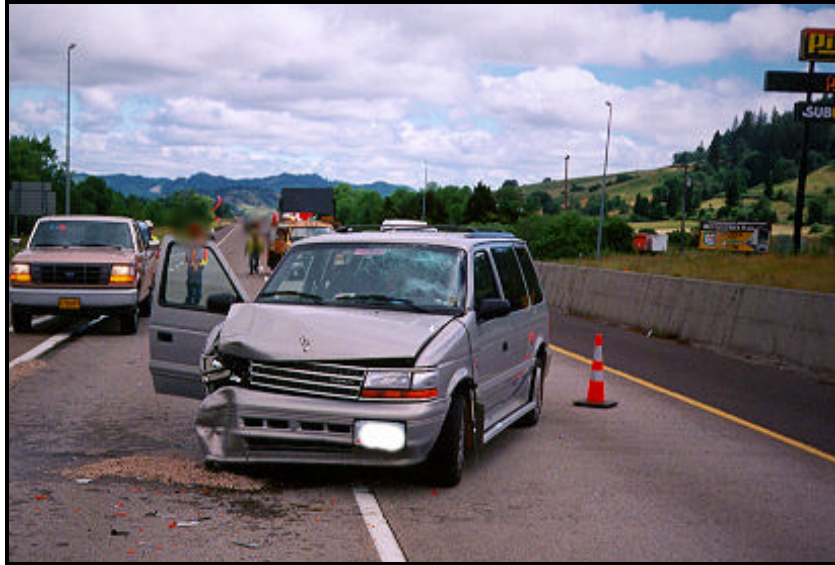
The case vehicle sustained an estimated longitudinal delta V of -17.7 km/h (-11.0 mph). Both the driver's and front right passenger air bags in the case vehicle deployed at this point. The case vehicle rotated clockwise slightly and came to rest straddling the two lanes of travel facing southwest.

Figure 2. Final rest, case vehicle

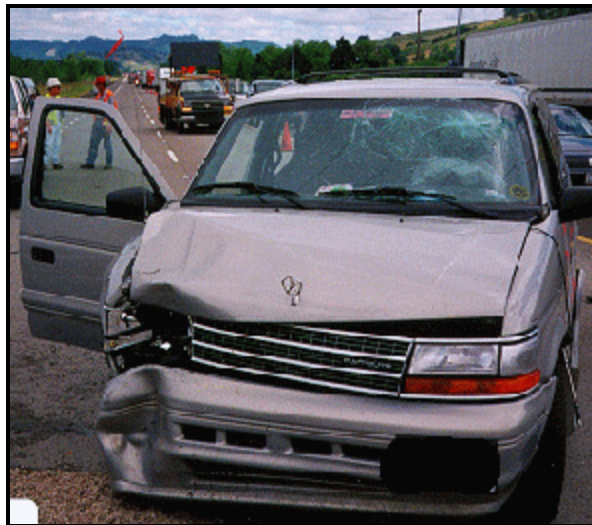
Description:	1995 Plymouth Voyager	
VIN:	2PAGH453GSRxxxxxx	
Odometer:	Unknown	
Engine:	3.0 L V-6	
Reported Defects:	None	
Cargo:	Unknown	
Damage Description:	Minor rearward crush to front bumper, primarily to the right front. Windshield damage to left side.	
CDC:	12FREE1	
Delta V:	Total	17.7 km/h (11.0 mph)
	Longitudinal	-17.7 km/h (-11.0 mph)
	Latitudinal	0 km/h (0 mph)
	Energy	19,609 joules (14,467 ft-lbs)

Figure 4. Exterior, case vehicle

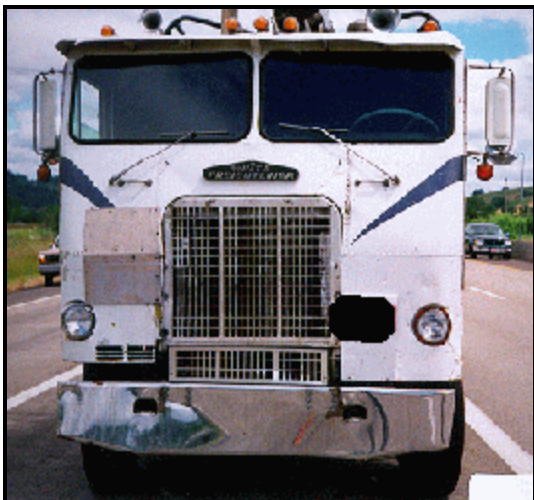
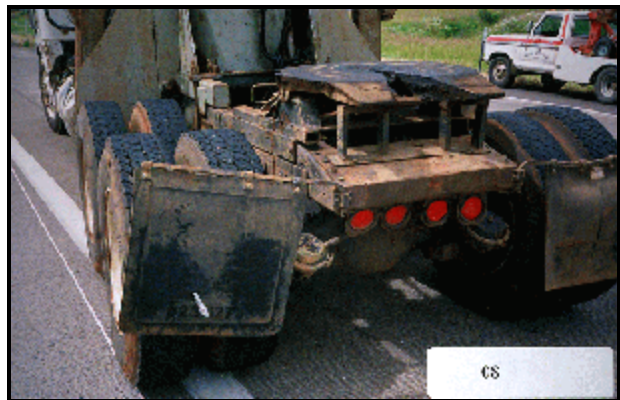
Damage Description: Minor contact damage to left rear dual and mud flap.

Figure 5. Exterior, other vehicle

Figure 6. Exterior, other vehicle

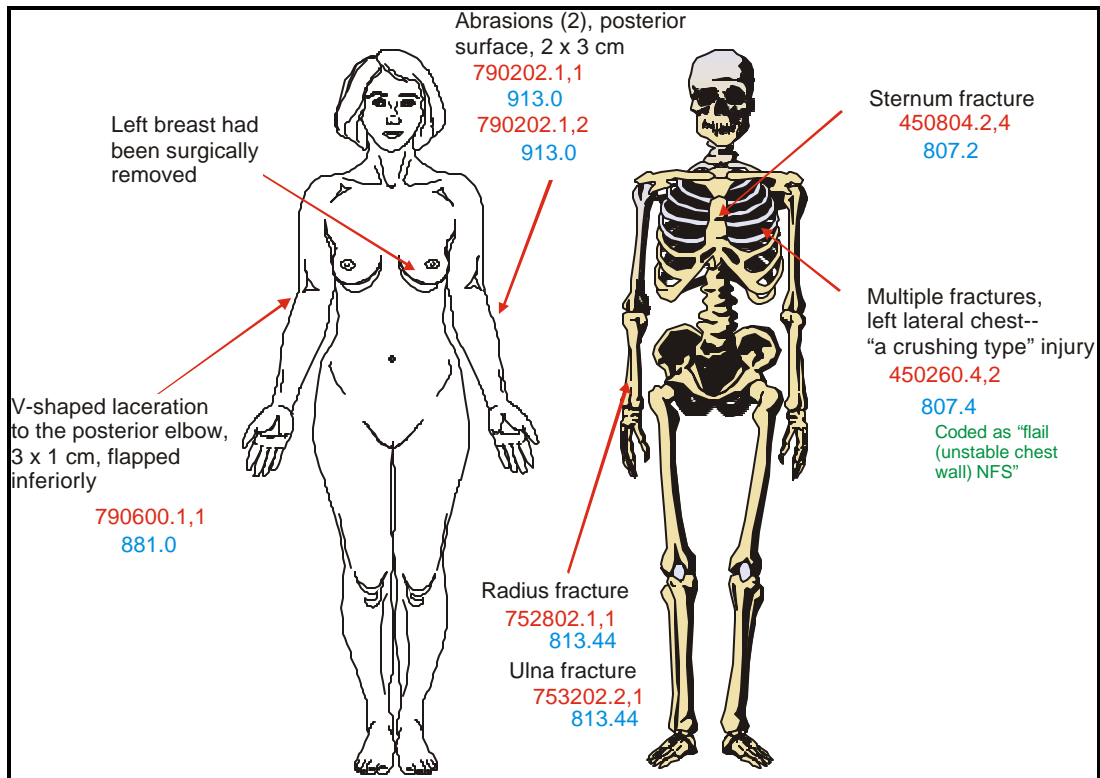
<u>INJURY</u>	<u>OIC CODE</u>	<u>ICD-9</u>	<u>SOURCE</u>
Driver:	Multiple fractures, left lateral chest—"a crushing type" injury. ³	450260.4,2	807.4	Air bag
	Sternum fracture	450804.2,4	807.2	Air bag
	Radius fracture, right	752802.1,1	813.44	Air bag module cover
	Ulna fracture, right	753202.2,1	813.44	Air bag module cover
	V-shaped laceration to the posterior elbow, 3 x 1 cm, flapped posteriorly	790600.1,1	881.0	Air bag module cover

Figure 7. Driver injuries (ME report, no invasive autopsy)

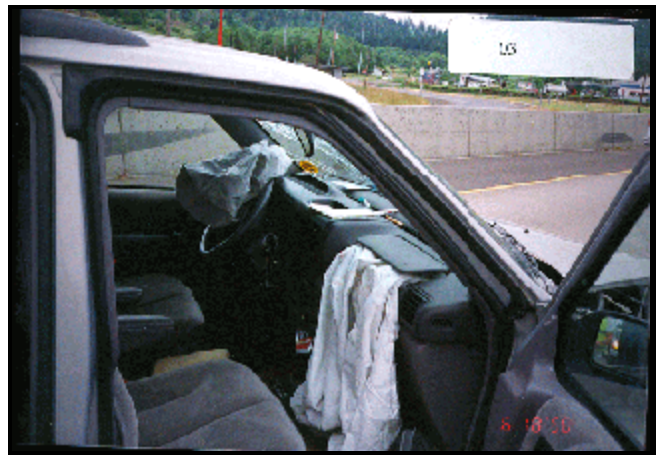
It appears likely that the driver had both hands on the steering wheel prior to impact. Her right foot was firmly pressing the brake. The pre-impact braking, plus the driver's unrestrained status and large girth, would have put this unrestrained occupant close to the steering wheel hub. At impact, the air bag began to deploy. The driver's distal right forearm appears to have been contacted by the upper module cover and fractured during deployment, while the laceration to the elbow occurred during contact with the lower module cover. This loading on the right may have made the deployment somewhat asymmetrical. As the air bag deployed fully, it struck the driver more toward the left side, causing the left side rib fractures. EMS personnel believe the sternum fracture likely came from CPR efforts. Based on the limited information available, it does not appear that there was any substantial loading of the steering wheel rim. The police indicated that the driver struck her head on the windshield. This appears unlikely; there was no residual evidence of a head strike. One possible explanation for the windshield damage would be from the driver's left forearm. If the driver was unable to retain her grip on the steering wheel her arm would have been forward of the steering wheel and above the deploying air bag. This would cause her arm to be lifted into the windshield, causing the windshield damage and the two abrasive injuries to the posterior portion of her forearm.

Figure 8. Interior, case vehicle
