On-scene Investigation / Vehicle to Vehicle
Dynamic Science, Inc. / Case Number: DS98028
1995 Plymouth Voyager
California
November 1998

| 4. Title and Subtitle In-Depth Accident Investigation | | | | 5. Report Date June 1999 | |

Dynamic Science, Inc.
Accident Investigation
Case Number: DS98028

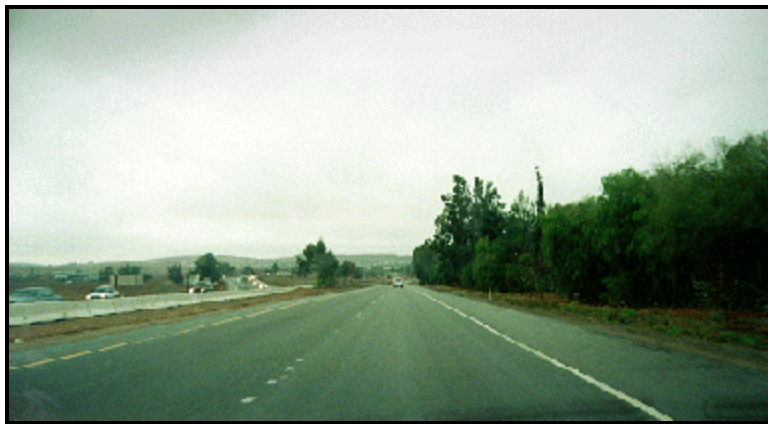
Figure 1. Crash scene, facing west

This collision occurred in California in November 1998 at 0815 hours. This four-vehicle, chain-reaction crash occurred in the westbound lanes of a crowded, two-lane divided state highway. The speed limit for vehicles in both direction is 105 km/h (65 mph). The weather was clear and the roadway was dry. There were no viewing obstructions in either direction.

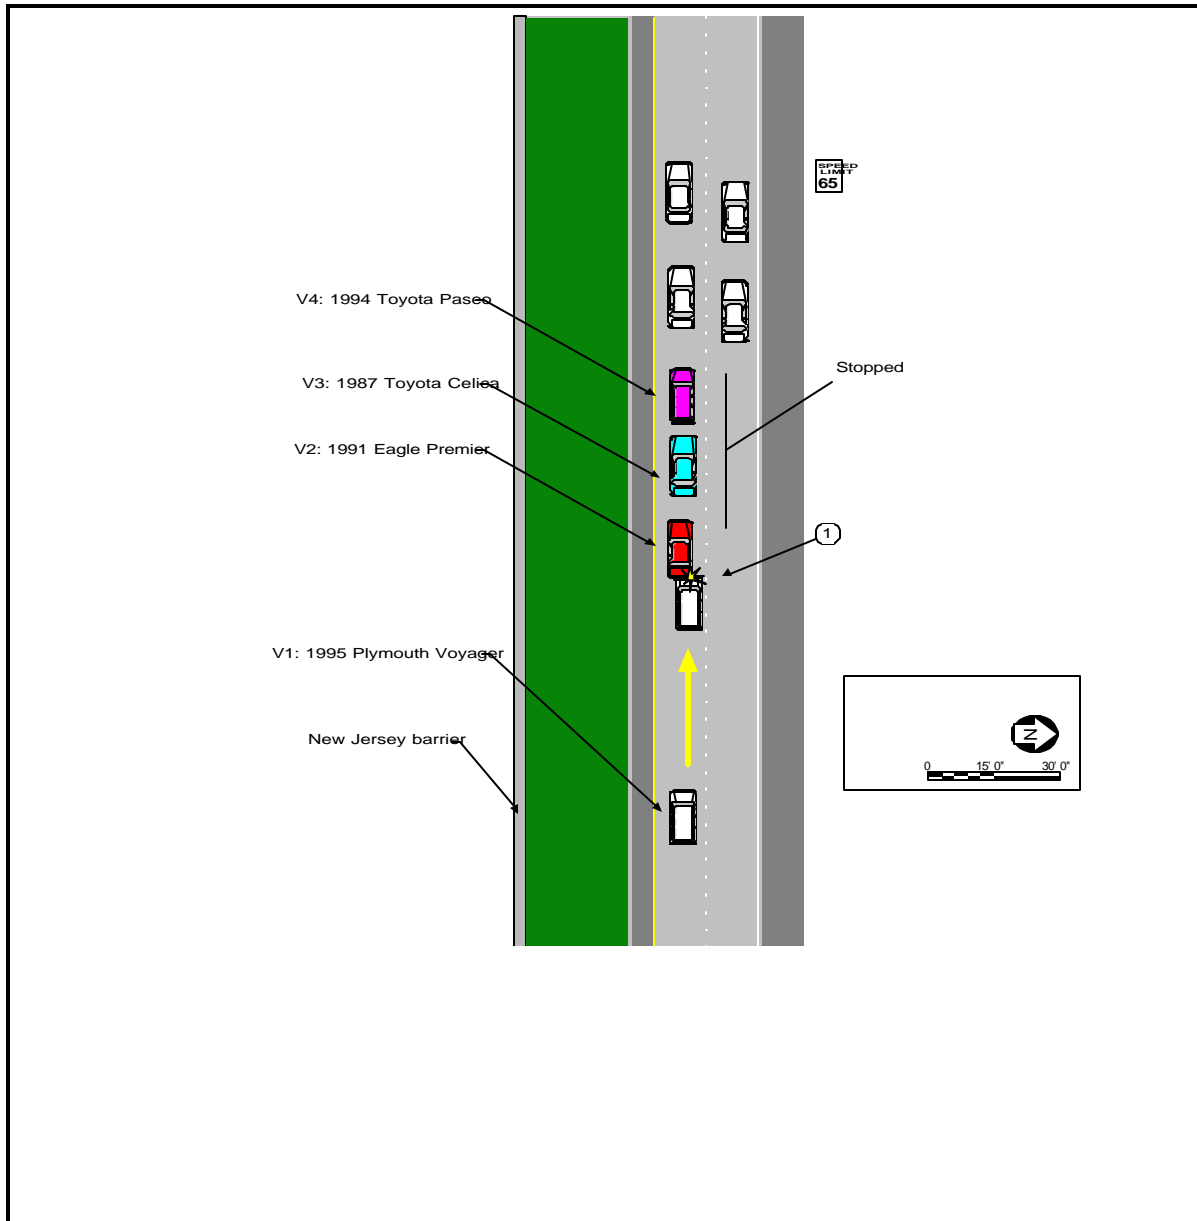
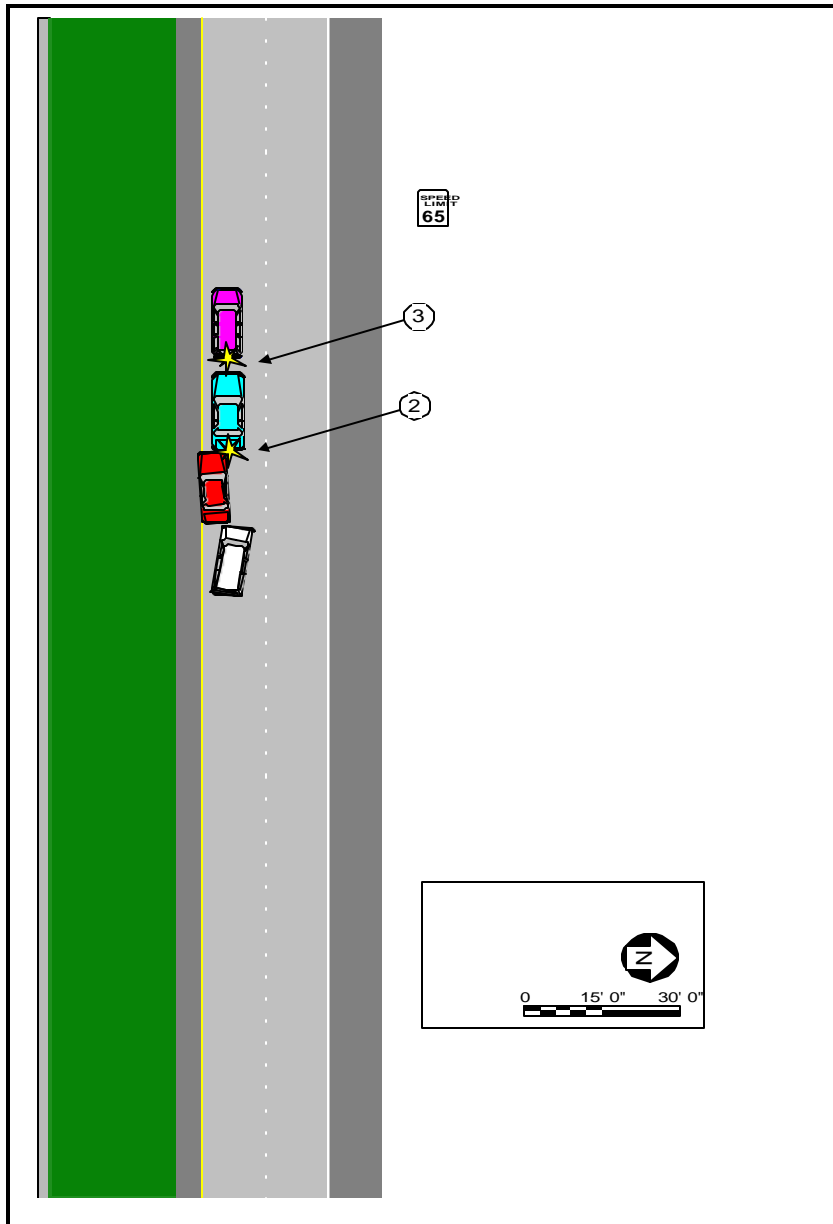
Scene Diagram

After the initial crash, the Eagle Premier was pushed into the Toyota Celica. The Toyota Celica was then pushed into the rear of the Toyota Paseo.

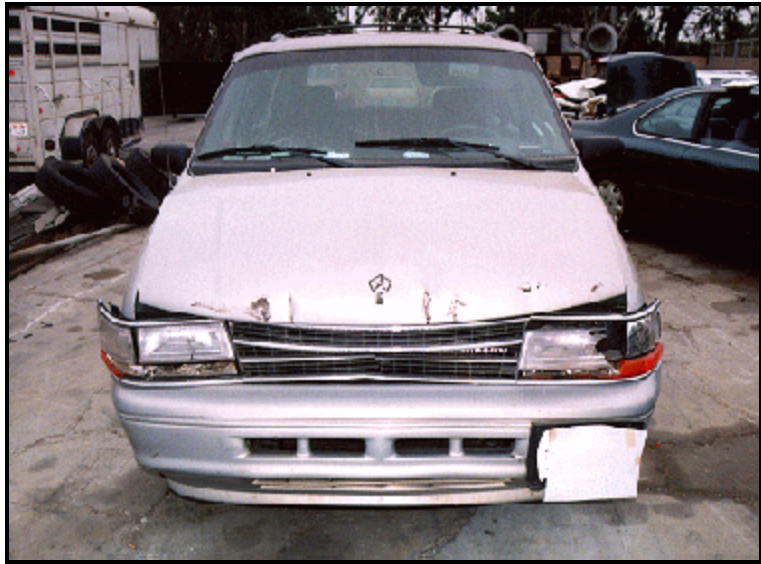
Figure 4. Exterior, front view

| Damage Description: | Minor rearward front bumper and grille crush. The hood was displaced rearward and buckled upward near its center. There was contact damage consisting of vertical creases and black transfers at the leading edge of the hood. The windshield was broken but remained intact. | |

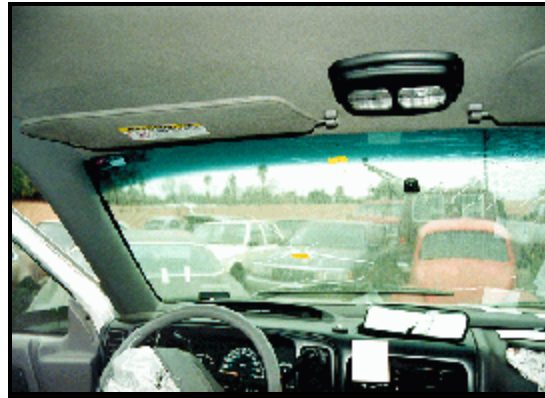
Figure 6. Interior, front left

The case vehicle was equipped with a driver's frontal air bag and a mid-mount passenger side air bag. The steering wheel hub mounted driver's air bag is circular and is 53 cm (21 in.) in diameter; it has two vent holes and is not tethered. There are nine horizontal and six vertical folds. There is 50 cm (19.6 in.) of air bag excursion. The distance from the center of the module cover to the seat back cushion is 67 cm (26.3 in.). There were markings on both the left and right side of the face of the air bag from contact with the interior module cover. There were no indications of occupant contact. The module cover has an "H" configuration. There were no indications of any damage or occupant contact.

There was damage found to the windshield from interior contacts. In the middle of the windshield there was damage from the mirror contacting the glass—this was possibly as a result of the driver's hand striking the mirror. There was also damage to the upper right portion of the windshield. This appears to be loading type damage from the deploying air bag.

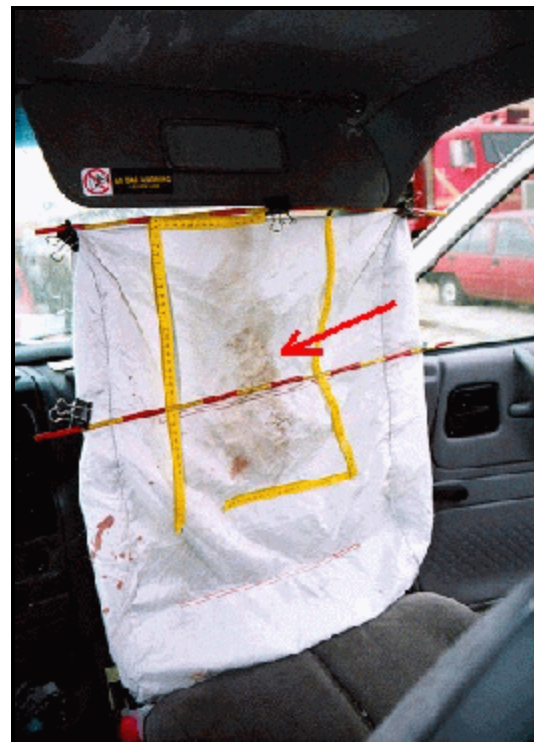
Figure 8. Passenger side front air bag

The passenger's air bag is rectangular in shape and measures 63 cm (24.8 in.) high by 49 cm (19.2 in.) wide; it has two tethers and no vent holes. There is 54 cm (21.2 in.) of air bag excursion. The distance from mid-instrument panel to the back of the front right seat is 79 cm (31.1 in.). There was a skin transfer found on the face of the air bag; it was 15 cm (5.9 in.) wide and 50 cm (19.6 in.) wide. The transfer began 22 cm (8.6 in.) below the top row of stitching and 18 cm (7 in.) from the right side. Spots of blood were found on the right side. The module cover is rectangular in shape and there were no indications of damage or contact.

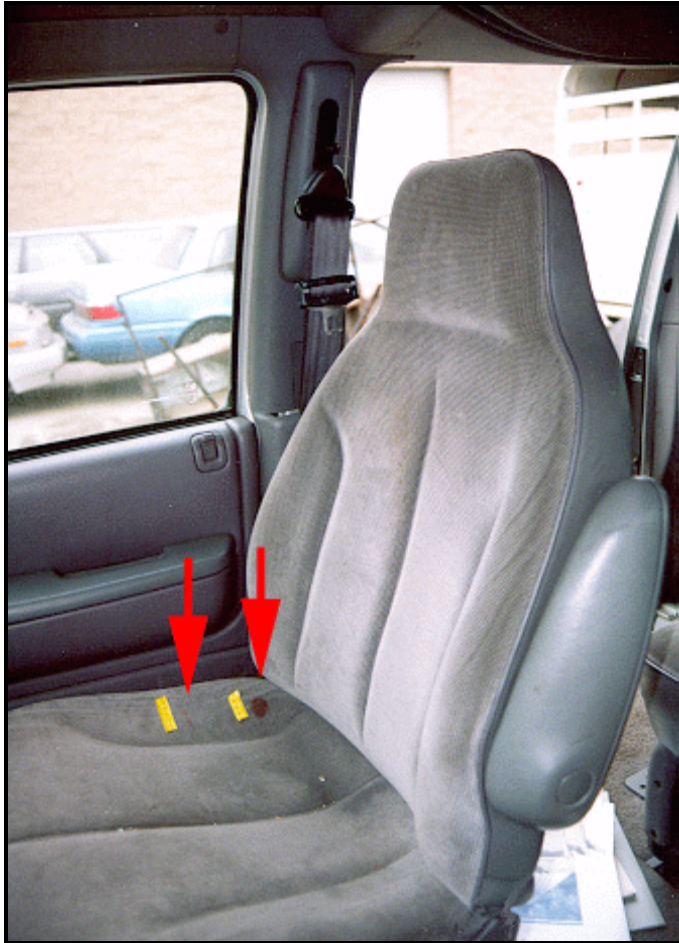
Despite the driver's statements to the contrary, it is believed that the front right passenger was not wearing the available lap and shoulder restraint. This is based on the skin transfer evidence found on the air bag and the lack of blood drop evidence found on the seat belt. There is evidence of seat belt usage, but this is a high mileage vehicle---161,993 kilometers (100,658 miles)---and the usage is likely not from this crash. There was no indication of loading.

Figure 9. Front right seat—arrows indicate blood drop evidence on seat (none found on seat belt)

Despite the driver's statements to the contrary, it is believed that the front right occupant was not wearing the available lap and shoulder restraint. This is based on the skin transfer evidence found on the air bag and the lack of blood drop evidence found on the seat belt. There is evidence of seat belt usage, but this is a high mileage vehicle---161,993 kilometers (100,658 miles)--and the usage is likely not from this crash.

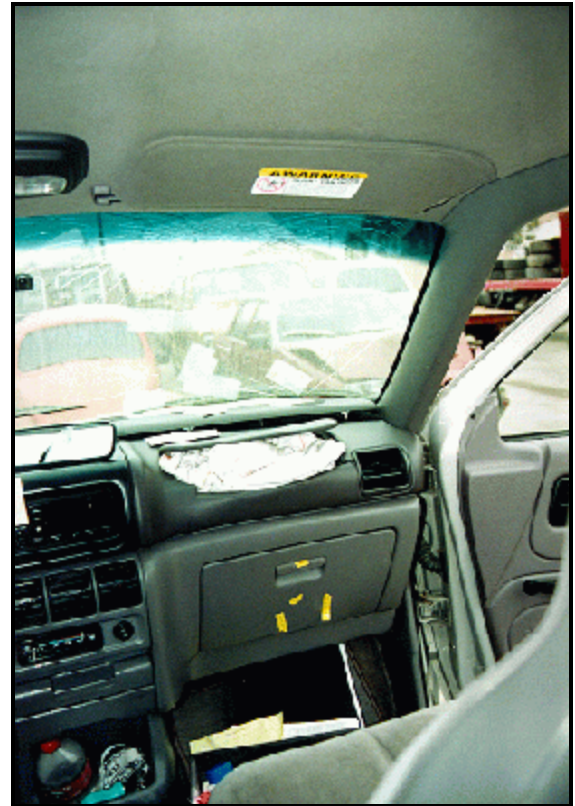
Figure 10. Interior, front right seat position

The case vehicle was traveling westbound in rush hour traffic at a driver estimated speed of 24-32 km/h (15-20 mph). The front right seat was occupied by a partially deaf 10-year-old male--the driver's son. He was seated in a box-mount, fabric-covered bucket seat. He was not wearing the available lap and shoulder belt. The seat was reclined at a 19E angle and was adjusted to the rear-most track position. The driver indicated that he had dropped off his other three sons at various schools in the area. This occupant had originally been seated in the rear, but moved to the front right position after the eldest son had vacated that position. Prior to the impact, this occupant had been instructed to put the game, with which he was playing, away. While looking to the right, the driver failed to notice traffic slowing ahead of him. The front right occupant leaned forward to put the game away. At this time, the driver saw the traffic and began braking. The front right occupant pitched forward. The front of the case vehicle struck the rear of the first other vehicle. The case vehicle sustained an estimated longitudinal ΔV of -16.5 km/h (-10.3 mph). Both the driver's side and passenger side frontal air bags deployed at this point. The braking motion and subsequent impact caused the front right occupant to pitch forward and into close proximity of the now-deploying air bag. The air bag struck the front right occupant directly in the face causing the fatal injuries.

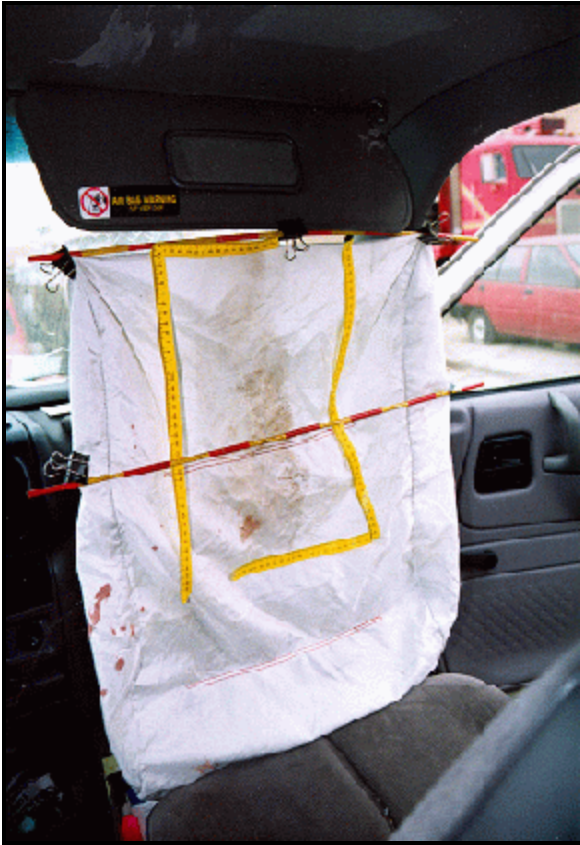
Figure 12. Passenger side air bag - skin transfer
