**VERIDIAN REMOTE AIR BAG RELATED
ADULT DRIVER FATALITY INVESTIGATION
VERIDIAN CASE NO. CA98-064
VEHICLE: 1997 TOYOTA CAMRY
LOCATION: PENNSYLVANIA
CRASH DATE: AUGUST 1997**

14. <i>Sponsoring Agency Code</i>	
15. <i>Supplementary Notes</i> Remote investigation of a moderate severity frontal crash that resulted in deployment of the driver air bag system in a 1997 Toyota Camry and the death of the 53 year old female driver and her 86 year old female front right passenger.

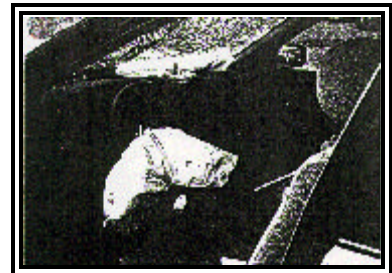
The Toyota Camry was equipped with a first generation frontal air bag system for the driver and right passenger positions. The system consisted of a single point air bag sensor and control module that was located at the forward aspect of the center console, the steering wheel mounted driver module, the top mounted passenger module, and an instrument panel mounted indicator lamp. The "Holmatro Rescuer's Guide to Vehicle Safety Systems" listed the availability of front seat belt retractor pretensioners and seat mounted side impact air bags. It was unknown if this vehicle was equipped with these additional safety features. **Figure 4** is a view of the deployed air bag system.

Figure 4. Deployed frontal air bag system.

The driver air bag membrane partially deployed through the H-configuration module cover flaps and fully expanded from between the module cover and the steering assembly **Figure 4**. This anomaly resulted from the forward positioned driver who restricted the normal deployment of the driver module. The driver bag was vented by two ports noted in **Figure 4**. Due to the remote nature of this investigation, it was unknown if further damage occurred to the driver air bag.

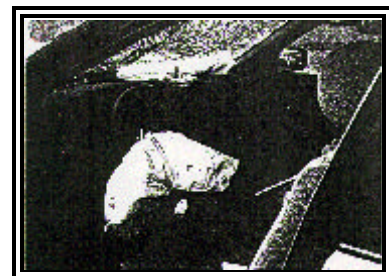
The unrestrained driver initiated a forward trajectory in response to the frontal impact force. This trajectory, combined with her pre-crash motion, placed her upper torso against the driver air bag module. As the air bag deployed, the driver's forward position restricted the H-configuration cover flaps from opening. The air bag membrane began to deploy from the flaps, however, a small portion of the bag became captured between the flaps. The continued expansion of the bag separated the entire module cover from the steering assembly (**Figure 5**). As a result, the driver sustained a punch-out loading force to the chest that resulted in bilateral 1-7 rib fractures with pulmonary contusions, a fracture of the right clavicle, complete separation of the left clavicle, lacerations of the aorta and pericardium, and multiple abrasions and contusion of the chest and upper abdomen. The continued expansion of the air bag membrane resulted in contact to the driver face. She sustained abrasions over the mandible, a fracture of the left mandible, a dislocated tooth, and a gaping laceration of the subcutaneous tissue overlying the fracture site.

Figure 5. Separated module cover and deployed driver air bag.

The continued expansion of the air bag membrane hyperextended the driver's neck as it wrapped around her face as evidenced by a left ear laceration and scalp abrasions. The hyperextension resulted in a gaping basilar skull fracture, a partial distraction of the pons from the brain stem, and tears of the carotid arteries.

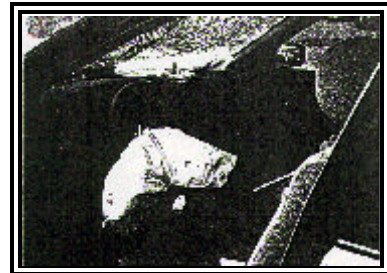
Due to the lack of detailed interior photographs/documentation that was available for this remote investigation (**Figure 6**), an accurate reconstruction of the front right passenger's kinematics and injury sources could not be made with certainty. The deployment of the front right passenger air bag and the nature and location of the passenger's injuries may suggest that the deploying air bag could have been a potential source for the majority of her injuries during its initial expansion. The driver was also viewed as a possible source of injury resulting from occupant-to-occupant interaction, however, the driver did not sustain injury that was consistent with this interaction sequence. Therefore, the majority of her injuries and the injuries that contributed to her death were from unknown sources.

Figure 6. Sole image of the front right passenger air bag and occupant's seated position .
