REMOTE AIR BAG RELATED CHILD FATALITY INVESTIGATION

VERIDIAN CASE NO. CA98-067

VEHICLE - 1995 TOYOTA COROLLA

LOCATION - GEORGIA

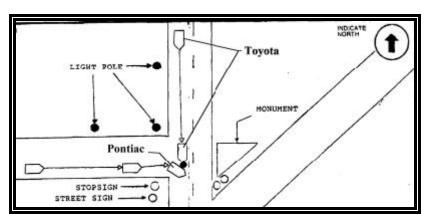
Figure 1: Police Diagram.

This two-vehicle crash occurred during the afternoon hours in June 1998. At the time of the crash, it was daylight and the weather was not a factor. The crash occurred at the three-leg intersection of a straight and level north/south two lane road and an east/west two lane road. The east/west roadway intersected the north/south roadway from the west. A stop sign for eastbound traffic controlled the intersection. The speed limit in the area of the crash was 48 km/h (30 mph). Figure 1 is the police investigator's sketch of the crash site.

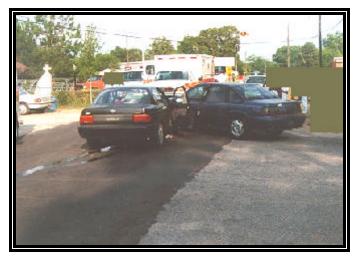
The crash occurred with the center and right aspects of the Toyota's front plane striking the left front axle and A-pillar area of the Pontiac, **Figure 2**. The vehicles came to rest in contact with each other approximately at the point of impact. The force of the 12/8 o'clock impact configuration was above the deployment threshold of the Toyota's Supplemental Restraint System. The driver and front right passenger air bags deployed.

Figure 2: On-scene photograph of the vehicle's at final rest.
