**REDESIGNED AIR BAG SPECIAL STUDY (RABSS)
SCI TECHNICAL SUMMARY REPORT**

NASS CDS CASE NO. 1999-43-085J

**RABSS VEHICLES - 1998 TOYOTA COROLLA VE
1998 JEEP CHEROKEE LIMITED**

CRASH DATE - APRIL, 1999

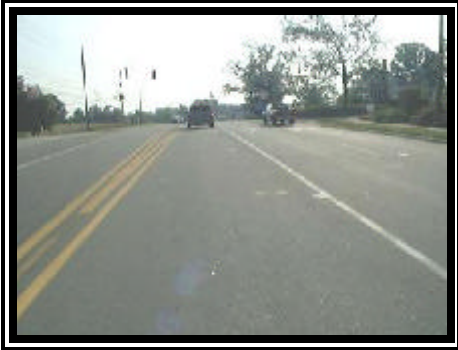
Figure 1. Eastbound approach for the 1998 Toyota Corolla VE.

The 63 year old female driver of the 1998 Toyota Corolla VE was operating the vehicle eastbound (**Figure 1**) on approach to a rural 4-leg intersection when she failed to observe the westbound Jeep as she attempted to turn left (north) at a (police reported) speed of 16 km/h (10 mph). The police reported no brake marks indicative of driver avoidance maneuvers.

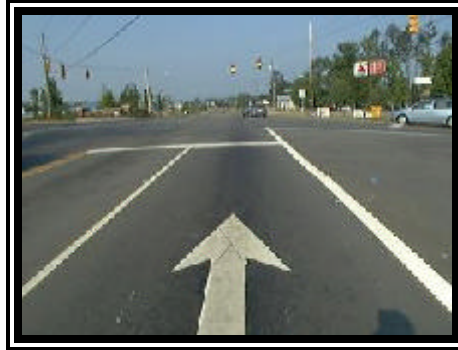
Figure 2. Westbound approach for the 1998 Jeep Cherokee Limited.

The 47 year old male driver of the 1998 Jeep Cherokee Limited was operating the vehicle westbound at a (driver reported speed) of 64 km/h (40 mph) when he proceeded straight through the 4-leg intersection (**Figure 2**) and observed the eastbound Toyota cross his path of travel. Upon recognition of the impending harmful event, the driver steered right and braked in avoidance.

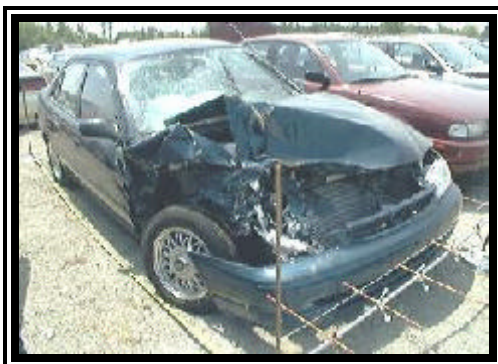
The 1998 Toyota Corolla VE sustained moderate frontal damage as a result of the impact with the Jeep Cherokee (**Figure 3**). The direct contact damage began at the front right bumper corner and extended 60.0 cm (23.6 in) inboard. The impact deformed the entire front end width resulting in a combined direct and induced damage length (Field L) of 141.0 cm (55.5 in). Six crush measurements were documented at the level of the bumper: C1= 6.0 cm (2.4 in), C2= 2.0 cm (0.8 in), C3= 4.0 cm (1.6 in), C4= 6.0 cm (2.4 in), C5= 8.0 cm (3.1 in), C6= 14.0 cm (5.5 in). A secondary crush profile was obtained above the level of the bumper to capture the underride damage resulting in an *averaged profile of*: C1= 12.0 cm (4.7 in), C2= 16.0 cm (6.3 in), C3= 23.0 cm (9.1 in), C4= 33.0 cm (13.0 in), C5= 39.0 cm (15.4 in), C6= 66.0 cm (26.0 in). The Collision Deformation Classification (CDC) for this impact to the Toyota was 01-FZEW-3 with a principal direction of force of (+)20 degrees. The hood was deformed rearward. The right fender was displaced rearward which restricted the right front wheel/tire (not deflated). The windshield was fractured from (exterior) impact forces and the (interior) front right passenger air bag deployment. Reduction in the left side wheelbase measured 2.0 cm (0.8 in).

Figure 3. Front right damage to the 1998 Toyota Corolla VE.

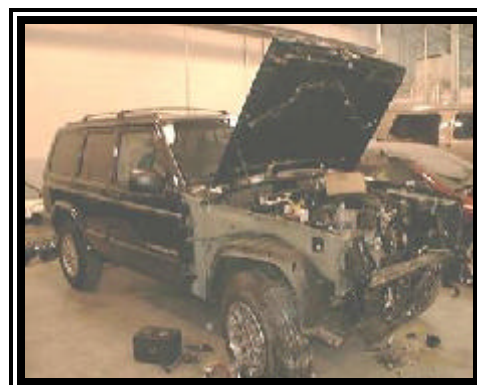
Figure 4. Frontal damage to the 1998 Jeep Cherokee Limited (vehicle under repair).

The 1998 Jeep Cherokee Limited sustained moderate frontal damage as a result of the impact with the Toyota Corolla (**Figure 4**). The *SCI revised* direct contact damage began 55.0 cm (21.7 in) to the right of the front left bumper corner and extended 93.0 cm (36.6 in) inboard. The impact deformed the entire front end width resulting in an estimated combined direct and induced damage length (Field L) of 119.0 cm (46.9 in). The vehicle was under repair at the time of the NASS inspection, therefore, a crush profile was not obtained. The Collision Deformation Classification (CDC) for this impact to the Jeep was 12-FZEW-9 (unknown crush extent zone represented by "9"). The right fender was removed as the right front wheel/tire was restricted (not deflated).

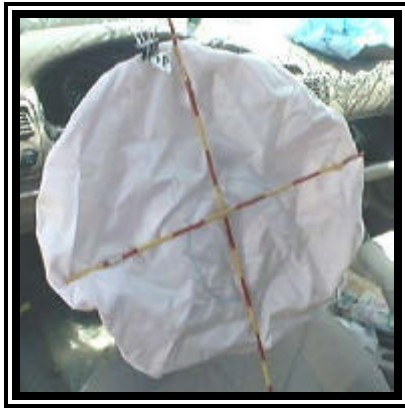
The 1998 Toyota Corolla VE was equipped with redesigned frontal air bags for the driver and front right passenger positions. The air bags deployed as a result of the crash. The driver air bag was housed in the center of the steering wheel with a horizontally oriented flap tear seam (H-configuration). The flaps were rectangular in shape as the upper flap measured 16.0 cm (6.3 in) in width and 6.0 cm (2.4 in) in height while the lower flap measured 16.0 cm (6.3 in) in width and 10.0 cm (3.9 in) in height. Although no contact evidence was identified on the exterior surface of the module cover flaps, blood spattering was noted on the left upper quadrant of the air bag face and left portion on the rear aspect. The NASS researcher measured the diameter of the driver air bag at 45.0 cm (17.7 in) in its deflated state (**Figure 5**). The bag was vented by two ports located at the 11 o'clock and 1 o'clock sectors on the rear aspect of the air bag. No internal tether straps were present.

Figure 5. 1998 Toyota Corolla VE deployed redesigned driver air bag.

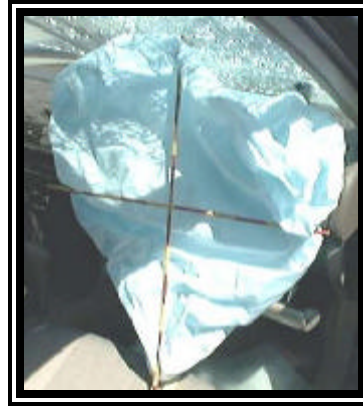
The front right passenger air bag deployed from the right top instrument panel area with a horizontally oriented flap tear seam (H-configuration). The flaps were symmetrical in shape and measured 23.0 cm (9.1 in) in width and 5.0 cm (2.0 in) in height. No contact evidence was identified on the air bag or exterior surface of the module cover flaps. The NASS researcher measured the passenger air bag at 52.0 cm (20.5 in) in width and 58.0 cm (22.8 in) in height in its deflated state (**Figure 6**). The bag was vented by two ports located at the 10 o'clock and 2 o'clock sectors on the side aspect of the air bag. No internal tether straps were present.

Figure 6. 1998 Toyota Corolla VE deployed redesigned passenger air bag.

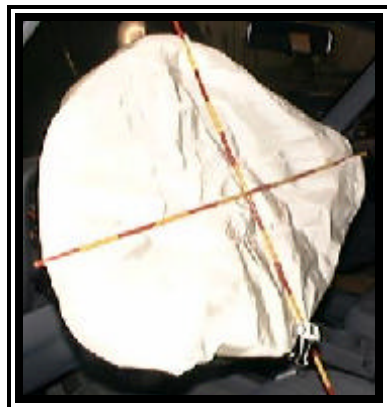
The 1998 Jeep Cherokee Limited was equipped with redesigned frontal air bags for the driver and front right passenger positions. The air bags deployed as a result of the crash. The driver air bag was housed in the center of the steering wheel with a single cover flap design hinged at the top aspect. The flap was rectangular in shape and measured 15.0 cm (5.9 in) in width and 11.0 cm (4.3 in) in height. No contact evidence was identified on the air bag or exterior surface of the module cover flap. Black vinyl transfers were noted to the (front/back) left upper quadrant from expansion within the module. The NASS researcher measured the diameter of the driver air bag at 49.0 cm (19.3 in) in its deflated state (**Figure 7**). No vent ports or internal tether straps were reportedly present.

Figure 7. 1998 Jeep Cherokee Limited deployed redesigned driver air bag.

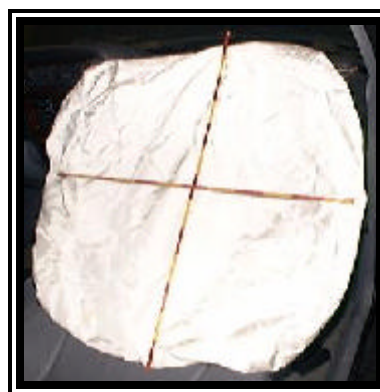
The front right passenger air bag deployed from the right mid-instrument panel area with a single cover flap design hinged at the top aspect. No contact evidence was identified on the air bag or exterior surface of the module cover flap. The cover flap was rectangular in shape and measured 39.0 cm (15.4 in) in width and 16.0 cm (6.3 in) in height. Black vinyl transfers were noted to the upper right quadrant of the air bag face. The NASS researcher measured the passenger air bag at 62.0 cm (24.4 in) square in its deflated state (**Figure 8**). No vent ports or internal tether straps were reportedly present.

Figure 8. 1998 Jeep Cherokee Limited deployed redesigned passenger air bag.

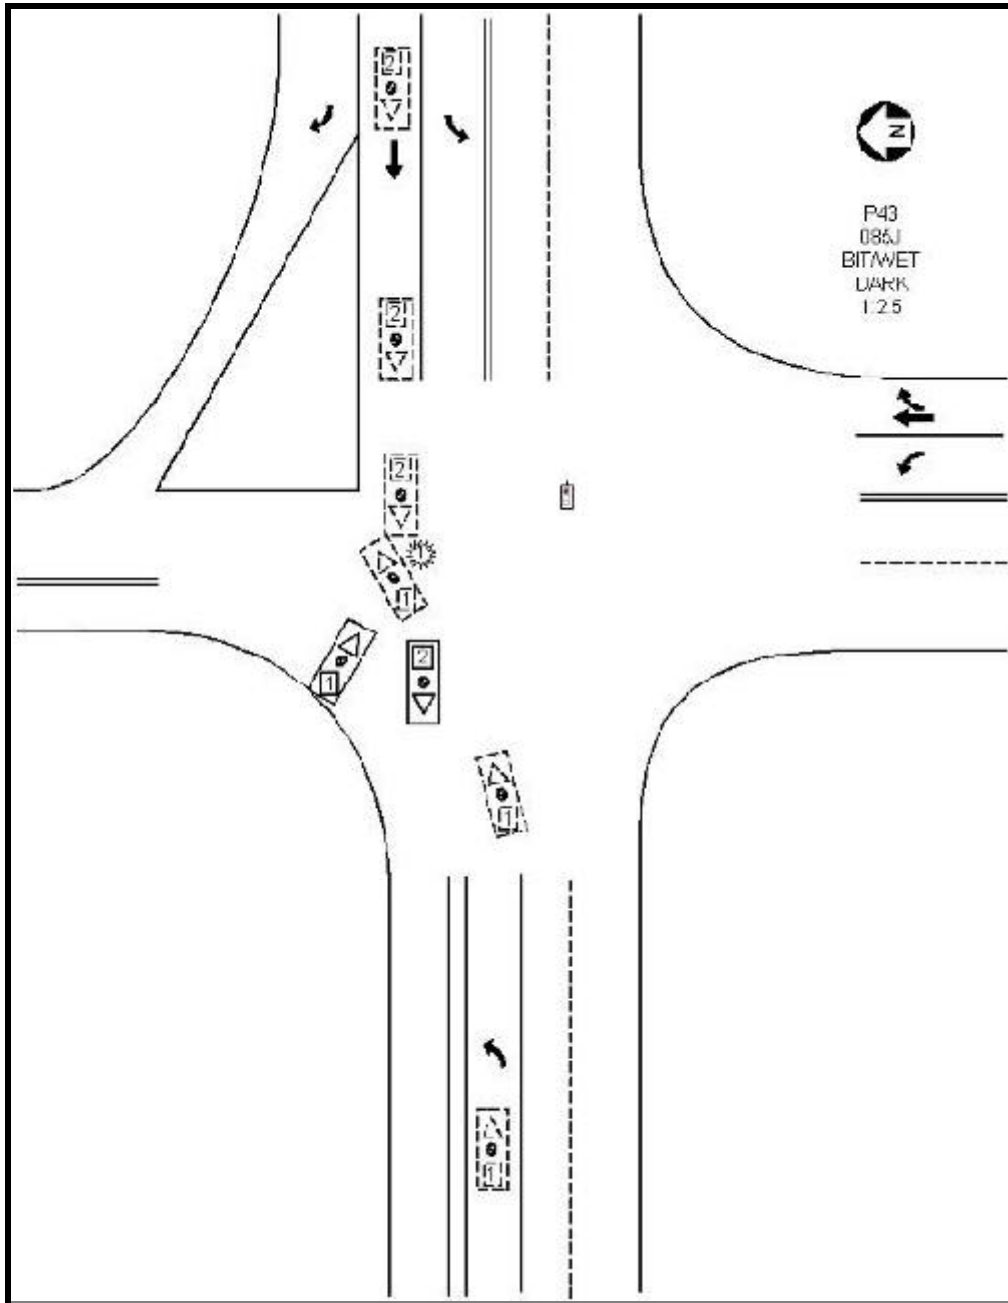
This two vehicle crash occurred during the evening hours of April, 1999. At the time of the crash, it was dark (street not lighted) with rainy conditions as the roads were wet. The crash occurred at a hillcrest in the westbound lane of a (asphalt/straight) 4-leg rural intersection (see **Figure 9 - page 8**). The east sector of the intersection consisted of one left turn lane, one through lane and one channelized right turn lane as the west sector consisted of one left turn lane and two through lanes. Traffic control through the intersection was controlled by an overhead signal system in green phase for east/westbound traffic. The posted speed limit at the crash site was 72 km/h (45 mph).

Figure 9. NASS Scene Diagram.
