Remote, Redesigned Air Bag Special Study

Dynamic Science, Inc., Case Number (1999-081-801E)

1999 Pontiac Grand Am

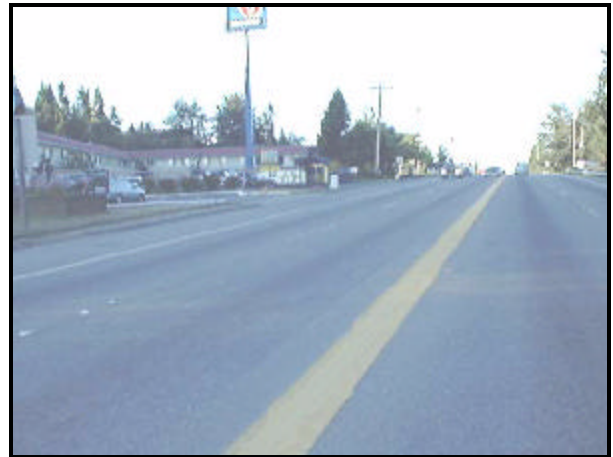
Figure 3. Crash scene, Vehicle 1 approach path.

As the two vehicles were approaching each other, Vehicle 1 crossed the painted double yellow center line and entered northbound traffic. The driver of Vehicle 2 attempted to avoid the impact by applying the brakes (with lock-up), leaving approximately 7.6 meters (25 feet) of skid marks. The front plane of Vehicle 1 (12FDEW2) struck the front plane of Vehicle 2 (72FDEW2) in the right northbound travel lane.

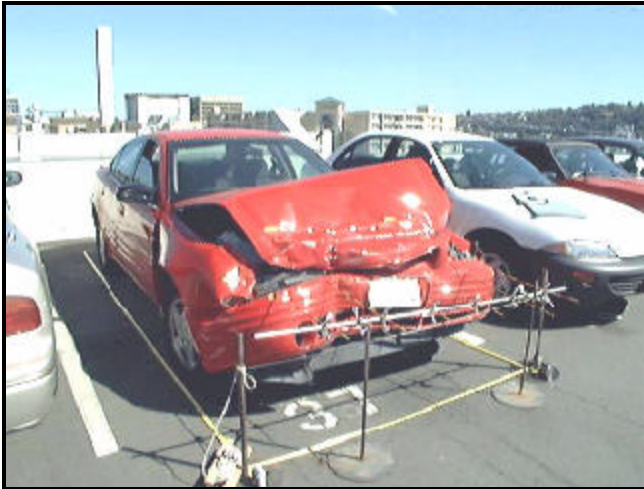
Figure 4. Exterior, Vehicle 1 (1999 Pontiac Grand Am)

Model year, make and model	1999 Pontiac Grand Am
VIN	1G2NE52E2XM
CDC	12FDEW2

Plane of Impact	Field L cm/in.	C1 cm/in.	C2 cm/in.	C3 cm/in.	C4 cm/in.	C5 cm/in.	C6 cm/in.
Bumper	143	10	16	28	33	28	16
	56.3	3.9	6.3	11	13	11	6.3

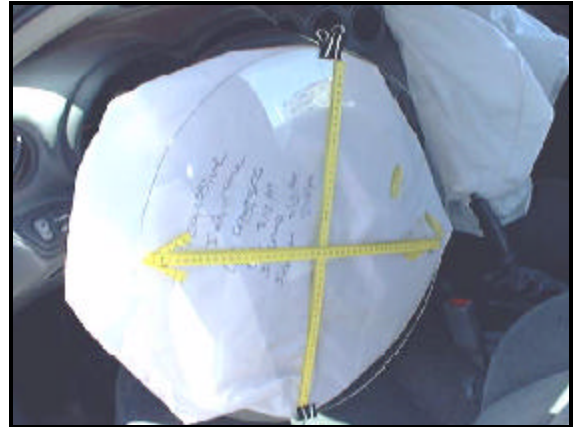
Figure 6. Driver's frontal air bag.

The front left air bag was housed in the steering wheel hub and was concealed by symmetrical I-configuration cover flaps which were not damaged in the crash. The circular air bag was equipped with two vent ports and no tether straps. Contact evidence which was described by the researcher as an "unknown smear" and also an "unknown ring shape" was found on the lower half of the front of the bag. The bag was not damaged.

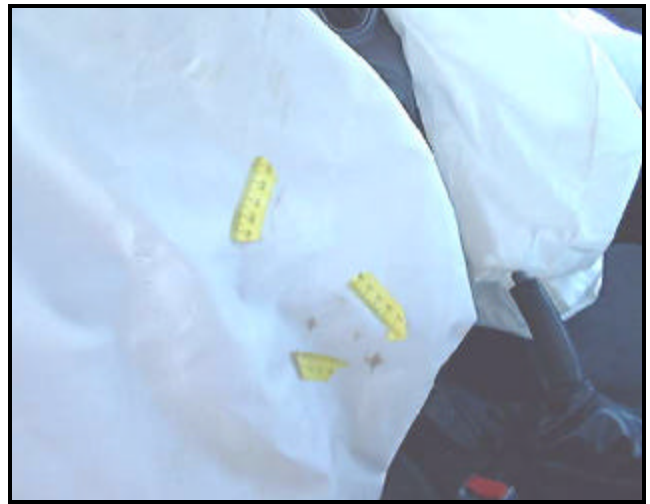
Figure 7. Driver's air bag contact evidence.

At impact, the occupants reacted to the 0 degree principle direction of force by moving forward and loading the lap/shoulder restraints. As the restraints locked, further forward movement of the occupants was prevented. The driver had moved far enough forward to impact the deploying driver's frontal air bag-causing the chin and nose abrasions. Several areas of discoloration were found on the front of the air bag (see figure 7). The driver's knees came into contact with the knee bolster-causing the bilateral knee contusions. The front right passenger's loading of the locked lap/shoulder restraint caused the right side neck abrasion and abdominal contusion. Both occupants of Vehicle 1 were transported from the scene to a hospital where they were treated and released.

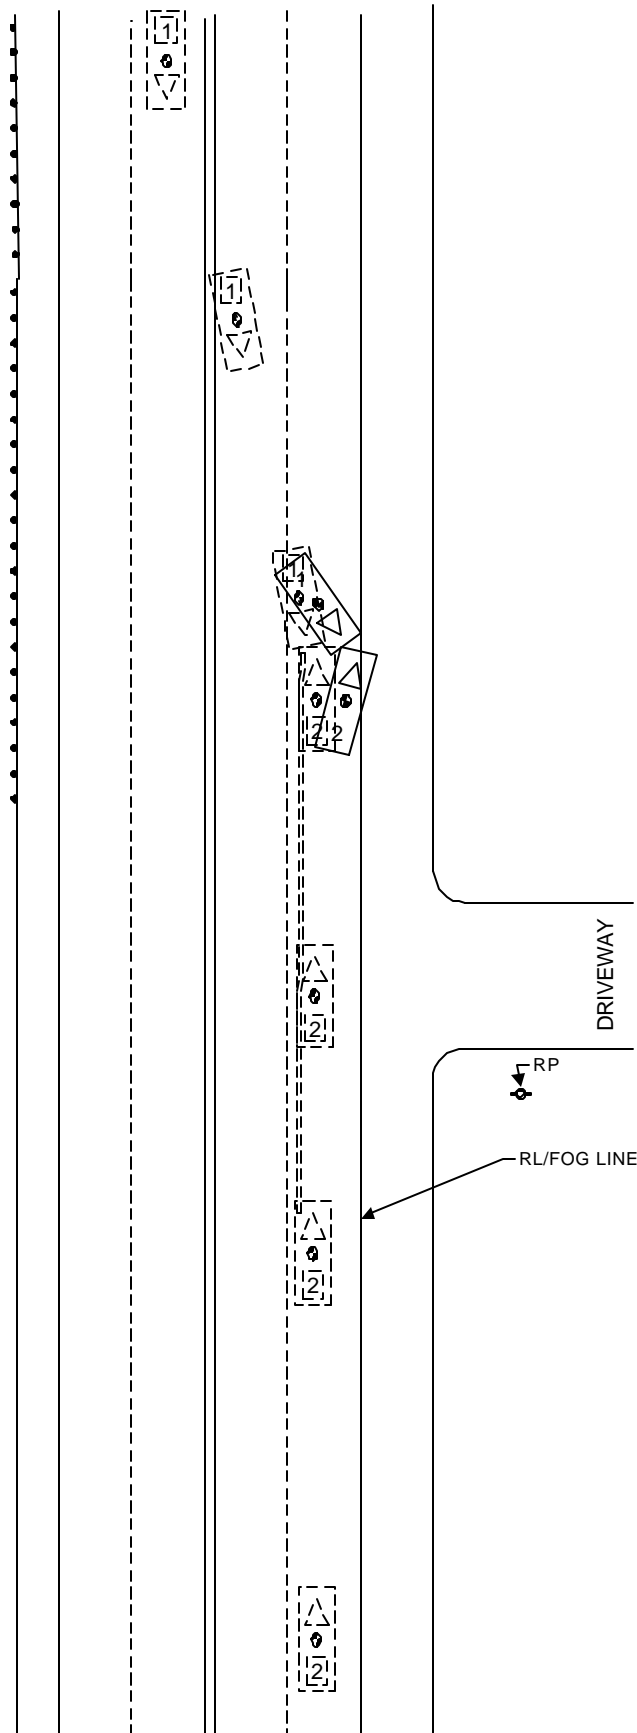
Scene Diagram

NEGATIVE GRADE 4/122
