Remote Investigation / Vehicle to Vehicle
Dynamic Science, Inc. / Case Number: DS99022
1997 Toyota 4Runner
Nevada
July 1999

1. Report No. DS99022		2. Government Accession No.		3. Recipient Catalog No.	
4. Title and Subtitle In-Depth Accident Investigation				5. Report Date June 1, 2000

Description: This case is being initiated in response to a report of a passenger air bag-related adult serious injury. The NHTSA was notified by phone on August 25, 1999. The initiator is the husband of the injured party. DSI was notified on August 26, 1999. This case was conducted as a remote investigation.

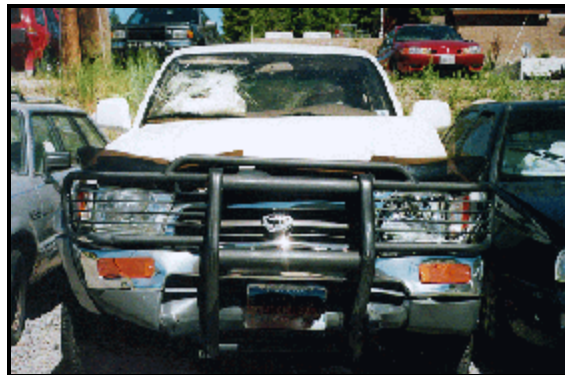
Figure 1. Exterior, case vehicle

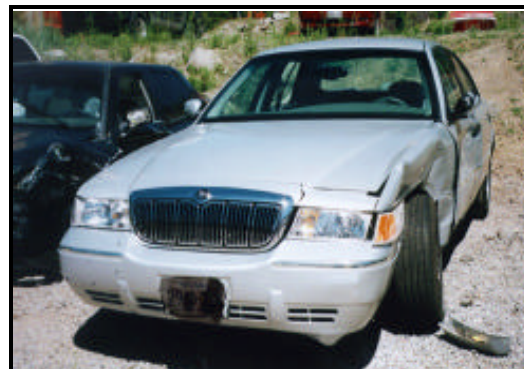
Figure 2. Exterior, other vehicle

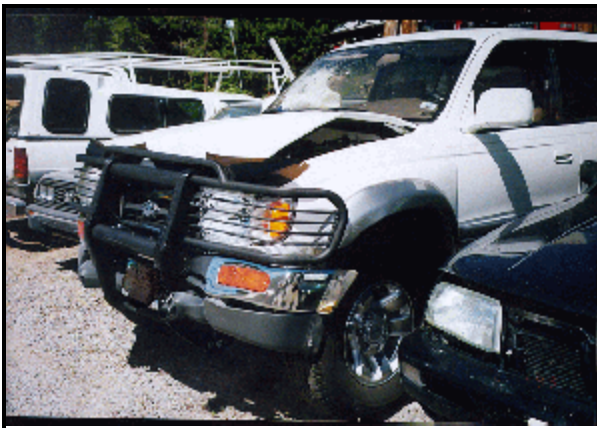
Description:	1997 Toyota 4-Runner LTD Sports Utility Vehicle	
VIN:	JT3HN87R9V0XXXXXX	
Odometer:	29,824 miles	
Engine:	3.4L V6	
Reported Defects:	None	
Cargo:	2 canvas chairs, 5 pairs of golf shoes, tool box, miscellaneous clothing and books	
Damage Description:	Minor front damage. Right side windshield broken by air bag.	
CDC:	12FDLW1	
Delta V:	Total	21.3 km/h (13.3 mph)
	Longitudinal	-21.2 km/h (-13.2 mph)
	Latitudinal	-1.9 km/h (-1.2 mph)
	Energy	43,344 joules (31.987 ft-lbs.)

Figure 4. Exterior, case vehicle

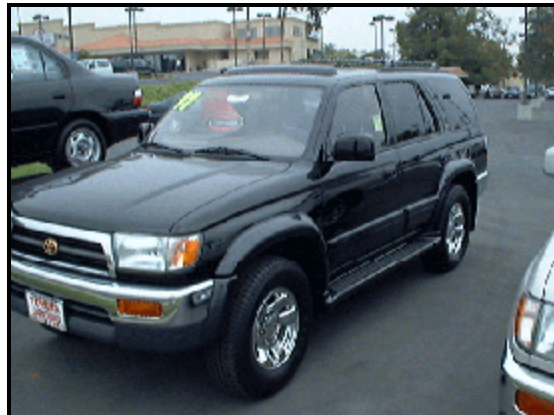
Figure 5. Exterior view of exemplar vehicle

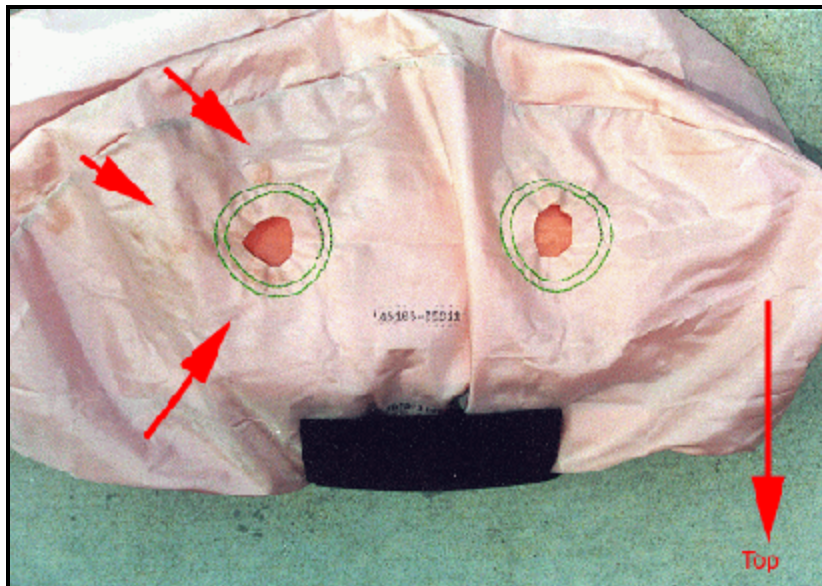
The front left air bag was housed in the steering wheel hub and was concealed by symmetrical H-configuration cover flaps. The circular air bag was equipped with one tether and two vent ports. No contact evidence was found on the bag and the bag and cover flaps were not damaged. There was, however, evidence of bleeding found on the back side of the upper portion of the air bag.

Figure 7. Back side of driver air bag—arrows indicate blood/saliva markings

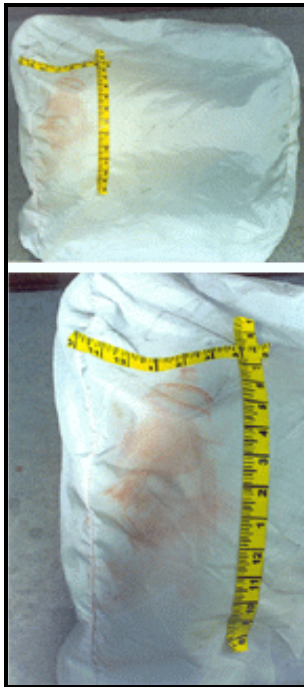
The front right midmount air bag is rectangular in shape and is equipped with two vent ports and no tethers. It measured 55 cm (21.6 in.) high by 54 cm (21.2 in.) wide with a deployed excursion of 69 cm (27.2 in.). Contact evidence consisting of make-up and skin tissue was found on the top left of the front of the bag as a result of contact with the front right passengers's face.

Figure 8. Front view of passenger air bag

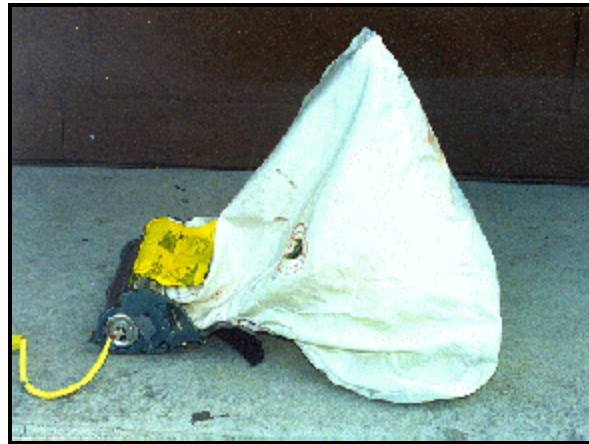
Figure 9. Passenger air bag, left side

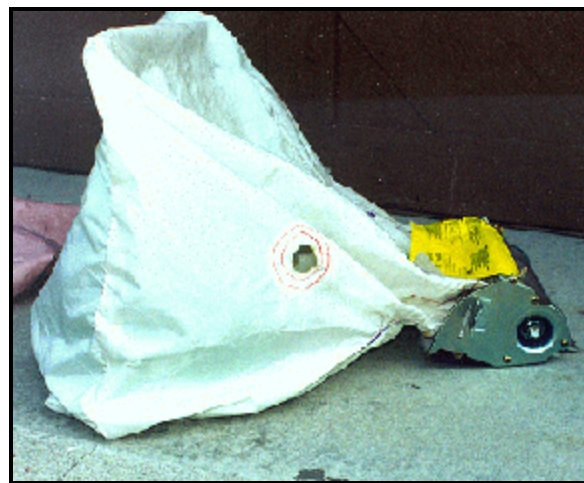
Figure 10. Passenger air bag, right side

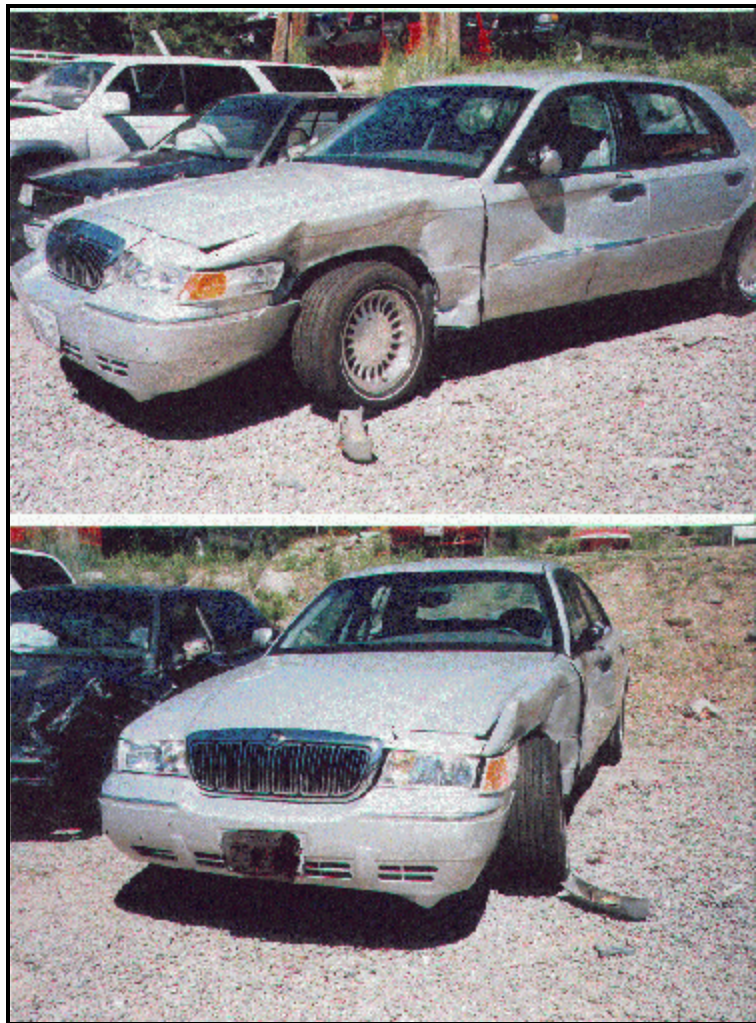
Description:	1999 Mercury Grand Marquis LS four-door sedan	
VIN:	2MEFM75W1XXXXXXXXXX	
Odometer:	4,648 miles	
Engine:	4.6 L V8	
Reported Defects:	None	
Cargo:	None	
Damage Description:	Minor lateral crush to left front fender area	
CDC:	09LYEW2	
Delta V:	Total	21.8 km/h (13.6 mph)
	Longitudinal	-3.8 km/h (-2.4 mph)
	Latitudinal	21.5 km/h (13.4 mph)
	Energy	25,575 joules (18,874 ft-lbs.)

Figure 12. Exterior, other vehicle

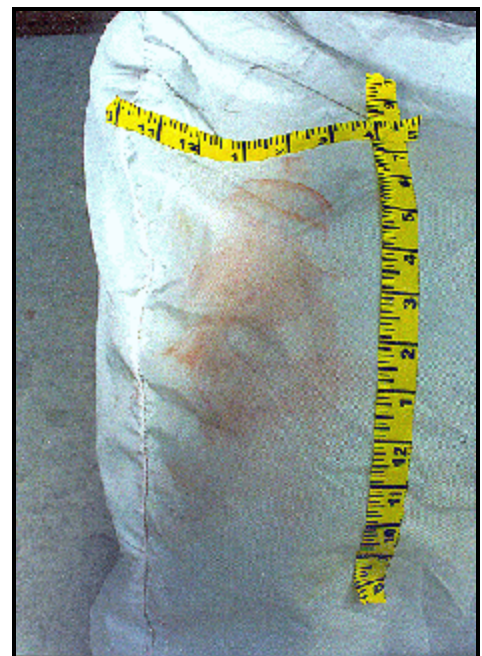
The front right occupant also pitched forward into close proximity of the now-deploying air bag. This occupant engaged the air bag near the left upper quadrant with her face—depositing a patch of skin and makeup transfer approximately 34 cm high by 12 cm wide (13.4 x 4.7 in.)—which caused the abrasions to her cheek, nose, chin, and neck. As the air bag deployed more fully, her head was thrust upward and rearward—causing the neck strain and contusion to the back of her head.

Figure 14. Passenger front air bag
