Remote Investigation / Vehicle to Vehicle
Dynamic Science, Inc. / Case Number: DS99040
1994 Jaguar XJS 2 door coupe
Colorado
April, 1997

1. Report No. DS99040		2. Government Accession No.		3. Recipient Catalog No.	
4. Title and Subtitle In-Depth Accident Investigation				5. Report Date June 1, 2000

Dynamic Science, Inc.
Accident Investigation
Case Number: DS99040

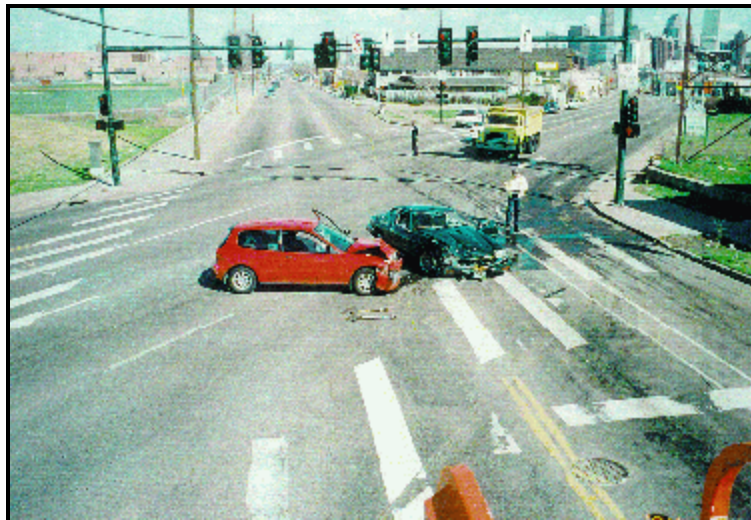
Figure 1. Final rest

As The case vehicle entered the intersection, the driver began a left hand turn. The driver of The other vehicle saw The case vehicle and began braking. The front of The other vehicle (11FDEW1) struck the front of The case vehicle (01FZEW1). The case vehicle sustained a total delta v of 17.4 km/h (11.2 mph), a longitudinal delta v of -15.0 km/h (-9.7 mph), and a lateral delta v of -8.7 km/h (-5.6 mph). The other vehicle sustained a total delta v of 26.8 km/h (17.3 mph), a longitudinal delta v of -23.2 km/h (-14.9 mph), and a lateral delta v of 13.4 km/h (8.6 mph). The impact was of sufficient magnitude and both frontal air bags in The case vehicle deployed and the driver's side front air bag in The other vehicle also deployed. The other vehicle was pushed into a clockwise direction and came to rest facing east. The case vehicle was pushed into a counterclockwise direction and came to rest facing southeast. Both vehicles were towed from the scene due to damage.

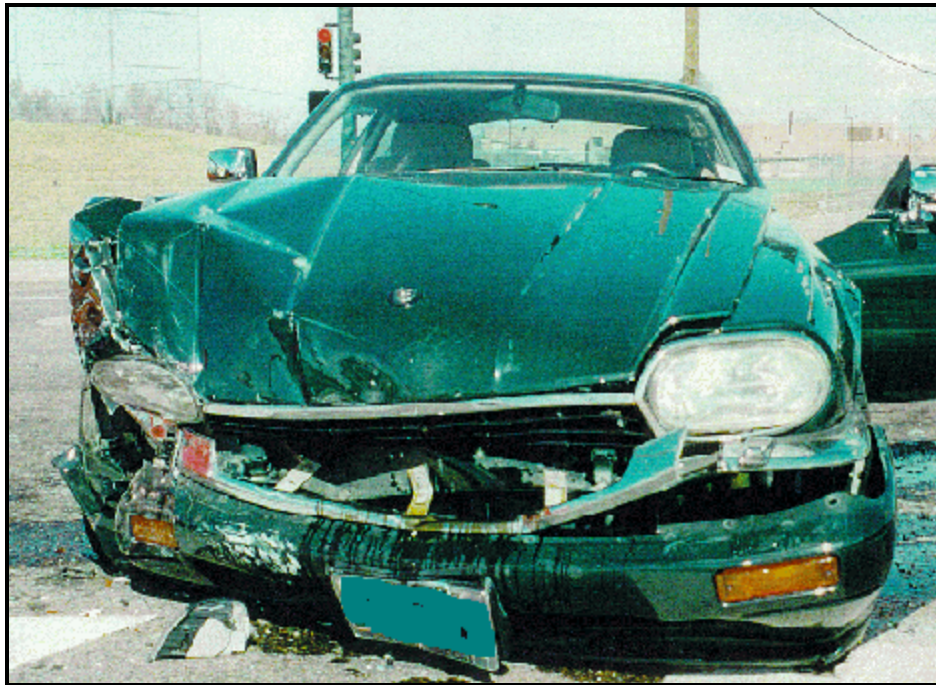
Figure 4. Exterior, Case vehicle.

Description:	1994 Jaguar XJS 2-door coupe	
VIN:	SAJNX5743RCxxxxxx	
Odometer:	24,897 km (15,471 miles)	
Engine:	4.0 L, Automatic transmission	
Reported Defects:	None	
Cargo:	Unknown	
Damage Description:	Moderate frontal damage to bumper, grille, and hood. Both door windows broken.	
CDC:	01FZEW1	
Delta V ² :	Total	17.4 km/h (11.2 mph)
	Longitudinal	-15.0 km/h (-9.7 mph)
	Latitudinal	-8.7 km/h (-5.6 mph)
	Energy	31,686 joules (23,385 ft-lbs)

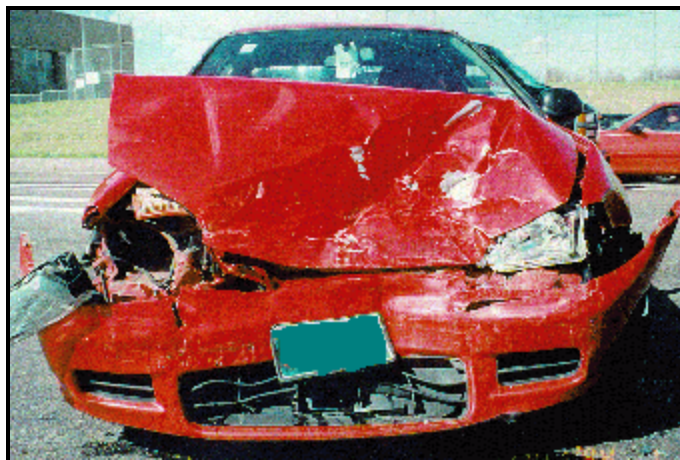
Figure 5. Exterior, Other vehicle.

Description:	1992 Honda Civic VX 3-door	
VIN:	2HGEH2367NHxxxxxx	
Odometer:	87,010 km (54,067 miles)	
Engine:	Unknown, Manual transmission	
Reported Defects:	None	
Cargo:	Unknown	
Damage Description:	Moderate frontal damage to bumper, grille, and hood. Movement of metal from left to right.	
CDC:	11FYEW1	
Delta V:	Total	26.8 km/h (17.3 mph)
	Longitudinal	-23.2 km/h (-14.9 mph)
	Latitudinal	13.4 km/h (8.6 mph)
	Energy	46,158 joules (34,048 ft-lbs.)

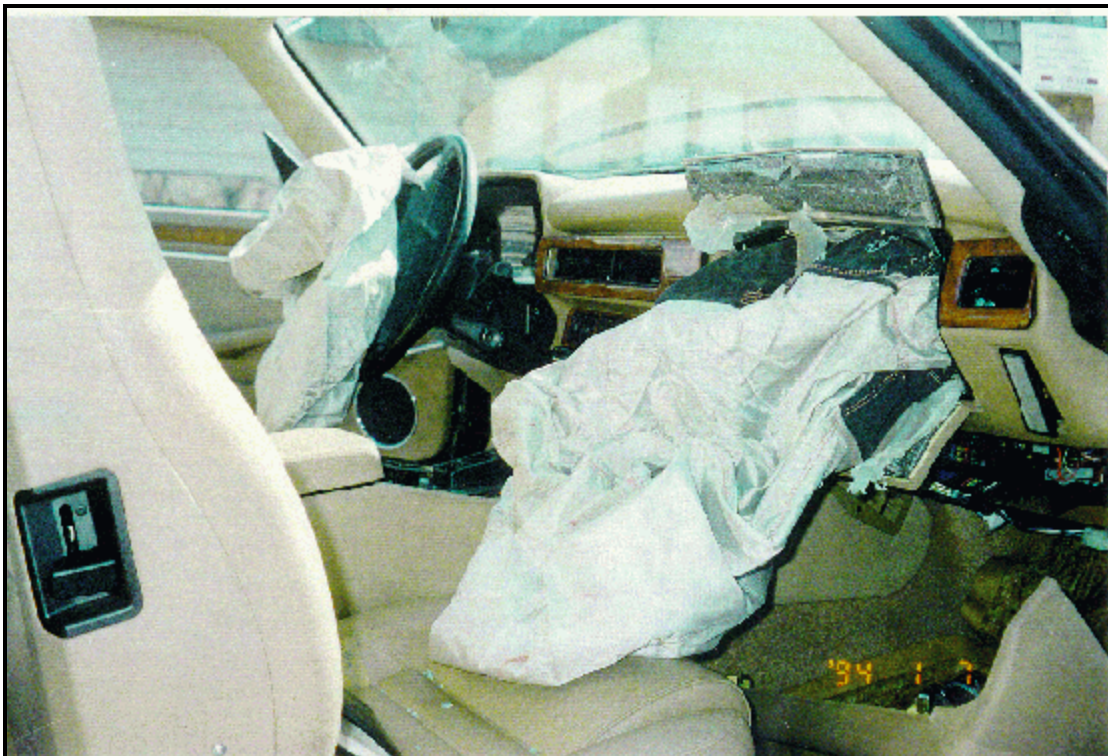
Figure 6. Interior, Case vehicle.

The two front right occupants were seated next to one another in the same bucket seat. The bucket seat was situated with seat back approximately 81 cm (32 in) rearward of the face of the instrument panel. They were both using the same seat belt. The position of the torso portion of the belt is not entirely clear, but in any event would not have been in the proper position for either child. The D-ring adjuster for the shoulder belt was in the full down position. The lap portion of the belt also was likely out of position (unable to be secured across the iliac crests of both children at any time). At impact, these occupants responded to the 30 degree principal force by moving forward and to the right. As the air bag deployed, the 5-year-old child occupant engaged and started loading the air bag. As the pressure increased, the membrane effect snapped his head rearward and to the right where he struck the wood paneling on the passenger side door with the right portion of his face. This contact likely caused the large laceration and avulsion, as well as the resultant brain injuries. The 5-year-old child came to rest against the door.

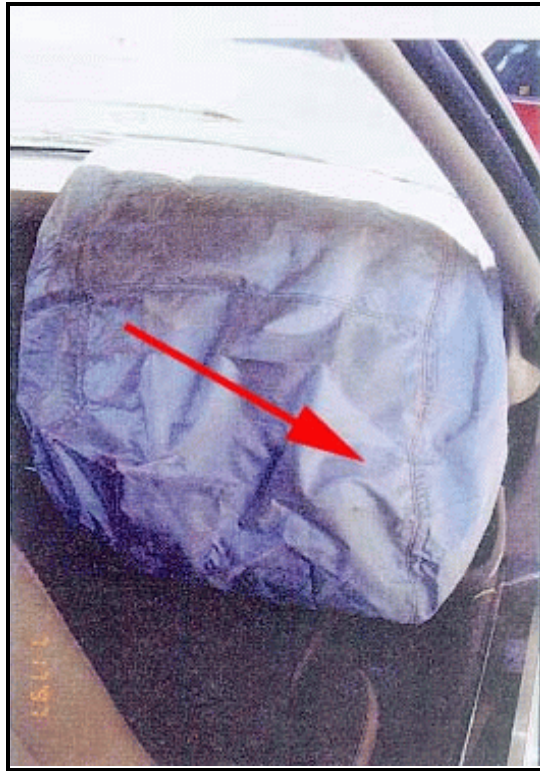
The case vehicle is a 1994 Jaguar XJS 2-door coupe equipped with driver side and passenger side front air bags. The Breed manufactured air bags are self contained units incorporating both the crash sensor and the inflator assembly. The passenger side air bag was a single tether design with no visible vent ports. In the fully deployed mode, the excursion of the air bag measured an estimated distance of 55.2 cm (21.7 in)¹ from the instrument panel. The case vehicle was traveling north at an unknown speed in the left turn lane approaching the intersection. The driver was a 73-year-old female. The front right seat was occupied by two male children, ages 4 and 5. The 5-year-old was nearest to the passenger side door and the 4-year-old was nearest to the driver. According to the attorney, they were both using the same lap and shoulder belt. The 5-year-old (107 cm/42 in, 20 kg/44 lbs) child is the case occupant.

Figure 7. Passenger air bag. Arrow depicts likely contact between case occupant and air bag.

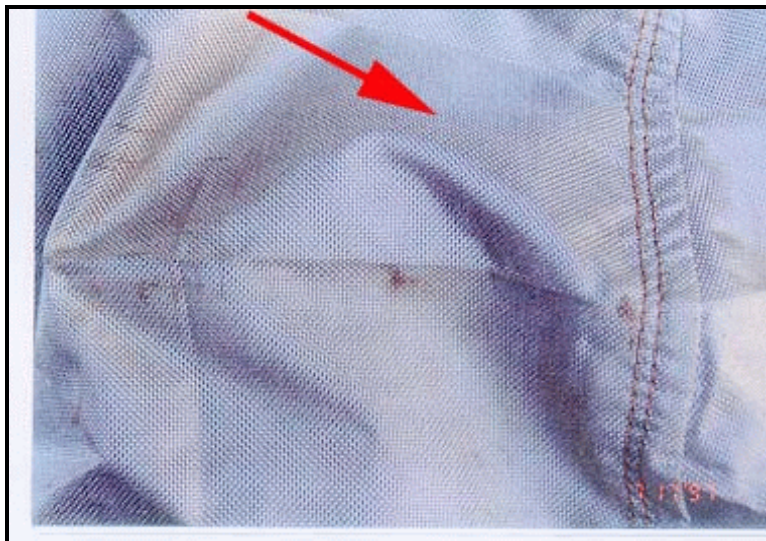
Figure 8. Close up of contact to air bag.
