**REMOTE FATAL AIR BAG DEPLOYMENT INVESTIGATION**

**CASE NO. CA99-44**

**1997 HYUNDAI ACCENT GS  
1996 HONDA CIVIC LX**

**Final Case Report**  
**Veridian Engineering Case No. CA99-44**  
**Front Right Air Bag Related Child Fatality**  
**State of Pennsylvania**  
**December, 1997**

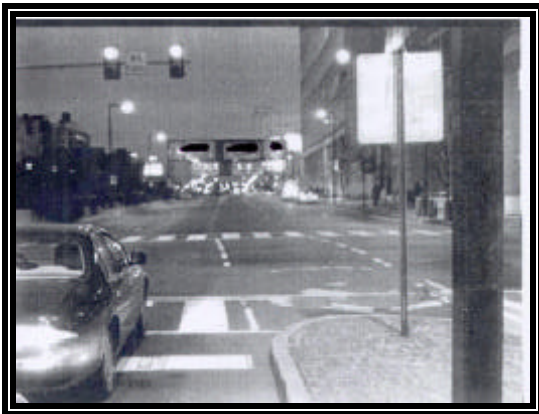
The 31 year old male driver of the Hyundai observed the presence of the Honda just prior to the crash and applied full brakes. The driver indicated that the Honda was moving very slowly as it made a right turn (**Figure 2**). The front of the Hyundai struck the right side plane of Honda resulting in light to moderate damage to both vehicles. The dual front air bags in the Hyundai deployed during the crash sequence.

Figure 2: Hyundai trajectory view just prior to impact.

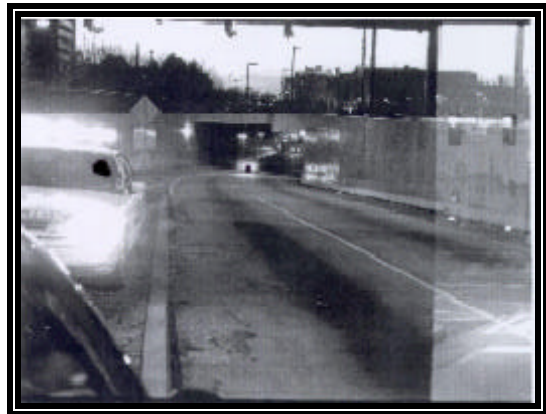
Figure 3: Look back view of the Hyundai trajectory.

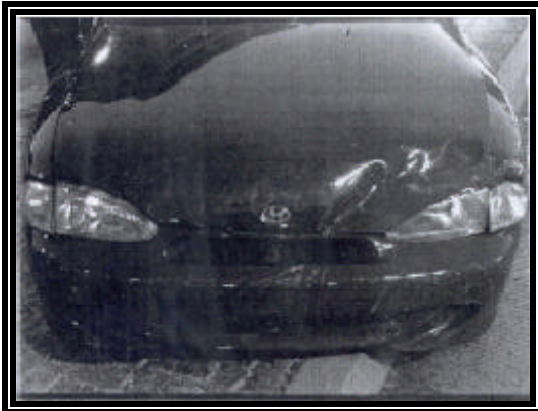
The 1997 Hyundai Accent GS was equipped with a dual front Supplemental Restraint System (SRS) which deployed as the result of the impact with the 1996 Honda Civic LX. Exterior damage to the vehicle involved the front bumper, grille, hood, left headlight assembly, and left front fender (**Figure 4**). The police listed rear displacement of the hood as 10.2 cm (4.0") and 7.6 cm (3.0") at the left front fender (**Figure 5**). An imprint of the Honda’s right rear wheel cover was noted on the bumper cover located below the left headlight assembly. The front right door glazing was shattered with glazing fragments noted along the right instrument panel.

**Figure 4:** Front view of the Hyundai.

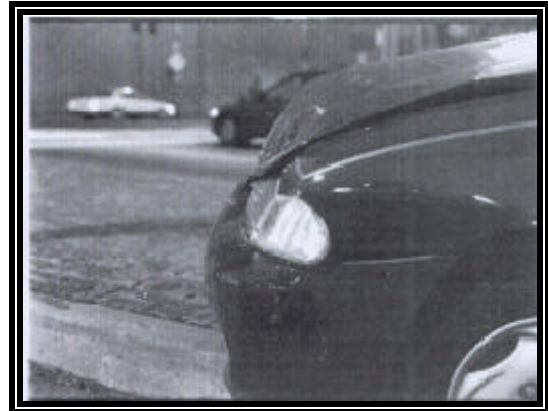
**Figure 5:** Left lateral view of the Hyundai’s damaged front plane.

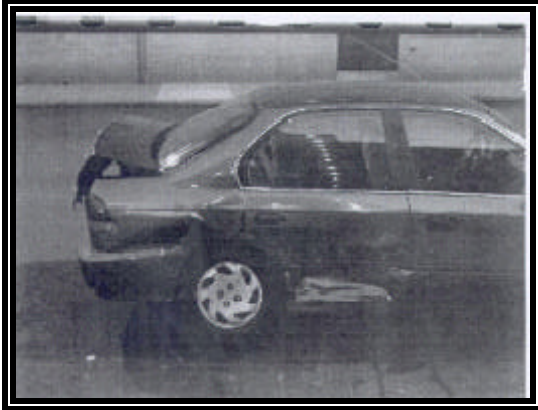
The 1996 Honda Civic LX was equipped with a dual front SRS which did not deploy as the result of the impact with the 1997 Hyundai Accent GS. Exterior damage to the Honda involved the right rear door surface, right rear wheel and axle, the right rear fender, the right C-pillar, the right rear bumper corner, and the trunk (**Figure 6**). The crush to the right rear door was listed by police as 10.2 cm (4.0") and 15.2 cm (6.0") for the right rear fender (**Figure 7**). The side glazing remained intact.

**Figure 6:** Right side view of the damaged Honda Civic.

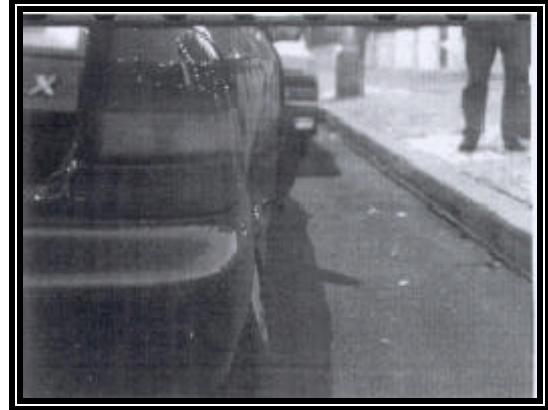
**Figure 7:** Rear view along the right side of the Honda.

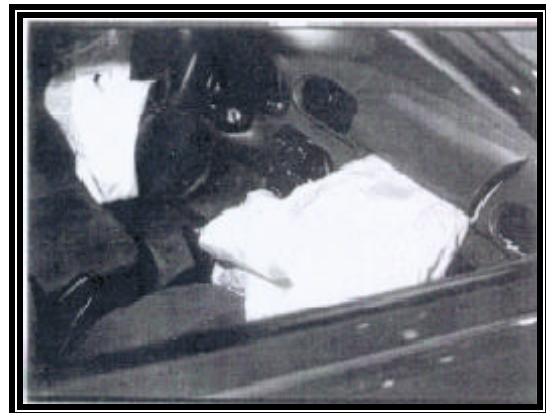
The Hyundai's dual front supplemental restraint system deployed during the crash (**Figure 8**). The front left air bag module cover opened in the typical "H" configuration. The air bag appeared to be untethered with vent ports in the 11/1 o'clock positions. It was not possible to determine if the driver came in contact with the air bag at the time of deployment as the photographic evidence was not conclusive. The driver, however, was not injured in the crash.

**Figure 8:** Right interior view of the Hyundai's deployed frontal air bags.

The front right air bag was a mid mount design where the hinge point of the air bag module cover was located along the top surface of the front right instrument panel. The air bag cover did not exhibit occupant contact evidence, although the quality of the police photographs was insufficient to categorically rule out occupant contact. It was not known whether the air bag was vented or tethered. There were no discernable occupant contact evidence artifacts noted on the air bag in the police photograph.
