**REMOTE REDESIGNED AIR BAG DEPLOYMENT INVESTIGATION
SCI TECHNICAL SUMMARY REPORT**

VERIDIAN CASE NO. CA99-061

RABSS VEHICLE - 1998 CHRYSLER CIRRUS

CRASH DATE - JULY 1998

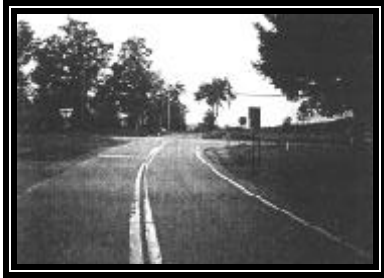
**Figure 1. (East leg)
Westbound approach for the
Chrysler Cirrus**

This two vehicle crash occurred during the daylight hours of July 1998. At the time of the crash, there were no adverse conditions as the asphalt roads were dry. The crash occurred at a rural 4-leg intersection of a state roadway, county roadway, and local roadway (**Figure 1**). At the intersection, the northbound state roadway continued from the south leg by turning onto the east leg (**Figure 2**), the county road began on the north leg, and the local road began on the west leg. The north/south roadway consisted of two travel lanes and a right turn lane leading to the east leg of the intersection (the continuation of the state roadway) (**Figure 3**). A gore area separated the main travel lanes from the right turn lane. The travel lanes were straight and level and bordered by soft shoulders. The east leg roadway was identical in composition to the north/south roadway. The west leg consisted of a two-lane roadway with no markings. The roadside

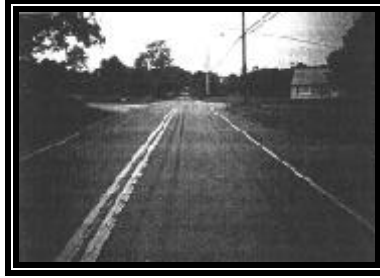
**Figure 2. (South leg)
Northbound approach for
the Chevrolet Corsica**

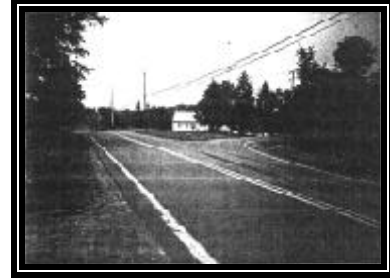
**Figure 3. South leg showing
the right turn lane for
eastbound traffic**

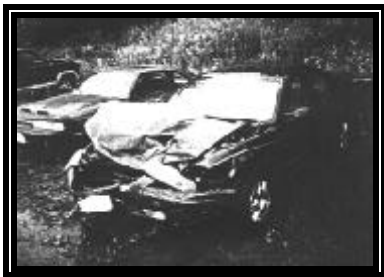
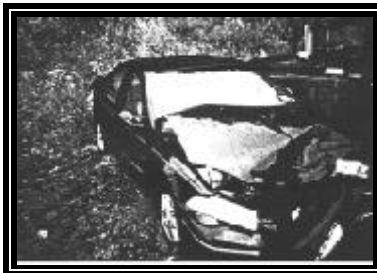
Black-and-white photocopies of insurance photographs provided the basis for damage notation. The 1998 Chrysler Cirrus sustained moderate frontal damage as a result of the impact with the Chevrolet Corsica (**Figure 4 and Figure 5**). The CDC for this impact to the Chrysler Cirrus was 11-FYEW-2. The direct contact damage began at the left bumper corner and extended laterally approximately 100 cm (40"). The combined direct and induced damage involved the entire frontal width of the Cirrus. Six crush measurements were estimated at the level of the bumper: C1 = 40 cm (16"), C2 = 35 cm (14"), C3 = 25cm (10"), C4 = 10 cm (4"), C5 = 5 cm (2"), C6 = 0 cm. The hood was displaced rearward and laterally from engagement against the front corner surface of the Chevrolet Corsica. Both front fenders were buckled from impact forces.

Figure 4. Frontal damage to the 1998 Chrysler Cirrus

Figure 5. Frontal damage to the 1998 Chrysler Cirrus

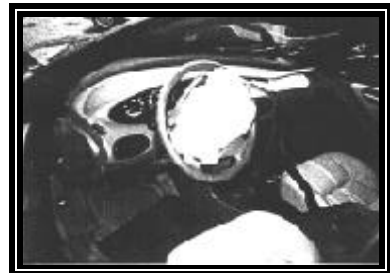
Figure 6. Interior view of the 1998 Chrysler Cirrus

Interior damage to the 1998 Chrysler Cirrus was based on one black-and-white photocopied insurance photograph (**Figure 6**). Interior damage appeared to be related solely to air bag deployment. No deformation was identified on the knee bolsters (rigid plastic type) or steering wheel hub/rim (tilt column set to center position in photos). No intrusions were noted in the vehicle.

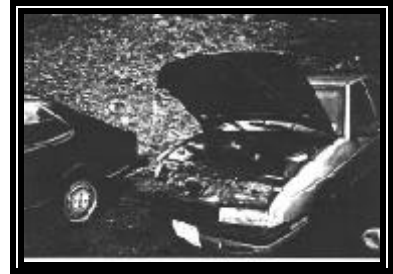
Black-and-white photocopies of insurance photographs provided the basis for damage notation. The 1989 Chevrolet Corsica sustained moderate damage as a result of the impact with the Cirrus (**Figure 7**). The CDC for this impact to the Chevrolet Corsica was 01-FREE-2. The direct damage began at approximately 35 cm (14") to the right of the center of the bumper and extended laterally to the right bumper corner. The right fender and front right corner of the hood were buckled rearward from the frontal impact forces. Six crush measurements were estimated at the level of the bumper: C1 = 0 cm, C2 = 5 cm(2"), C3 = 10 cm (4"), C4 = 15 cm (6"), C5 = 30 cm (12"), C6 = 40 cm(16").

Figure 7. Frontal damage to 1989 Chevrolet Corsica
