## REMOTE AIR BAG DEPLOYMENT REPORT

CASE NUMBER - IN99-110  
LOCATION - ILLINOIS  
VEHICLE - 1998 SATURN SW2 WAGON  
CRASH DATE - October 1998

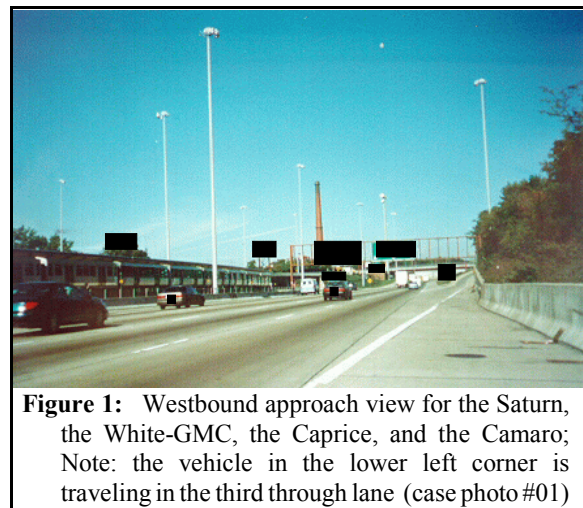
**Figure 1:** Westbound approach view for the Saturn, the White-GMC, the Caprice, and the Camaro; Note: the vehicle in the lower left corner is traveling in the third through lane (case photo #01)

The Saturn, the White-GMC, the Caprice, and the Camaro were all traveling west in the third westbound through lane of a seven-lane (six through lanes plus a deceleration lane) roadway that was part of a 14-lane, divided, urban interstate trafficway (**Figure 1**). The Camaro was farthest ahead, followed by the Caprice, the Saturn and the White-GMC, in that order. It was dark, lighted, the weather was clear, and no vision obstructions were noted. The roadway was concrete, dry, straight, level, and free of defects. Pavement markings visible in photographs were a single solid white (north) edge line and single broken white lane lines separating travel lanes. The posted speed limit is not known. Traffic density was estimated by police as medium-to-heavy because of road construction. The Caprice and the Camaro had slowed or stopped because of construction activity ahead.

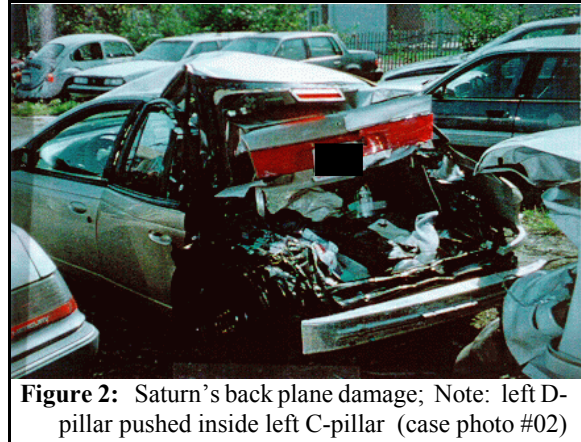
The Saturn sustained heavy underride damage across almost the entire back plane from the first impact (**Figure 2**). The back bumper fascia was torn off. The back left of the bumper reinforcement bar was pushed forward slightly more than the back right corner, with rear-to-front scratching on the top of the bar. The lower lip of the cargo area was displaced forward, as was the back left quarterpanel and everything but the sheet metal of the right rear quarterpanel. The left and right upper D-pillars were pushed forward. Visible induce damage to the Saturn included: the back roof rail pushed forward to the C-pillar, the back door glazing missing, the left roof rail buckled near the B-pillar, the left rear door panel buckled, and the left rear door glazing missing. A CDC for the Saturn's first impact in this crash sequence was estimated from photographs as **06-BDEW-5 (190)**. The WinSMASH reconstruction program was used to estimate Barrier Equivalent Speed (BES) based on the Saturn's CDC for the back plane impact. The result indicates a BES of 40 km.p.h. [25 m.p.h.]. This is a border line reconstruction, but the results appear reasonable. The crash severity for the Saturn from the first impact was on the high side of moderate (24-40 km.p.h. [15-25 m.p.h.]).

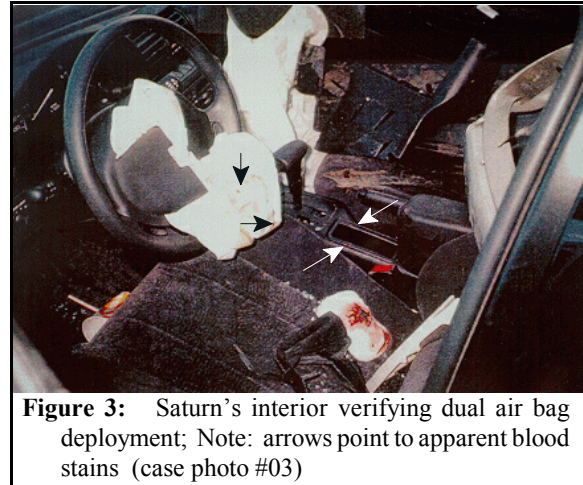
Photographs verify that the Saturn's driver and front right passenger air bags deployed. The Saturn's front right passenger air bag module appears to have been located in a mid-mount position on the right side of the instrument panel and the driver's air bag module was located in the steering wheel hub. The passenger module appears to have been equipped with a single cover flap. The shape of the passenger's air bag is not known, and it is not known if the passenger air bag was equipped with tethers or vent ports. There are two areas of staining visible on the passenger's

air bag fabric but neither appears to be blood or other body fluid. The driver module's cover flaps were in the I-configuration. The left flap visible in the Saturn's interior photograph seems to have opened along its tear points; the right flap is not visible. The shape of the driver's air bag is unknown, and it is not known if the driver air bag was equipped with tethers or vent ports. Two small blood stains are visible in the one available interior photograph (**Figure 3**) but their location on the driver's air bag fabric cannot be specified.

**Figure 3:** Saturn's interior verifying dual air bag deployment; Note: arrows point to apparent blood stains (case photo #03)

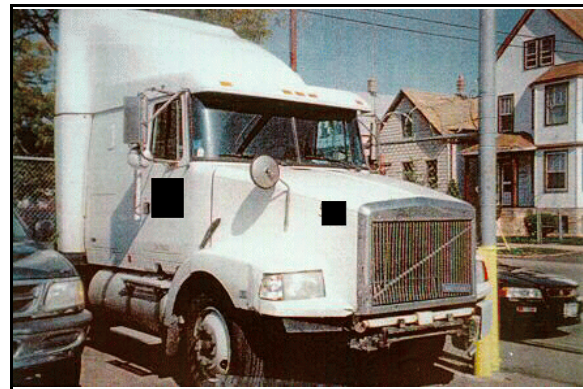
The first other vehicle was a 1995 White-GMC Integral Sleeper ES, 6x4, Aero truck tractor (VIN: 4V1WDBRF45N-----). It was towed from the scene due to disabling damage. Attached to the tractor was a 16.2 meter [53 foot] semi-trailer, with two axles. The overall length of the tractor and semi-trailer was 22.9 meters [75 feet]. Direct damage to the White-GMC cannot be fully assessed because its front bumper is missing in the only available photograph (**Figure 4**). There is

**Figure 4:** Front of White-GMC (case photo #04)

possible horizontal direct damage to the right side of the front grille, perhaps 15 centimeters [six inches] up from the bottom. The right front turn signal lens is missing. Possible induced damage

included slight buckling of the right front fender, just forward of the wheel well. No TDC could be assigned. The White-GMC's driver (49-year-old male; race, ethnicity, height, and weight unknown) was reportedly restrained. Police assessed his injuries as "C" (reported, not evident). He declined to be transported from the scene.

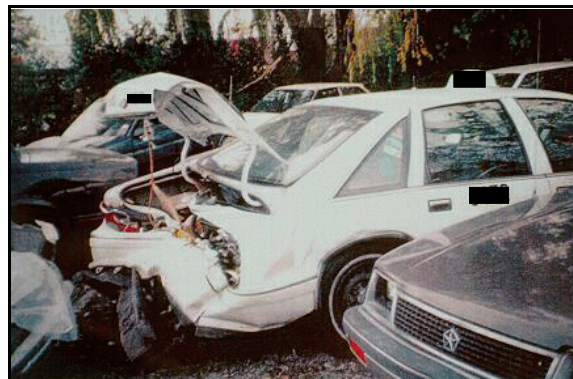
Photographs showing the Saturn's frontal damage from the second impact were not available. A CDC for the back plane damage on the Caprice, caused by the front of the Saturn, was estimated from the one available photograph (**Figure 5**) as **06-BDEW-2 (180)**. The WinSMASH reconstruction program, missing vehicle algorithm with CDC estimated crush profile (with the Saturn being the missing vehicle), provided a borderline reconstruction, and the results seem reasonable. The Saturn's estimated Total, Longitudinal, and Lateral Delta Vs are, respectively: 34 km.p.h. [21 m.p.h.], -34 km.p.h. [-21 m.p.h.], and 0 km.p.h. [0 m.p.h.]. The crash severity for the Saturn from the second impact, which caused the air bags to deploy, was moderate (24-40 km.p.h. [15 to 25 m.p.h.]).

**Figure 5:** Back and right side of the Caprice, damage caused by the front of the Saturn (case photo #05)

damage. From the second event in this crash sequence, the Caprice's back plane sustained direct contact damage: the back bumper fascia and reinforcement bar were pushed forward, with a mid-bumper "V" at maximum crush; the right back taillight assembly was crushed; the left back taillight assembly lens was cracked; the rear trunk's lower lip was pushed forward and separated at its midpoint; and the back plane of the trunk lid was pushed forward and creased. Induced damage visible from the attorney-provided photographs was limited to buckling of the right rear quarterpanel (**Figure 5**). Based on the photographs, a CDC for Caprice was estimated as: **06-BDEW-2 (180)**. The WinSMASH reconstruction program, missing vehicle algorithm (with the Saturn being the missing vehicle), provided a borderline reconstruction, and the results appear reasonable. The Caprice's estimated Total, Longitudinal, and Lateral Delta Vs are, respectively: 22 km.p.h. [14 m.p.h.], 22 km.p.h. [14 m.p.h.], and 0 km.p.h. [0 m.p.h.]. The Caprice's front plane collided with the Camaro's back plane in the third and final event of this crash sequence. No further information concerning this third impact is available. The Caprice's driver (44-year-old male, race, ethnicity, height, and weight unknown) was reportedly restrained. Police assessed his injuries as "C" (reported, not evident). He was transported from the crash scene by ambulance to a medical facility. His specific injuries and treatment status are not known.
