CASE: D016-99

**Crash Description:** 22 Year old, Black, Female, Driver, Inspector

**Impact Type:** Undercarriage

Case Vehicle: 1999 Nissan GXE  
Crash Type: Vehicle to Large Truck  
Restraint: Lap & Shoulder Belt  
Airbag Deployment (front): Driver Side: Deployed Passenger Side: Deployed

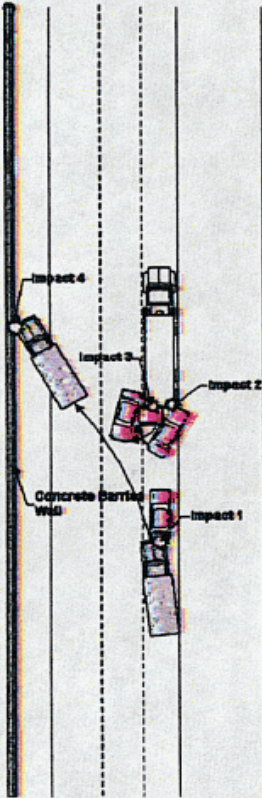
D 016 99  
Scale 1/200  
Case Vehicle: 1999 Nissan Sentra  
POV 1: (grey) 1999 International Dump Truck  
POV 2: (white) Tractor/trailer combo

The crash site was a divided limited access highway. All three vehicles were southbound in the outside lane. POV 2 was in the lead followed by the case vehicle, which was followed by POV 1. Both POV 2 and the case vehicle were traveling at a low rate of speed. It is estimated that POV 1 was traveling at a normal highway speed.

The driver of POV 1 noticed the slower moving case vehicle and took the evasive action of steering left, but it was too late to avoid a collision. The front of POV 1 impacted the rear of the case vehicle. The impact force pushed the case vehicle forward to the south while initiating a clockwise rotation. The front of the case vehicle impacted the right upright support of POV 2's under-ride bar. This impact accentuated the case vehicle's clockwise rotation. The case vehicle's left side impacted the rear of POV 2's under-ride bar. The case vehicle continued to rotate clockwise and snagged its left side structure on the left side of POV 2's trailer.

POV 2 came to rest facing south in the outside lane. The case vehicle came to rest facing north in the center lane adjacent to the back of POV 2's trailer. POV 1 departed the roadway to the left and impacted the dividing wall coming to rest at that point.
