**REMOTE AIR BAG REPORT**

**CASE NO. - 92-06**  
**FLEET - PRIVATE VEHICLE**  
**LOCATION - [REDACTED] INDIANA**  
**ACCIDENT DATE - [REDACTED] 1992**

Remote Air Bag Case No. 92-06

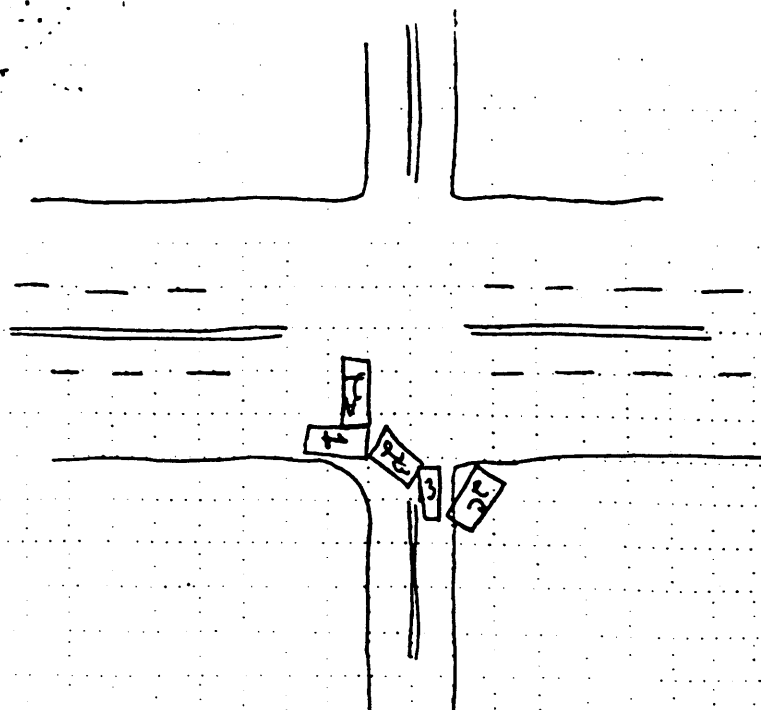
Diagram

Driver #1 said she was E/B in the curb lane of W. [REDACTED] St. At the intersection of W. [REDACTED] St and N. [REDACTED] Av, driver #1 had the green automatic signal and she proceeded thru the intersection when vehicle #2 disregarded the red light and came into the intersection. Driver #1 could not stop, and struck vehicle #2. Vehicle #2 then spun into vehicle #3, waiting in the N/B lane of N. [REDACTED] Av at W. [REDACTED] St. Vehicle #2 then spun over the curb and came to rest on the S/E corner of W. [REDACTED] St & N. [REDACTED] Av.

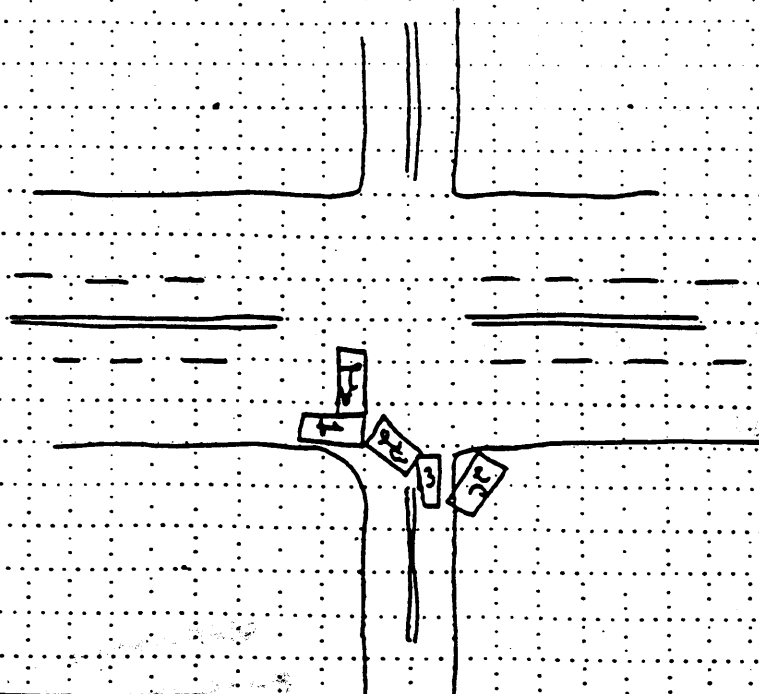
Driver #1 said she was E/R in the curb lane of [REDACTED]. At the intersection of [REDACTED] and [REDACTED] Av., driver #1 had the green automatic signal and she proceeded thru the intersection when vehicle #2 disregarded the red light and came into the intersection. Driver #1 could not stop, and struck vehicle #2. Vehicle #2 then spun into vehicle #3, waiting in the [REDACTED] of [REDACTED] Av. at [REDACTED]. Vehicle #2 then spun over the curb and came to rest on the S/E corner of [REDACTED] St. & [REDACTED] Av.

Driver #2 said he was waiting at the light at [redacted] St, N. [redacted] facing S/B. Driver #2 said the light turned green for him and he proceeded S/B on N. [redacted] vehicle #1 came thru the intersection and struck vehicle #2 spinning him into vehicle #3 and then onto the curb.
