AIRBAG INVESTIGATION

CASE NO. 93-07

[REDACTED] COUNTY, PENNSYLVANIA

14. Sponsoring Agency Code	
15. Supplementary Notes			
16. Abstract Accident involving an airbag equipped 1991 Chevrolet Corsica in a frontal impact with a tree approximately 16 inches in diameter. The driver of the Corsica was fatally injured. The airbag may have improperly deployed between the cover flap and the steering wheel rim, instead of through the designated tear seam.

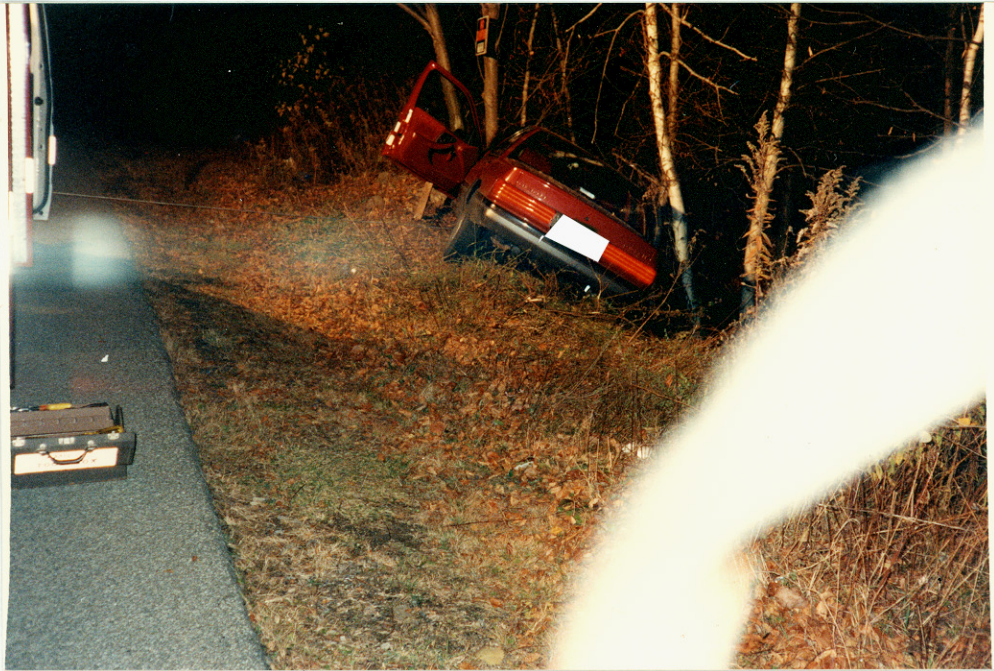
1. View of the 1991 Chevrolet Corsica at final rest. Photo is taken along the north edge of Road looking west, the pre-impact travel direction of the Vehicle.

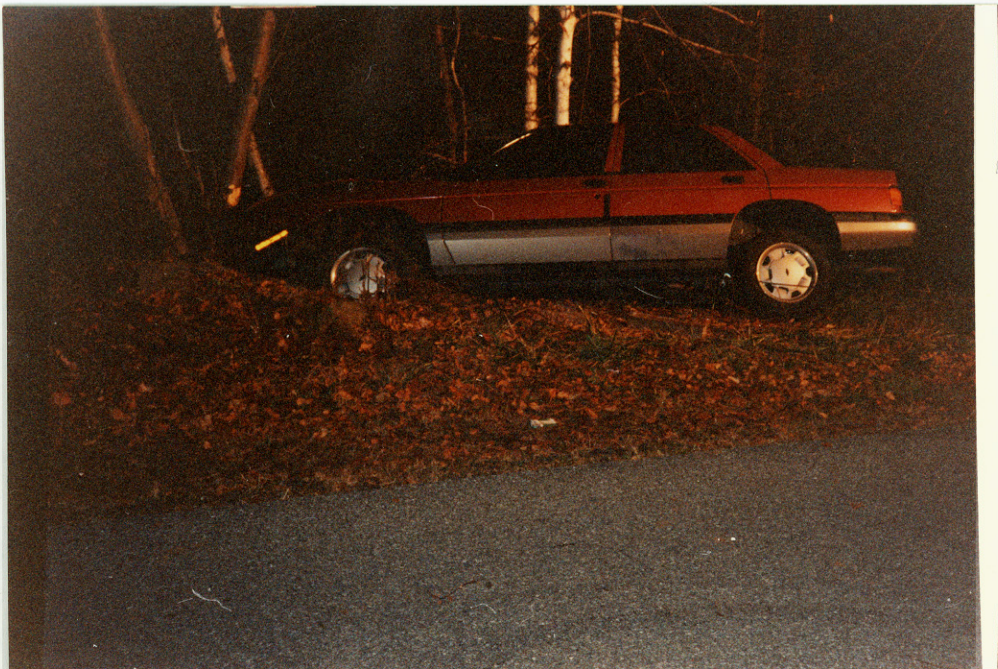
2. Left side view of the Corsica at final rest. Photo is taken looking north.

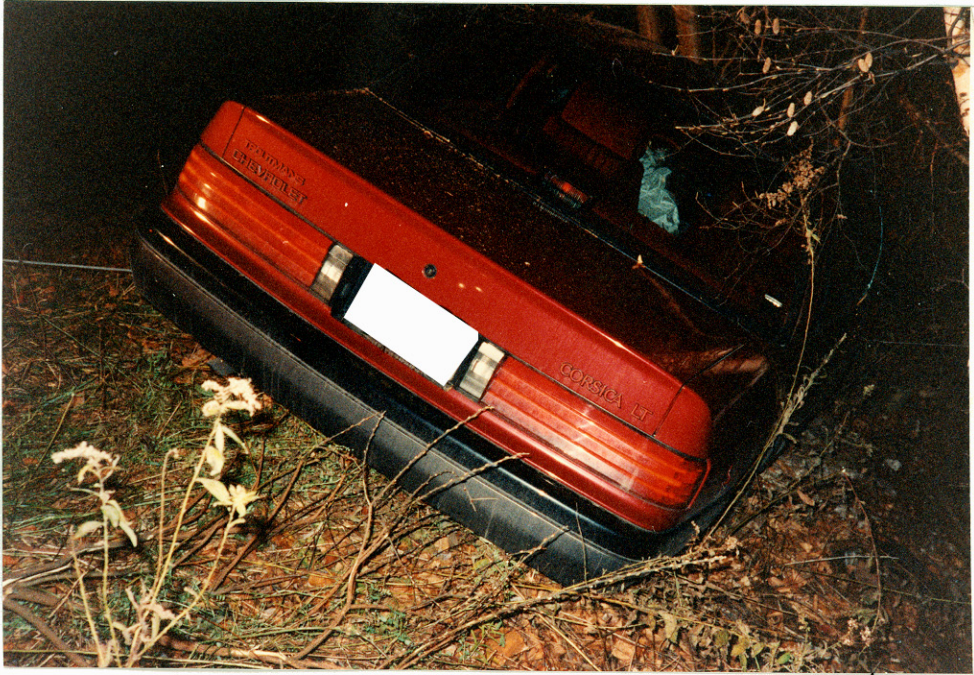
3. Rear view of the Corsica at final rest.

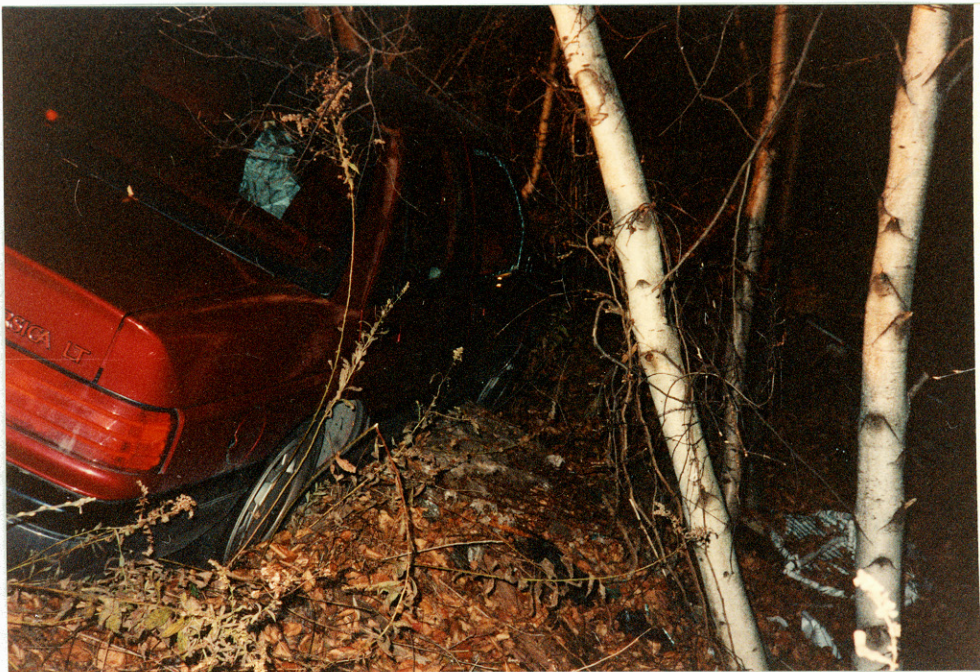
4. Right-rear view of the Corsica at final rest.

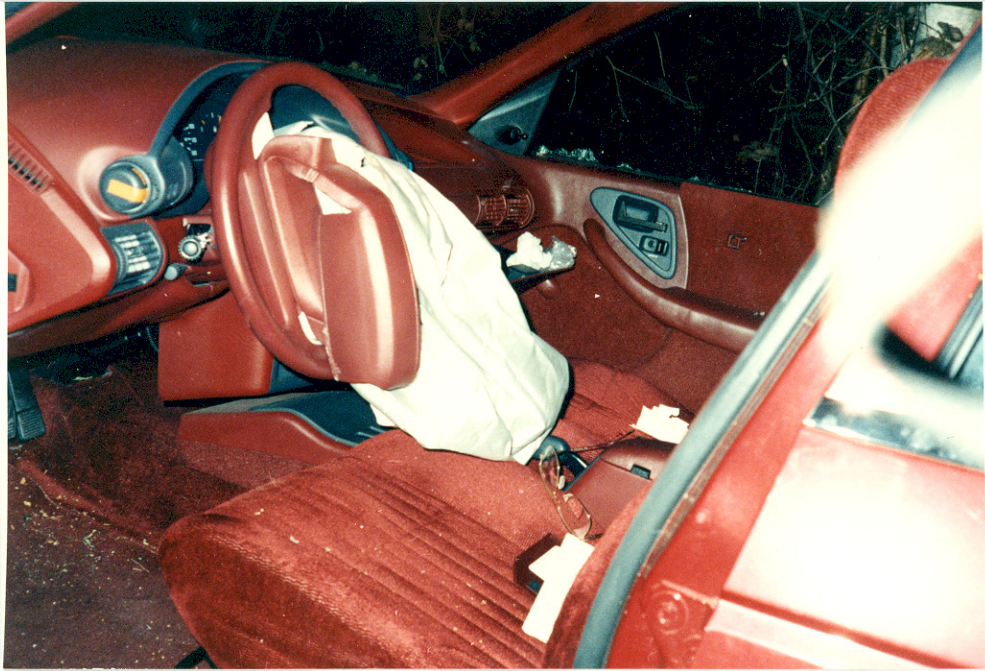
5. Overall view showing the airbag steering wheel, airbag, front instrument panel and driver's seat of the Corsica.

Occupant Crash Protection: The 1991 Chevrolet Corsica was equipped with a factory installed driver supplemental airbag restraint system. The airbag deployed during the accident sequence. The airbag apparently failed to deploy properly between the designated tear seams. Photographs indicate that the airbag deployed between the upper cover flap and the steering wheel rim.

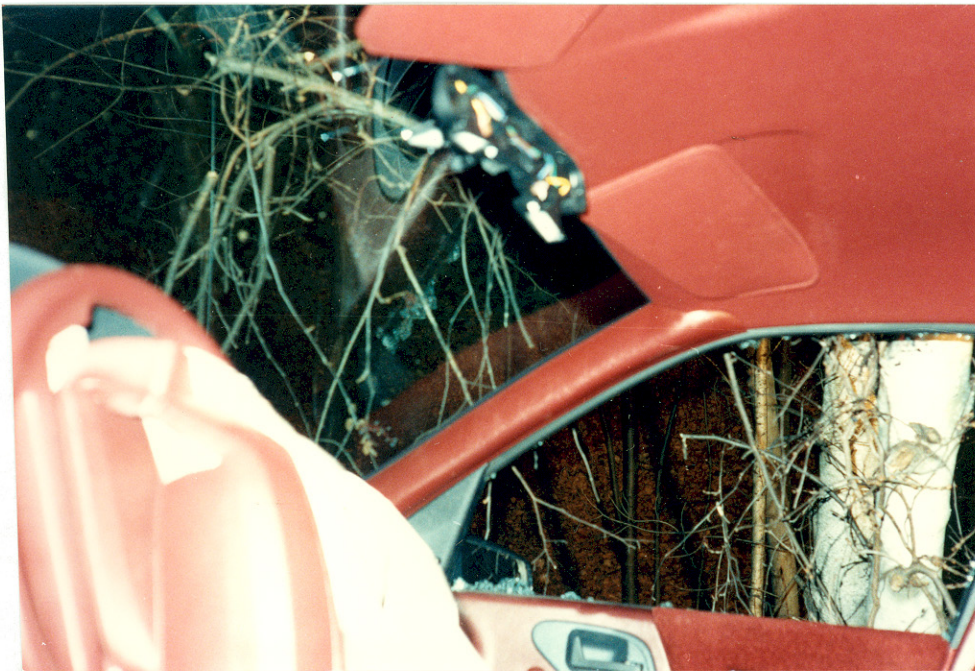
6. Additional interior view showing the windshield, front header, and what appears to be a broken rear-view mirror.

Damage to the interior of the vehicle consisted of steering column, and the rear view mirror being smashed. No other damage noted.
