REPORT NO. 111-KAR-04-002

**SAFETY COMPLIANCE TESTING  
FOR FMVSS 111**

**REARVIEW MIRRORS  
(Other Than School Buses)**

2004 SATURN ION  
4 DOOR SEDAN

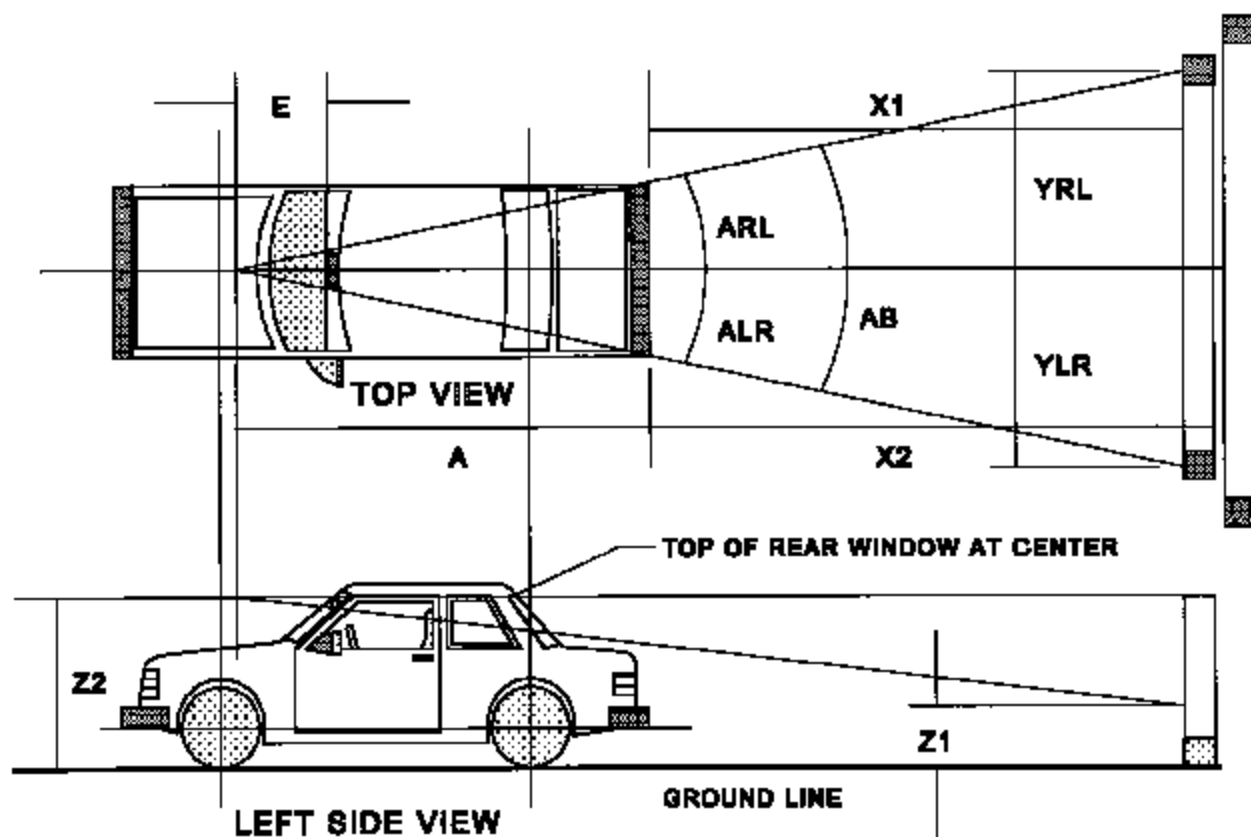
# INSIDE REARVIEW MIRROR FIELD OF VIEW TEST GRID AND MARKER SETUP

E Distance from center of mirror to projected eye point location = 582.0 mm

A Distance from rear of vehicle to projected eye point location = 3117.0 mm

X1 Distance from rear of vehicle to field of view grid = 8382.0 mm

Z1 Vertical distance to lowest point of field of view at distance X1 635.0 mm

Z2 Height of center of mirror = 1295.0 mm

X2 Distance from rear of vehicle where the road surface is first visible  
 $X2 = [(Z2 \times X1) + (Z1 \times A)] / (Z2 - Z1) =$   
 (S111 REQUIREMENT = 61m maximum) 19445.43 mm (19.44 m)

ANGLE AB = 26.9° (S111 REQUIREMENT = 20 degrees minimum)

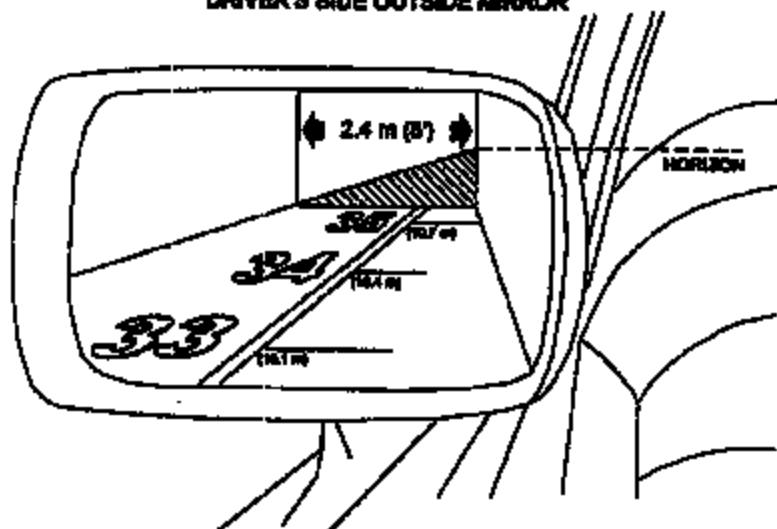
REQUIRED FIELD OF VIEW AS SEEN IN  
DRIVER'S SIDE OUTSIDE MIRROR

ENTIRE TRIANGULAR TEST TARGET AREA ON SCREEN VISIBLE YES   X   NO

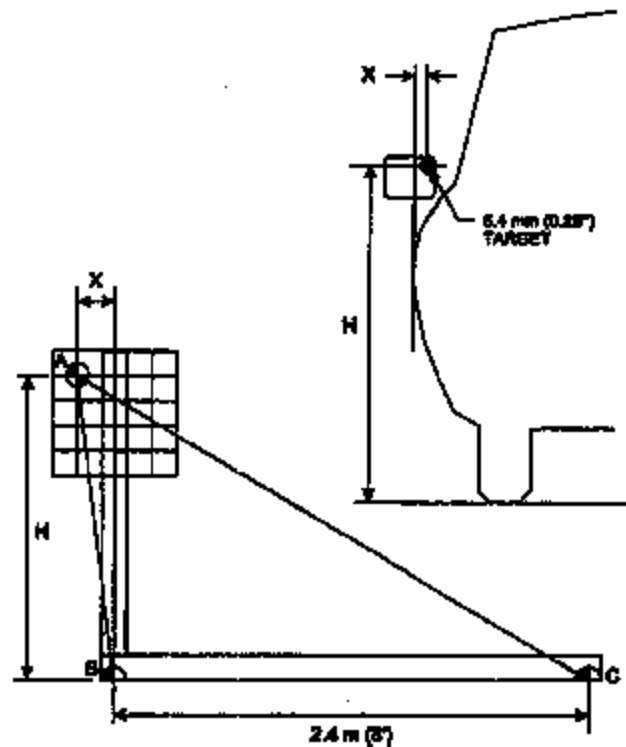
## DRIVER SIDE OUTSIDE MIRROR TARGET DISC LOCATION WITH X AND H DIMENSIONS

HEIGHT OF TARGET DISC ON MIRROR 1077 mm

DISTANCE OF TARGET DISC ON MIRROR FROM VEHICLE  
TANGENT PLANE 84 mm

TARGET DISC LOCATION RELATIVE TO VEHICLE TANGENT PLANE INBOARD  
(Inboard or Outboard)

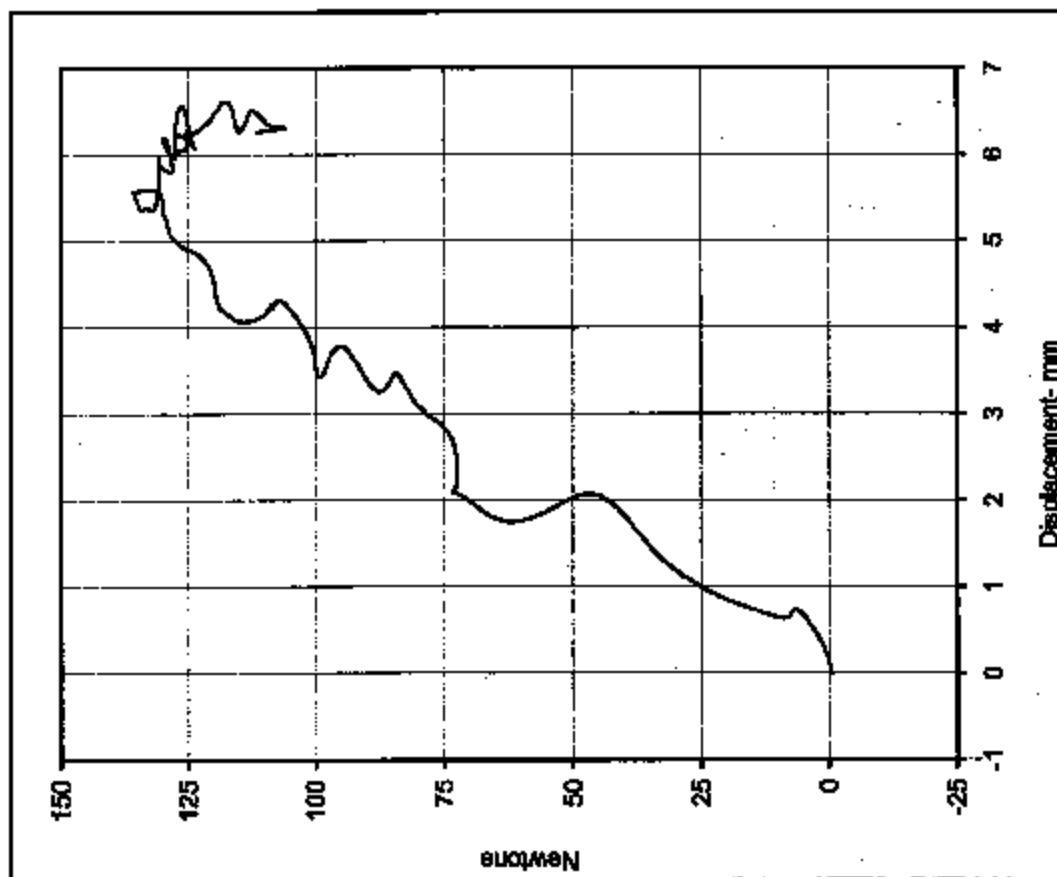
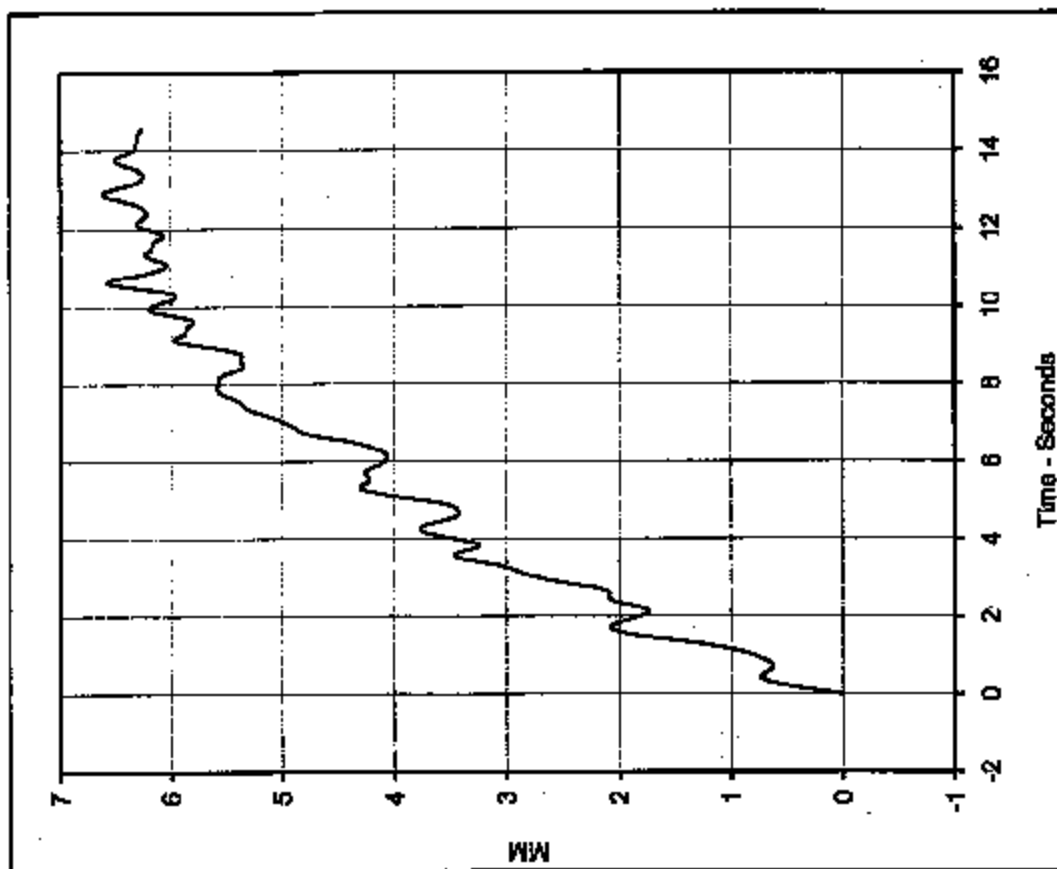
Test Program: 2004 FMVSS 111 Rearview Mirrors Test No.: 1  
 Test Vehicle: 2004 Saturn Ion No.: C40104

Units	Peak Force	Displacement	Filter (Hz)
Newtons	135.9	5.6	1

Units	Max	Time	Displ. Rate (mm/min.)	Filter (Hz)
MM	6.6	12.9	36.9	1

Load Direction: 0 / 90  
 Test Date: 5/26/04

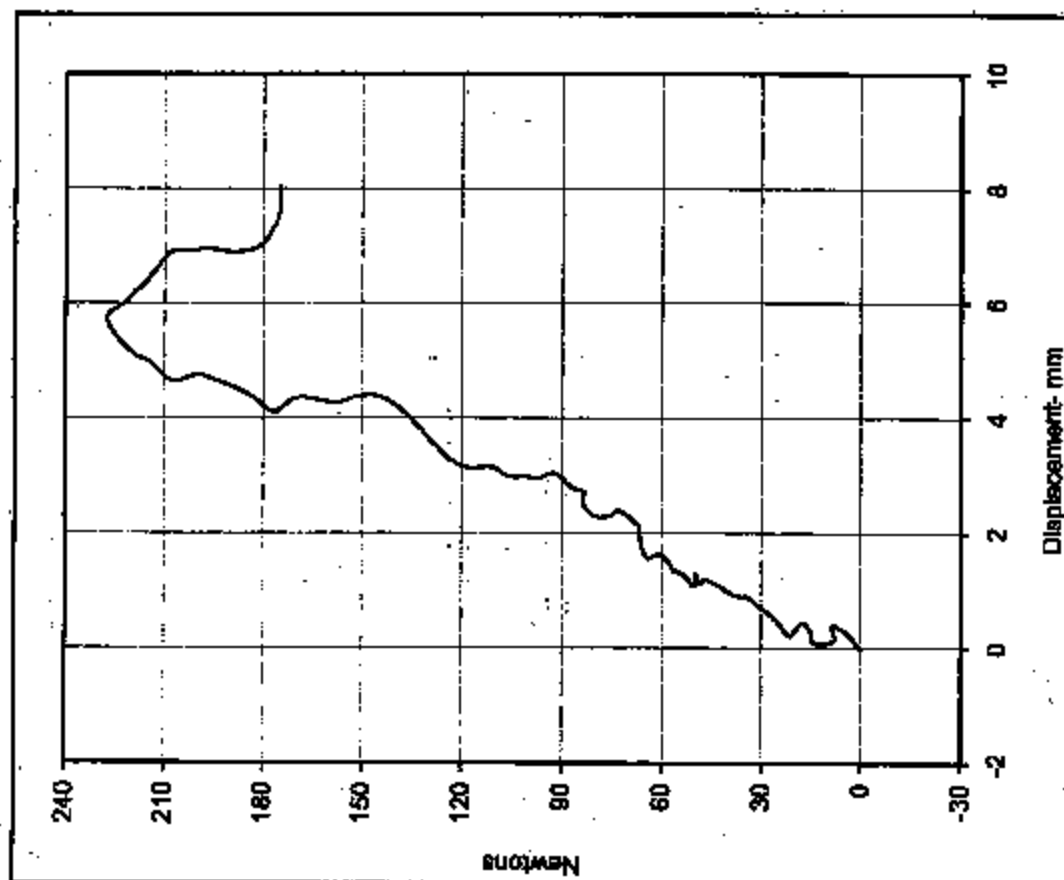
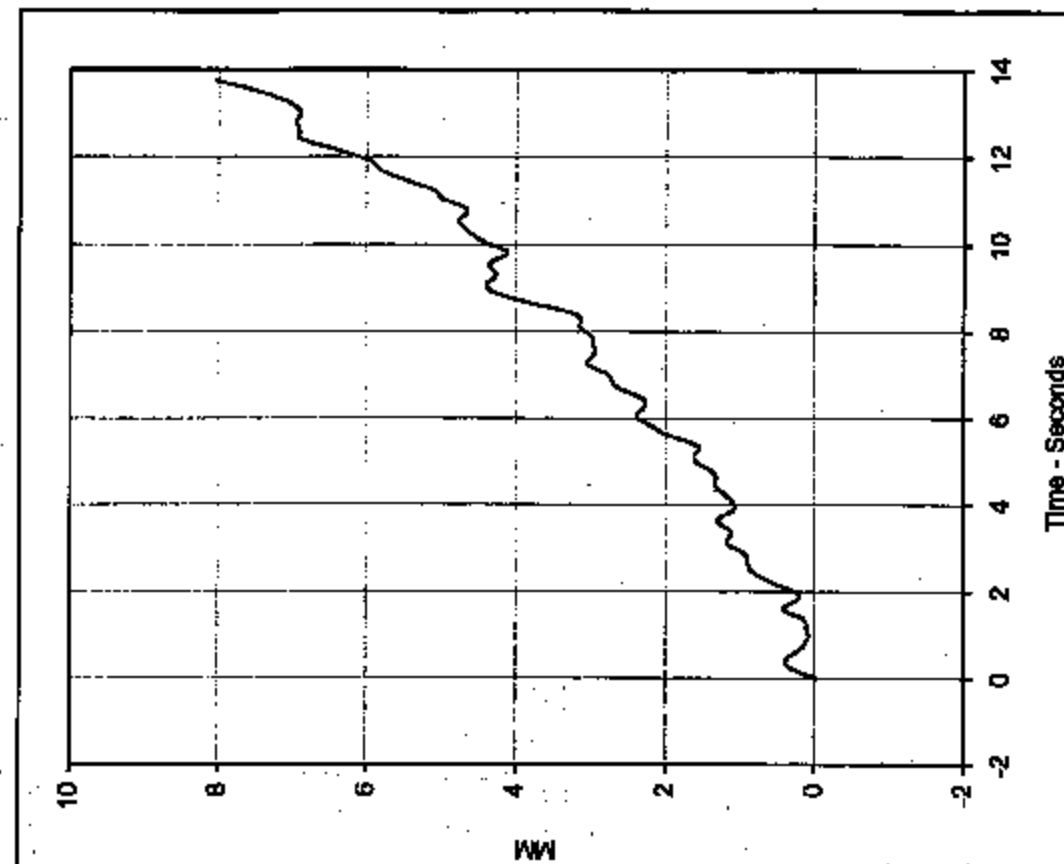
Test Program: 2004 FMVSS 111 Rearview Mirrors Test No.: 2  
 Test Vehicle: 2004 Saturn Ion No.: C40104

Units	Peak Force	Displacement	Filter (Hz)
Newtons	227.3	5.7	1

Units	Max	Time	Displ. Rate (mm/min.)	Filter (Hz)
MM	8.0	13.8	35.0	1

Load Direction: +45 / 90  
 Test Date: 5/26/04

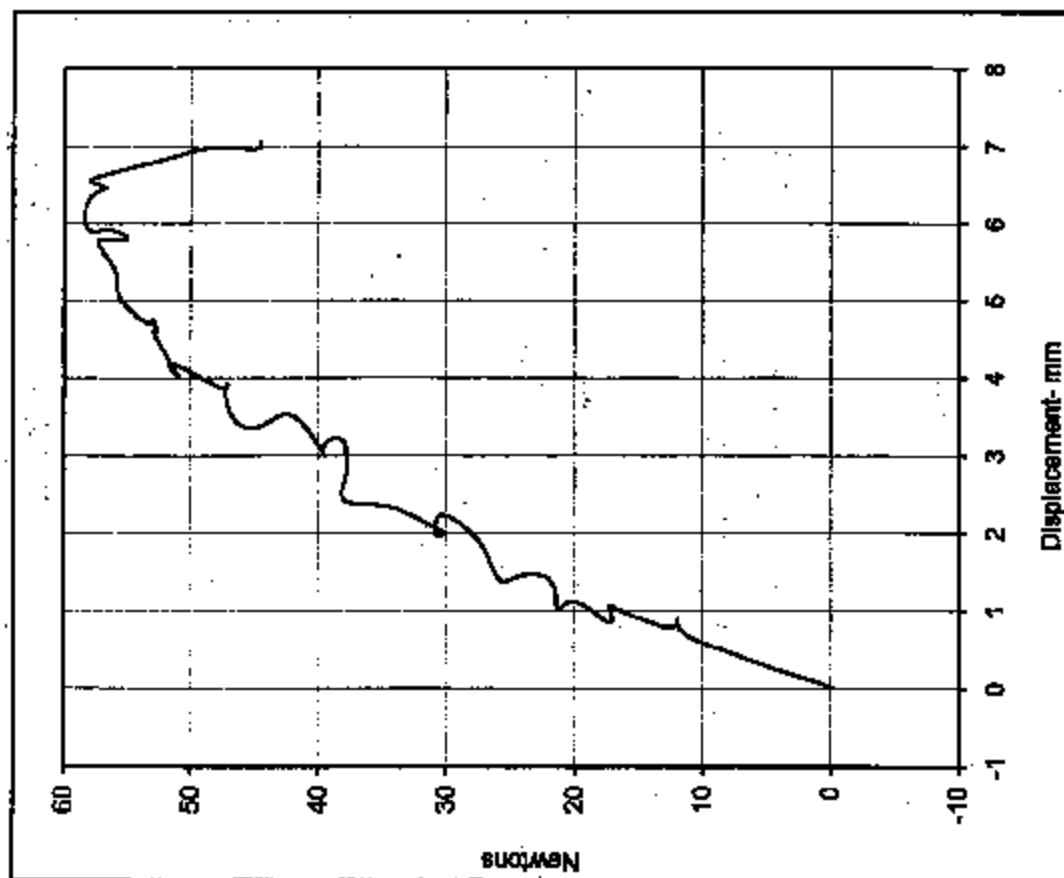
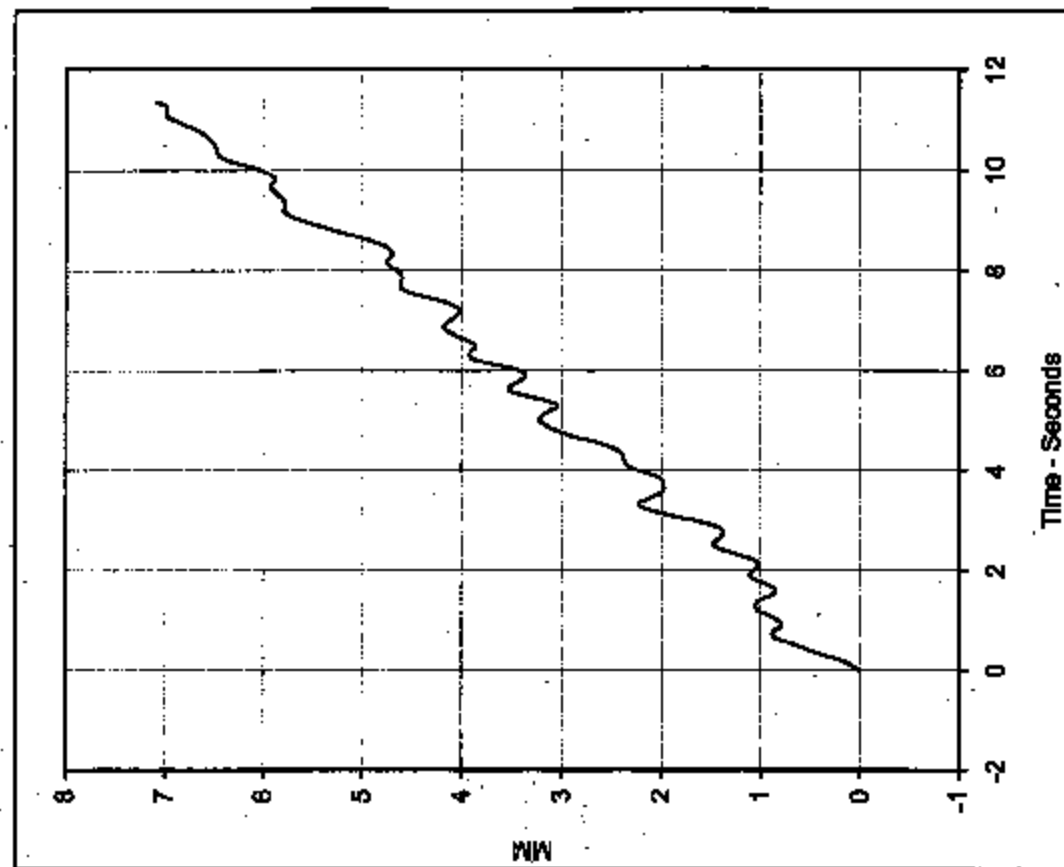
-45 / 90  
5/27/04

Units	Peak Force	Displacement	Filter (Hz)
Newtons	55.5	6.0	1

Units	Max	Time	Displ. Rate (mm/min.)	Filter (Hz)
MM	7.1	11.4	36.2	1

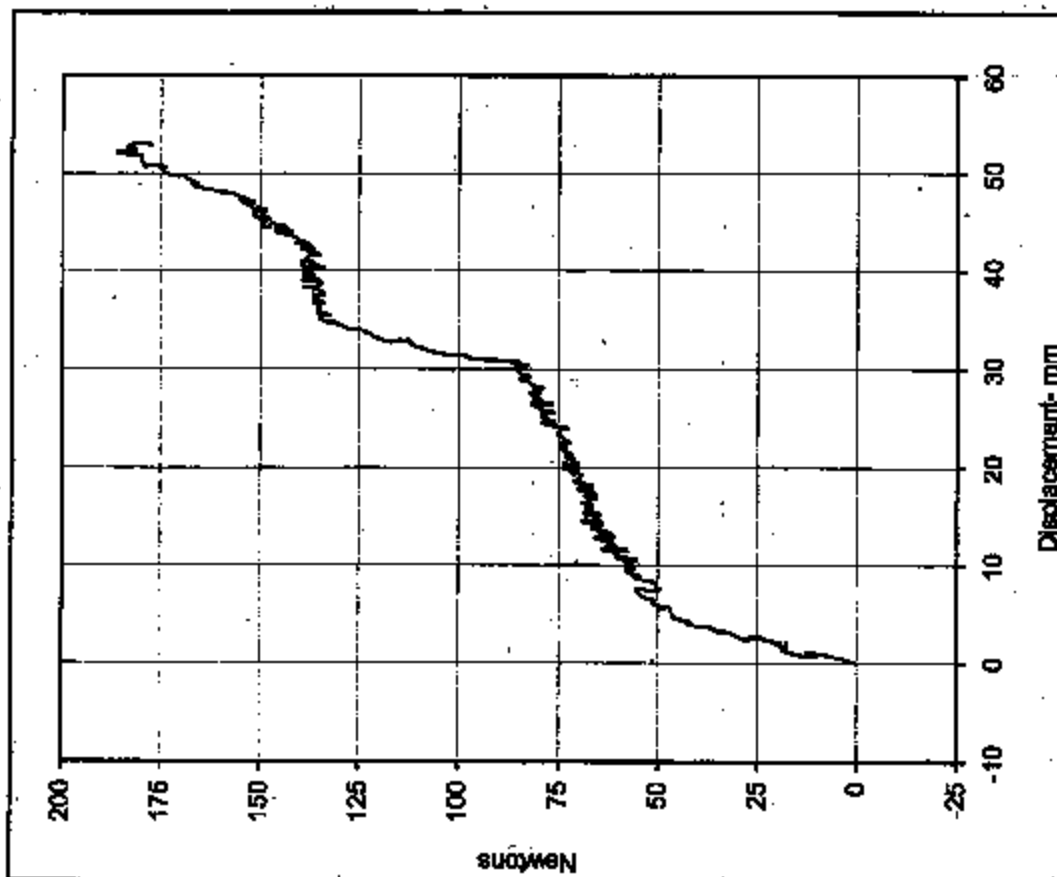
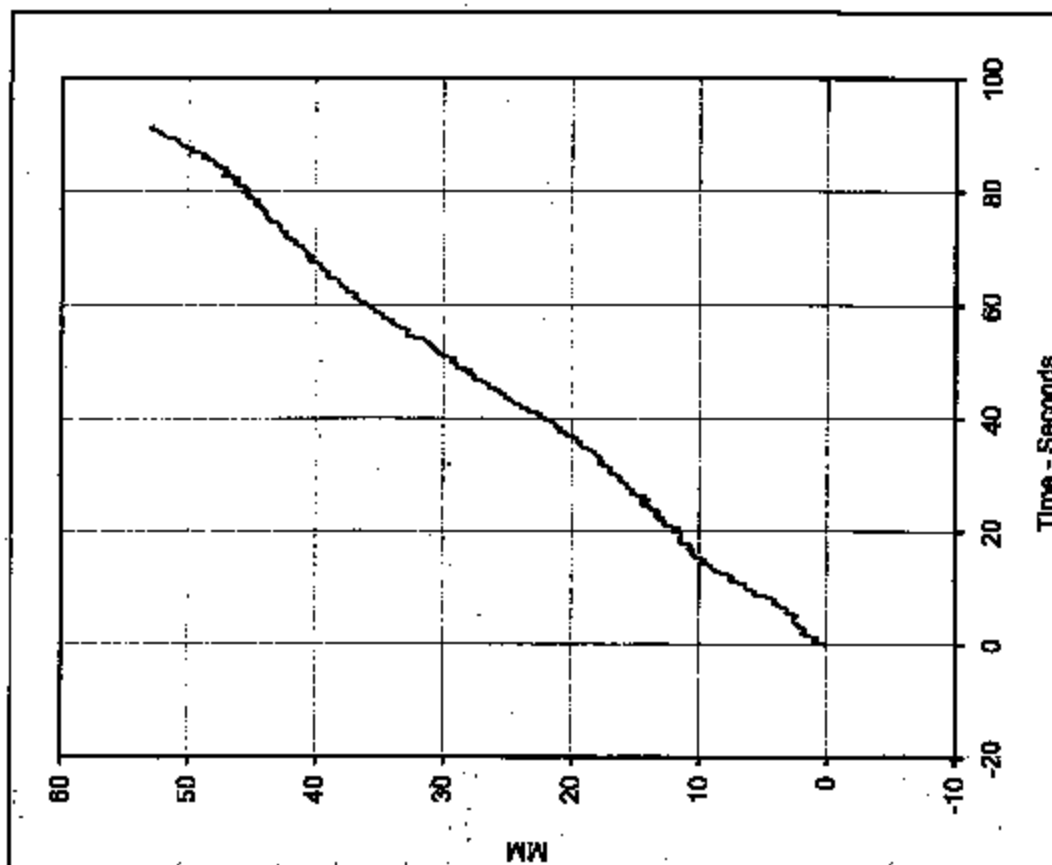
Test Program: 2004 FMVSS 111 Rearview Mirrors Test No.: 4  
 Test Vehicle: 2004 Saturn Ion No.: C40104

Units	Peak Force	Displacement	Filter (Hz)
Newtons	186.0	52.1	1

Units	Max	Time	Displ. Rate (mm/min.)	Filter (Hz)
MM	53.0	91.2	34.7	1

Load Direction: -45 / +45  
 Test Date: 5/27/04

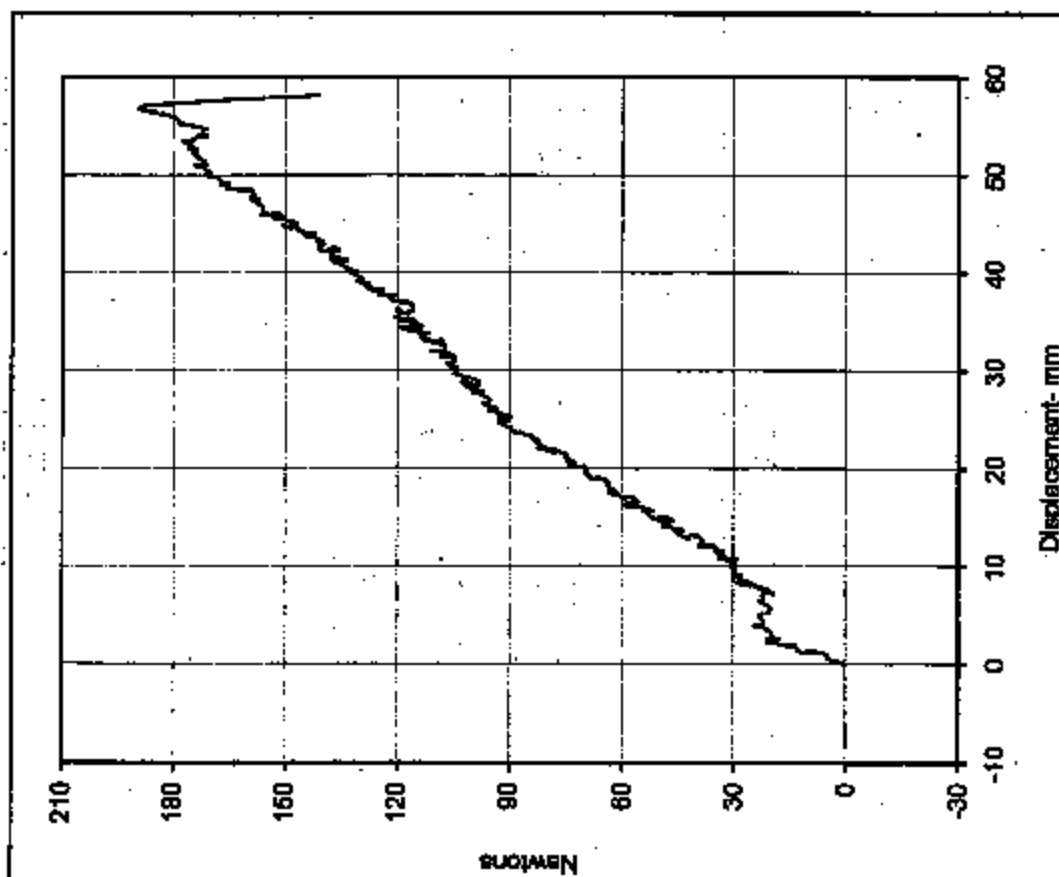
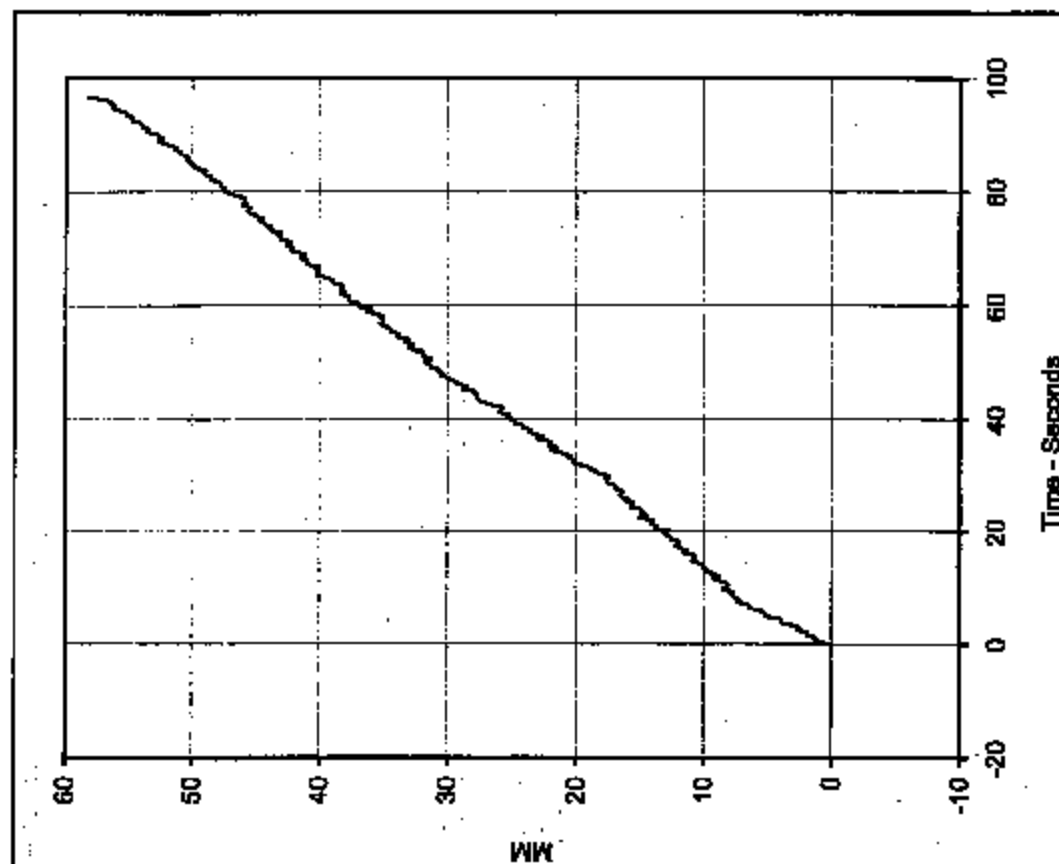
Test Program: 2004 FMVSS 111 Rearview Mirrors Test No.: 5  
 Test Vehicle: 2004 Saturn Ion No.: C40104

Units	Peak Force	Displacement	Filter (Hz)
Newtons	189.6	58.8	1

Units	Max	Time	Displ. Rate (mm/min.)	Filter (Hz)
MM	58.2	96.8	36.1	1

Load Direction: +45 / +45  
 Test Date: 5/27/04

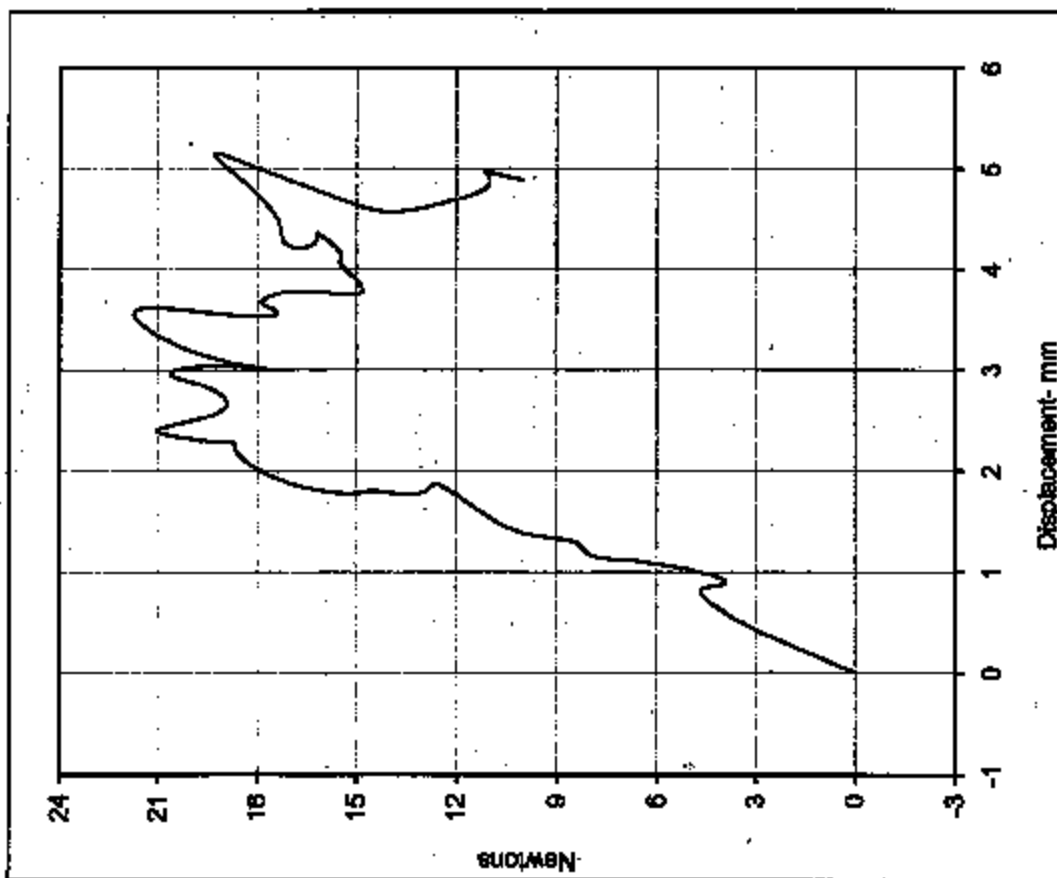
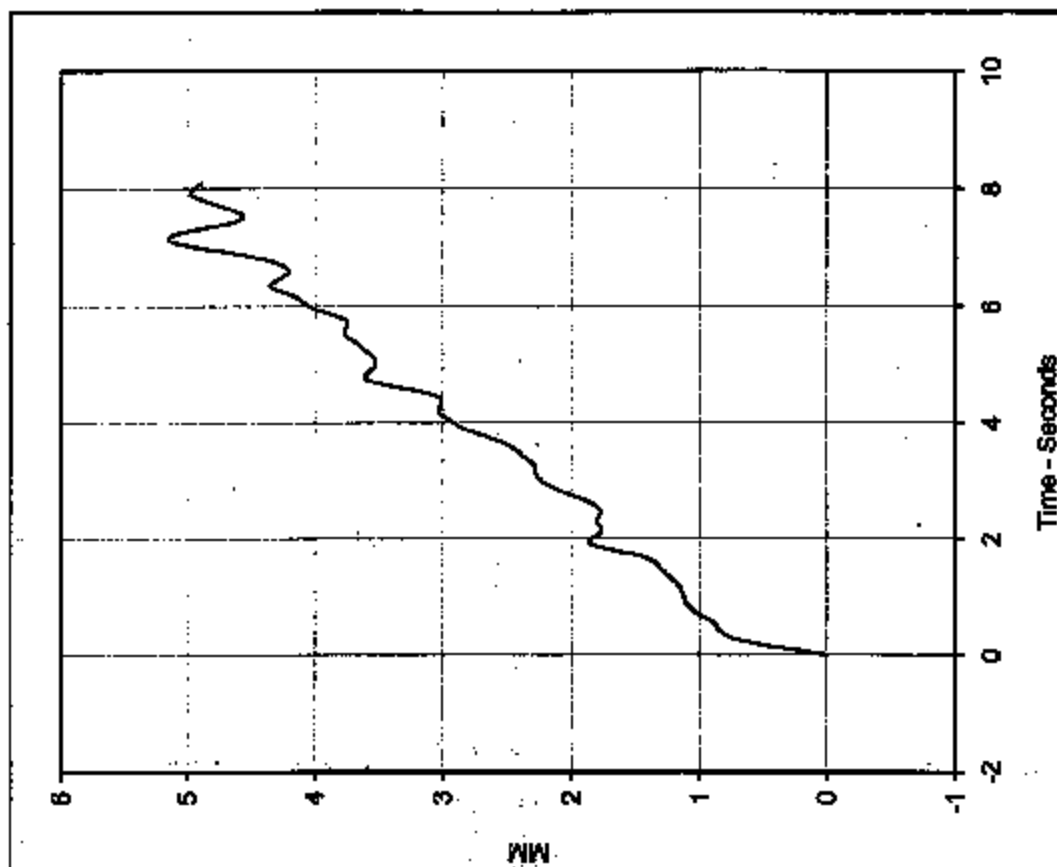
Test Program: 2004 FMVSS 111 Rearview Mirrors Test No.: 6  
 Test Vehicle: 2004 Saturn Ion No.: C40104

Units	Peak Force	Displacement	Filter (Hz)
Newtons	21.7	3.5	1

Units	Max	Time	Displ. Rate (mm/min.)	Filter (Hz)
MM	5.2	7.2	40.7	1

Load Direction: +45 / -45  
 Test Date: 5/27/04

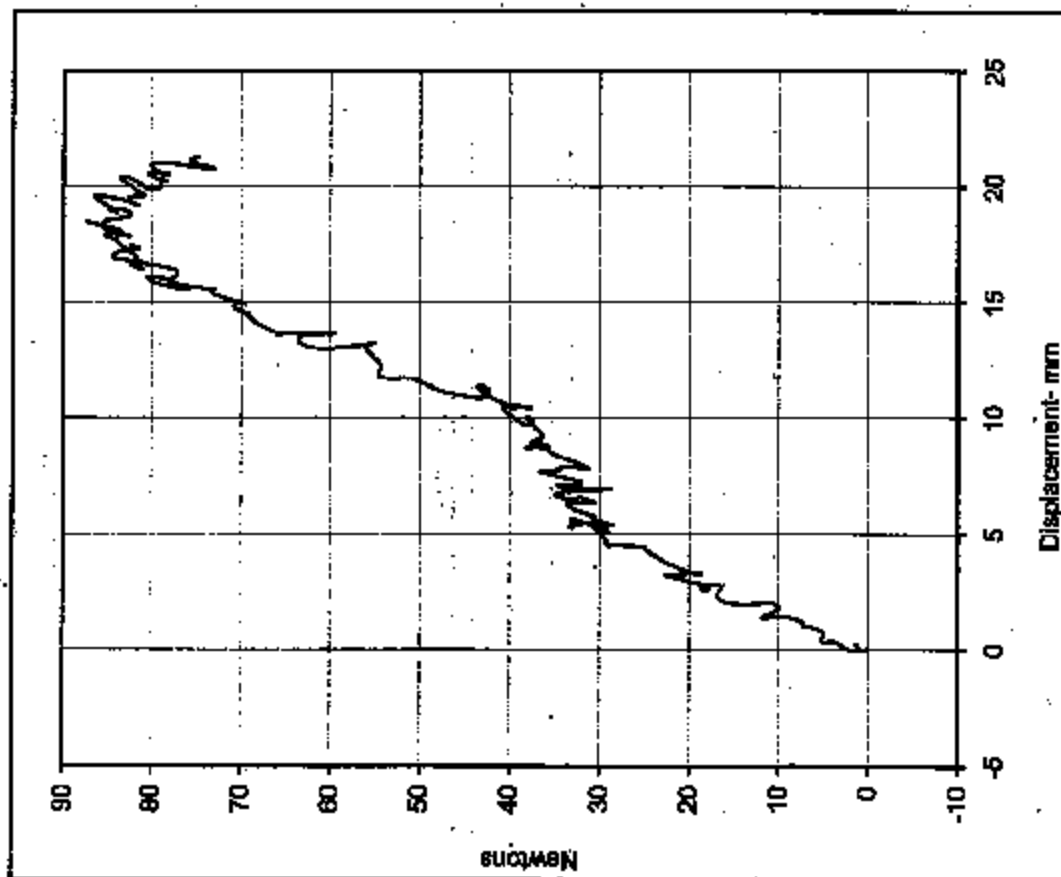
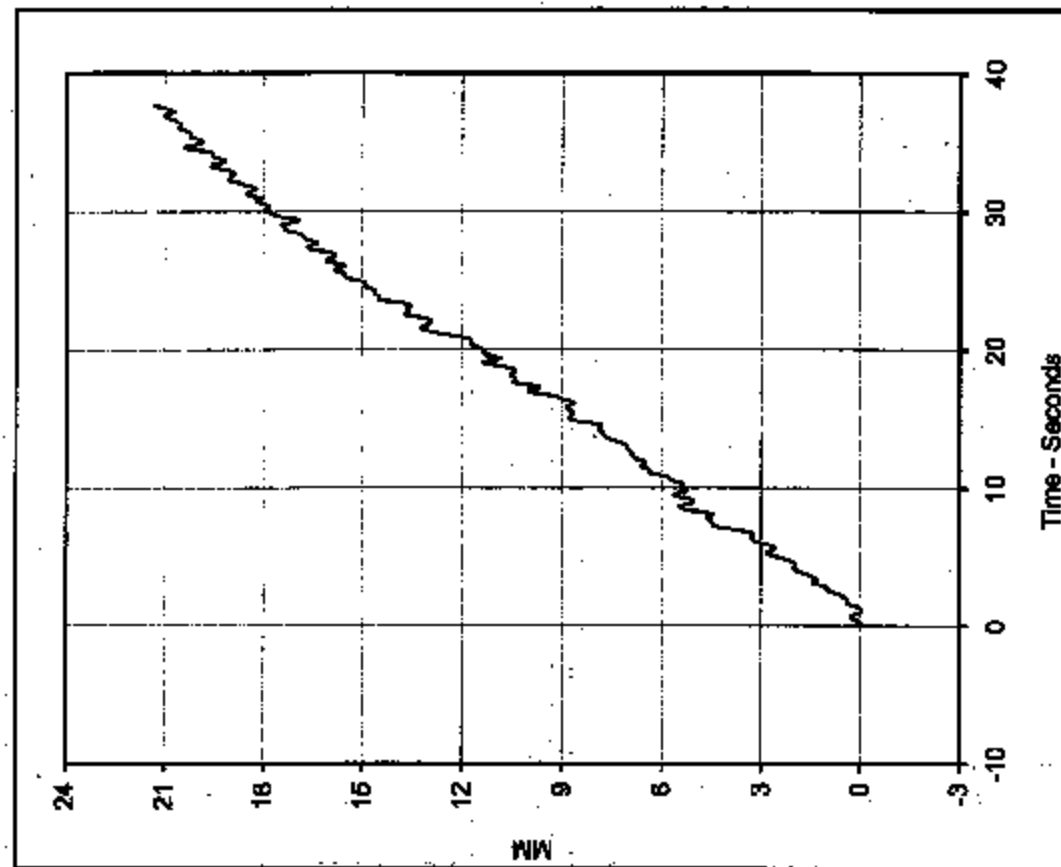
Test Program: 2004 FMVSS 111 Rearview Mirrors Test No.: 7  
 Test Vehicle: 2004 Saturn Ion No.: C40104

Units	Peak Force	Displacement	Filter (Hz)
Newtons	87.5	18.5	1

Units	Max	Time	Displ. Rate (mm/min.)	Filter (Hz)
MM	21.3	37.7	34.1	1
