REPORT NUMBER 103-GTL-06-004

**SAFETY COMPLIANCE TESTING FOR  
FMVSS NO. 103  
WINDSHIELD DEFROSTING AND  
DEFOGGING SYSTEMS**

**MITSUBISHI MOTORS NORTH AMERICA, INC.  
2006 MITSUBISHI ECLIPSE, PASSENGER CAR  
NHTSA NO. C65600**

**FINAL REPORT**

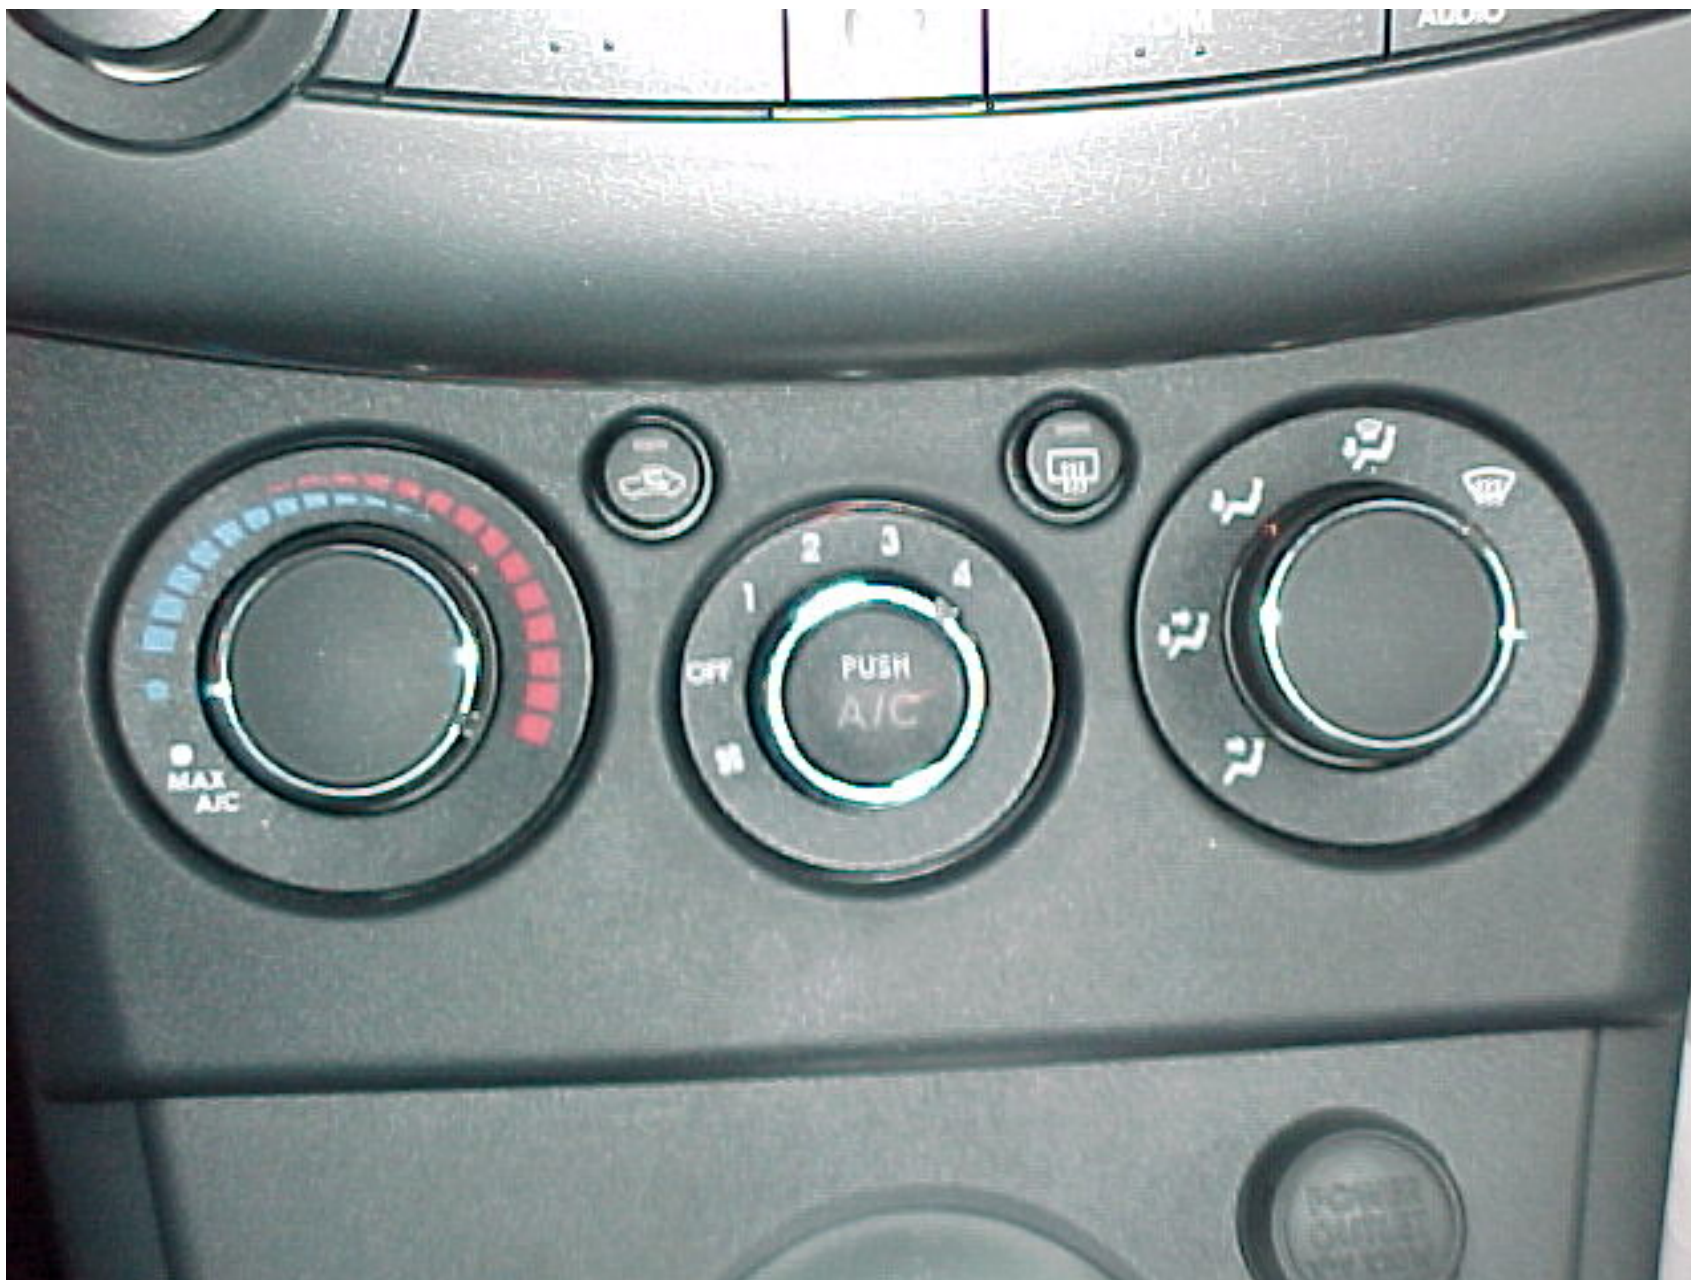
FIGURE 5.7  
CLOSE-UP VIEW OF DEFROSTER CONTROL  
SETTING ON DASH

At the conclusion of the additional soak time the vehicle's engine was started and operated at a target speed of 1500-1600 rpm or at the manufacturer's specification if different as noted on data sheets. The defroster blower was turned on to the high speed setting with the heater selector in the de-ice (defrost) position, and the temperature control in the maximum temperature position. All doors and windows were closed. The heater air intake was fully open and the vehicle's hood closed. At no time during the test were the windshield wipers used.

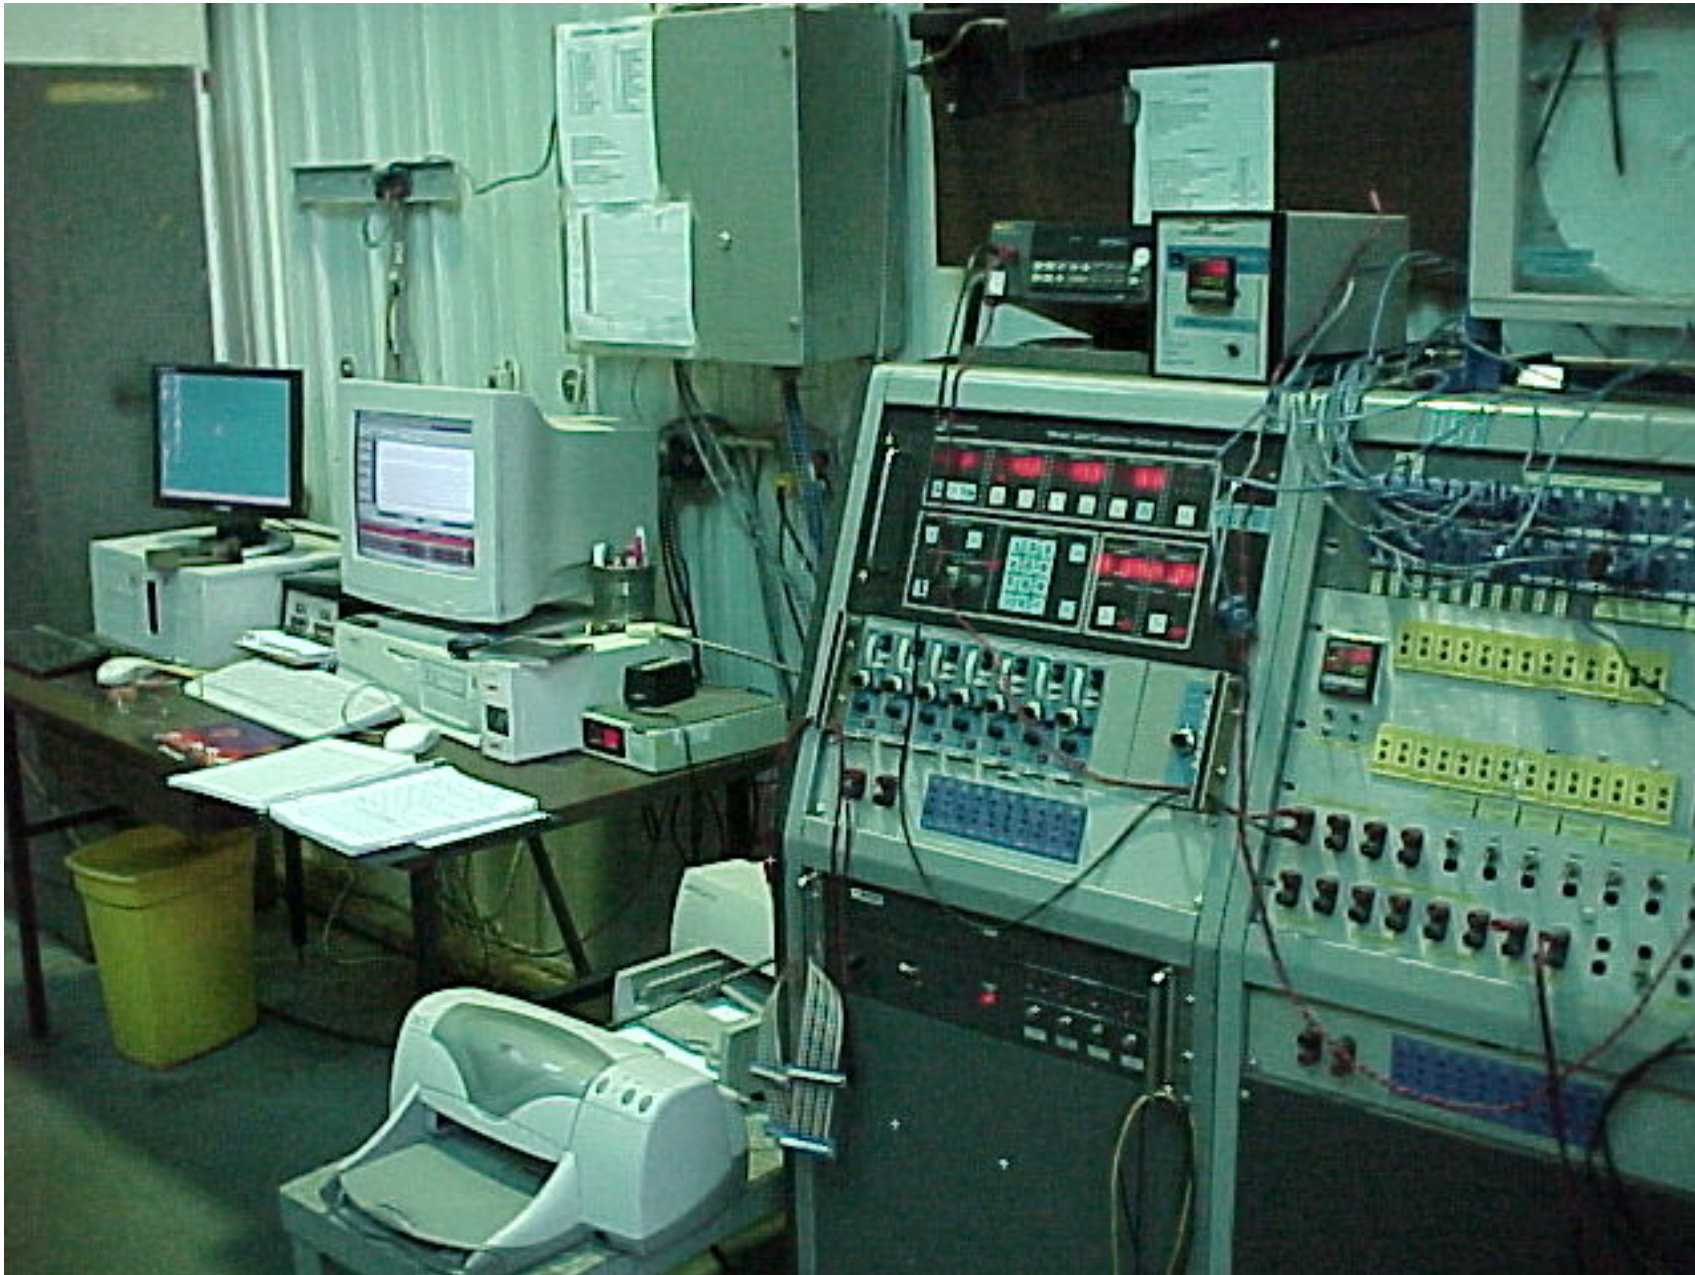
FIGURE 5.8  
INSTRUMENTATION SET-UP

At start of testing and during test, at each 5-minute interval after engine start, cold chamber, engine coolant, heater coolant in and defroster air left/defroster air right temperatures were recorded. Likewise at each 5-minute interval the boundary of the defrosted area was marked on the inside surface of the windshield. The test was run for a maximum of 40 minutes from engine start, or until such time as 100 percent windshield clearance was achieved. Photographs were made of the windshield at the pre-test frosted state and 20-minute and 25-minute intervals. Post test actions included placing a vellum pattern on the windshield and tracing the windshield's 5-minute interval defrosted area boundary lines onto the vellum pattern.

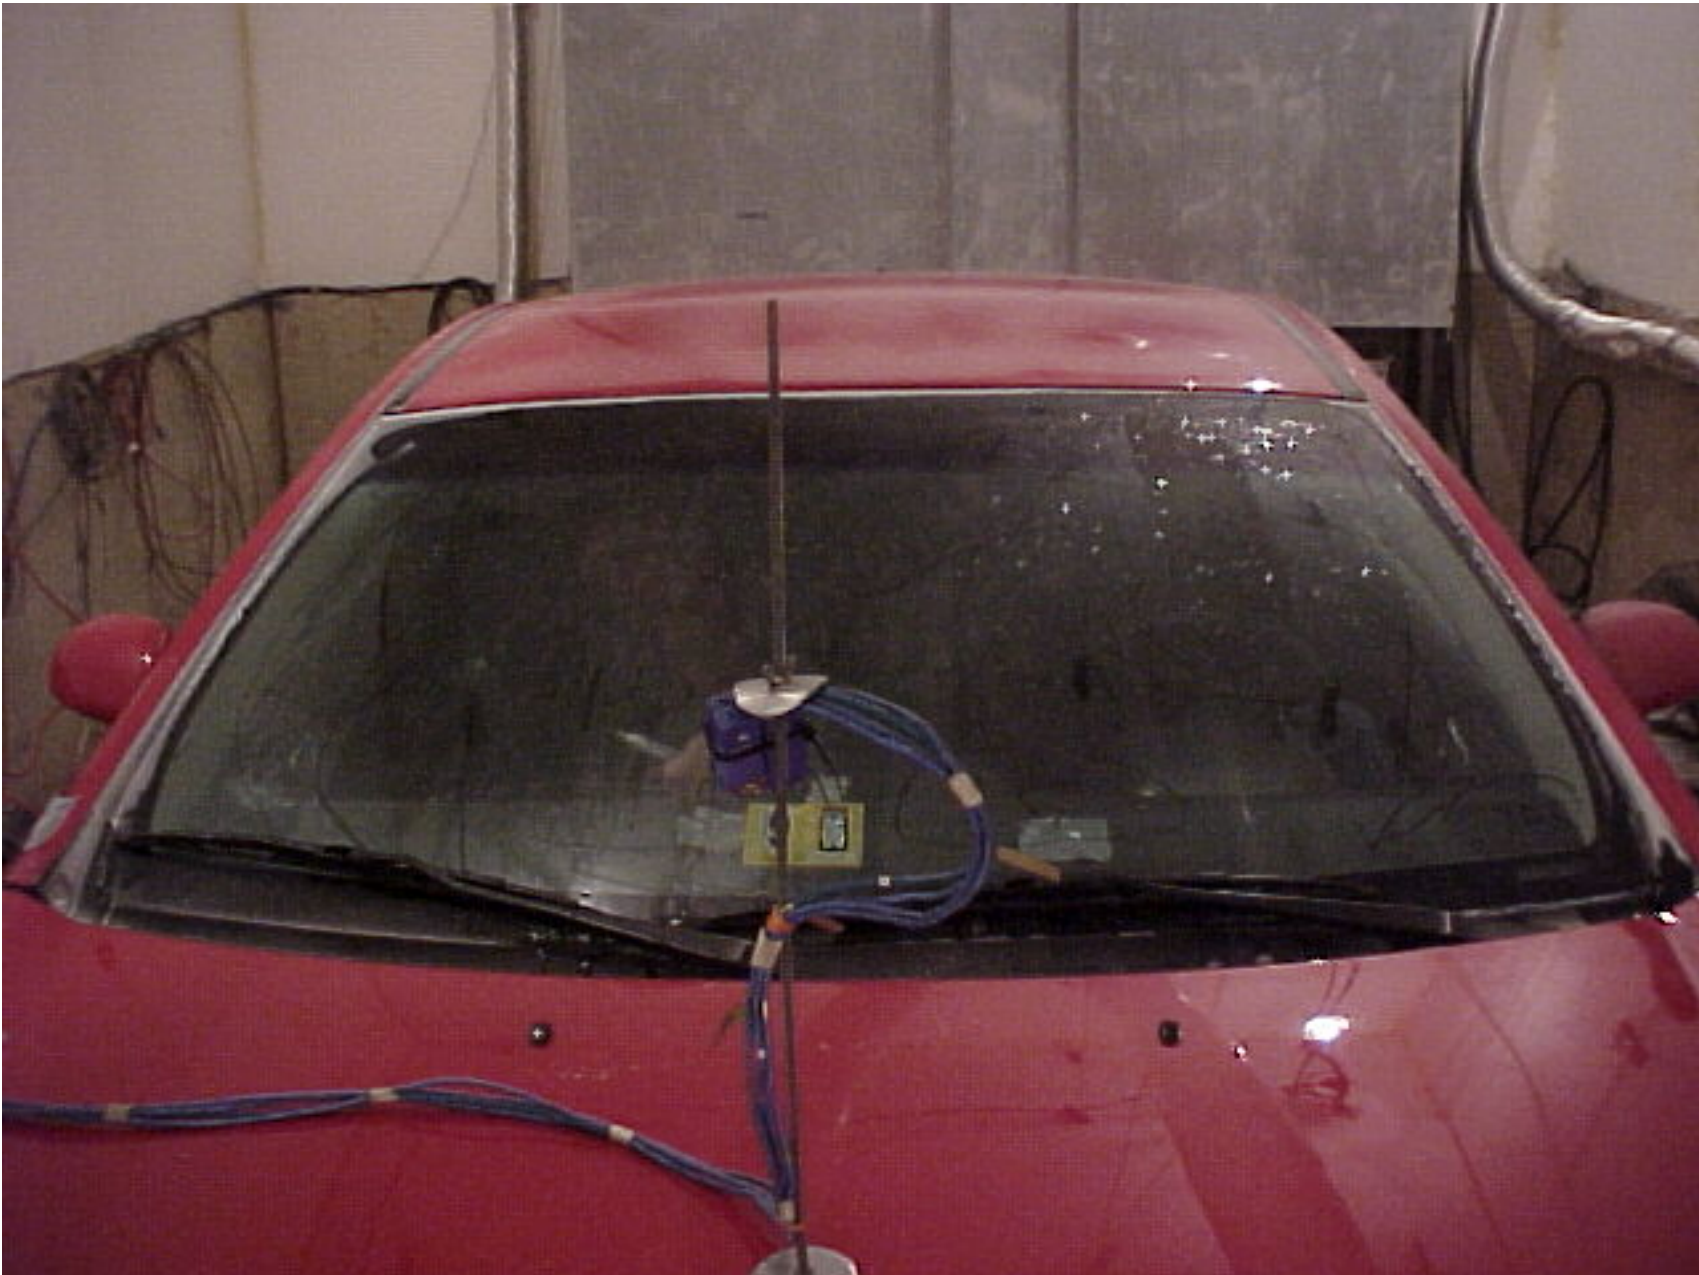
FIGURE 5.10  
DEFROSTED AREA AT 20 MINUTES TEST #1

TIME FROM START (minutes)	MOTOR VOLTAGE (volts)	TEMPERATURE, °F					DEFROSTED AREA, %		
		TEST ROOM	ENGINE WATER	HEATER WATER IN	DEFROSTER AIR		A	C	D
					DRVR	PSGR			
0	13.5	-4.0	-4.0	-4.0	-4.0	-4.0	0%	0%	0%
5	14.8	-4.0	38.3	101.0	76.8	81.0	6.4%	1.1%	1.3%
10	14.7	-2.6	84.2	131.1	104.7	109.6	55.5%	78.8%	60.6%
15	14.7	-1.7	110.8	149.5	122.0	127.4	95.1%	100%	98.2%
20	14.6	-1.3	124.3	156.6	129.3	134.6	99%	100%	100%
25	14.6	0.0	135.1	163.2	135.3	140.7	100%	100%	100%

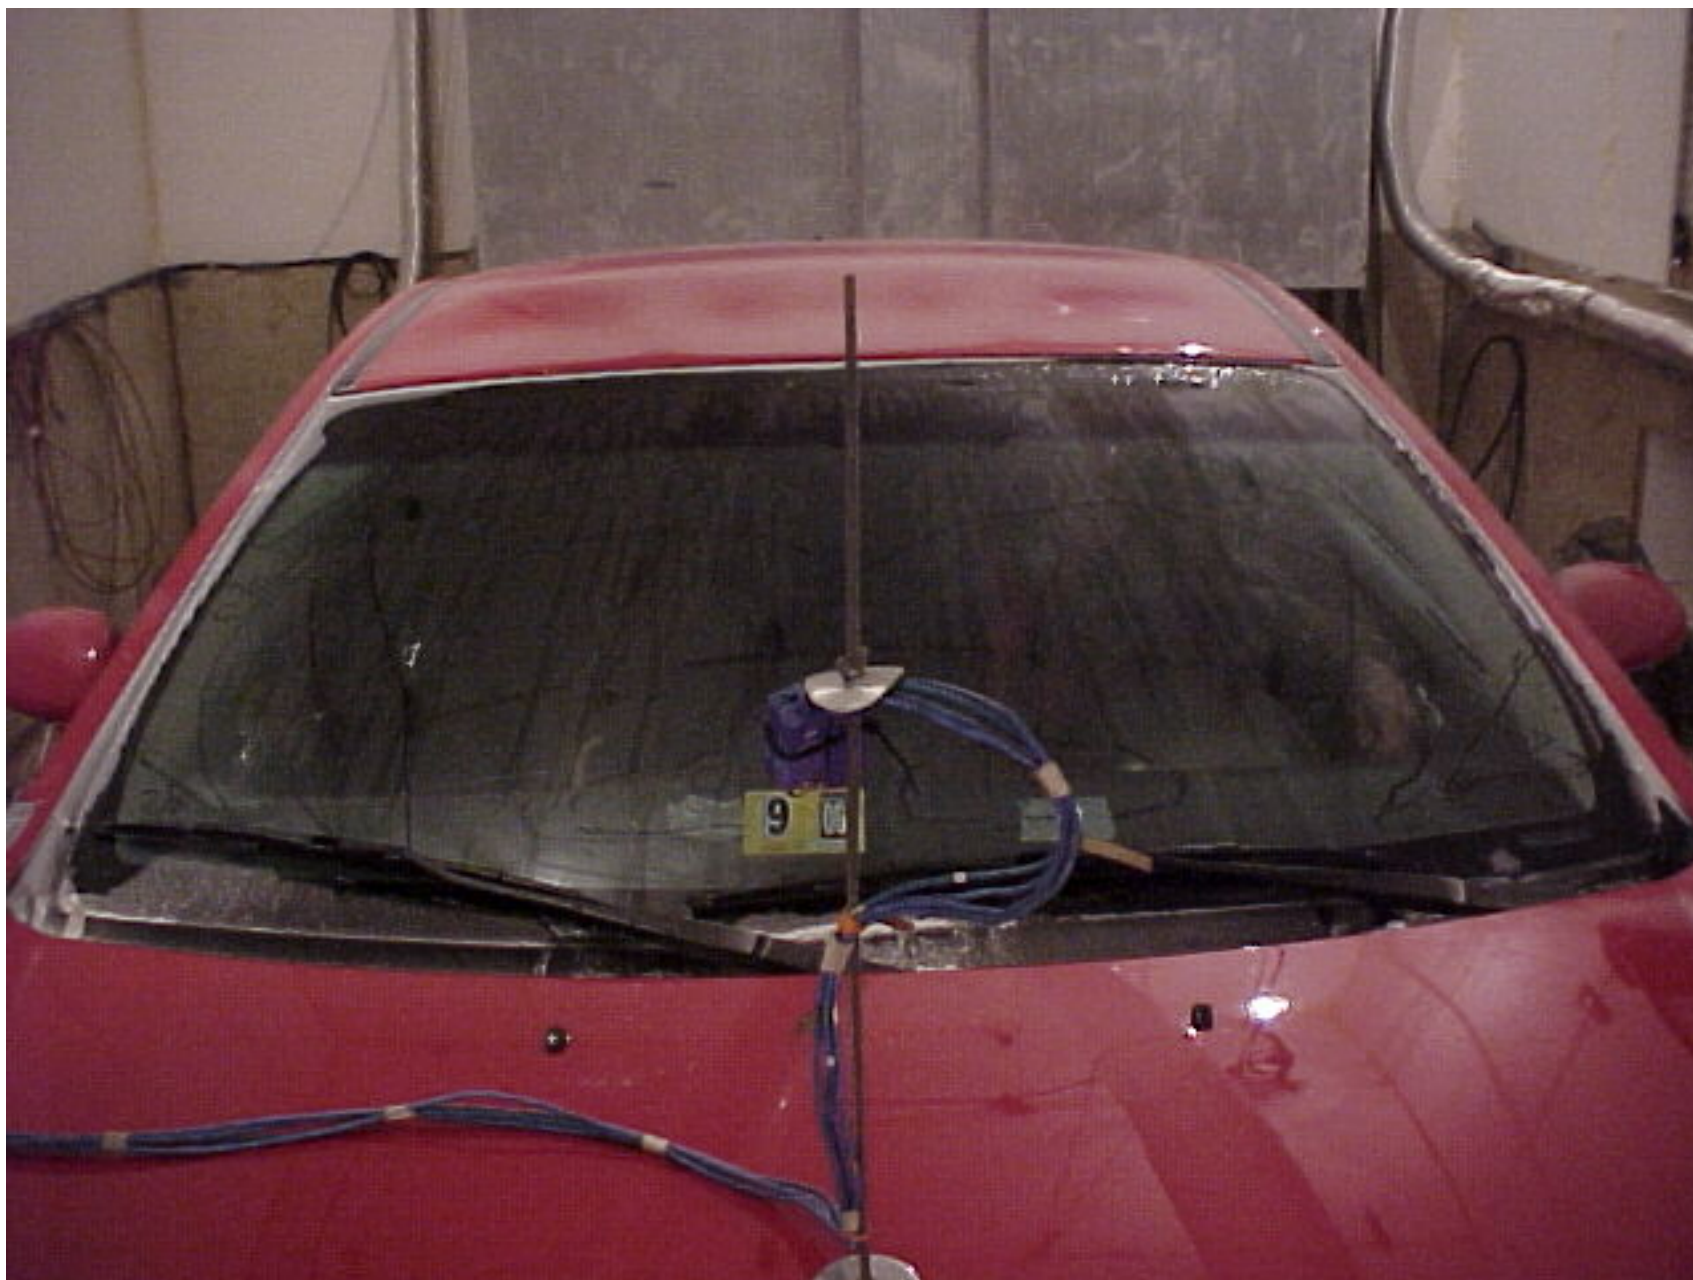
FIGURE 5.14  
DEFROSTED AREA AT 20 MINUTES TEST #2

TIME FROM START (minutes)	MOTOR VOLTAGE (volts)	TEMPERATURE, °F					DEFROSTED AREA, %		
		TEST ROOM	ENGINE WATER	HEATER WATER IN	DEFROSTER AIR		A	C	D
					DRVR	PSGR			
0	13.4	-4.0	-4.0	-4.0	-4.0	-4.0	0%	0%	0%
5	14.9	-4.0	74.6	102.7	77.1	81.5	6.2%	.5%	1.2%
10	14.7	-3.3	110.5	130.0	104.9	109.3	54.3%	76.2%	60.6%
15	14.7	-1.8	132.5	148.5	122.2	126.7	94.2%	100%	97.9%
20	14.6	-0.8	144.6	158.9	132.1	136.8	97.8%	100%	100%
25	14.6	0.5	151.7	165.4	138.5	143.2	100%	100%	100%
