REPORT NUMBER: 201U-CAL-06-08

**SAFETY COMPLIANCE TESTING FOR FMVSS 201
OCCUPANT PROTECTION IN INTERIOR IMPACT
UPPER INTERIOR HEAD IMPACT PROTECTION**

**FORD MOTOR CO.
2006 FORD 500 SE**

NHTSA NUMBER: C60200

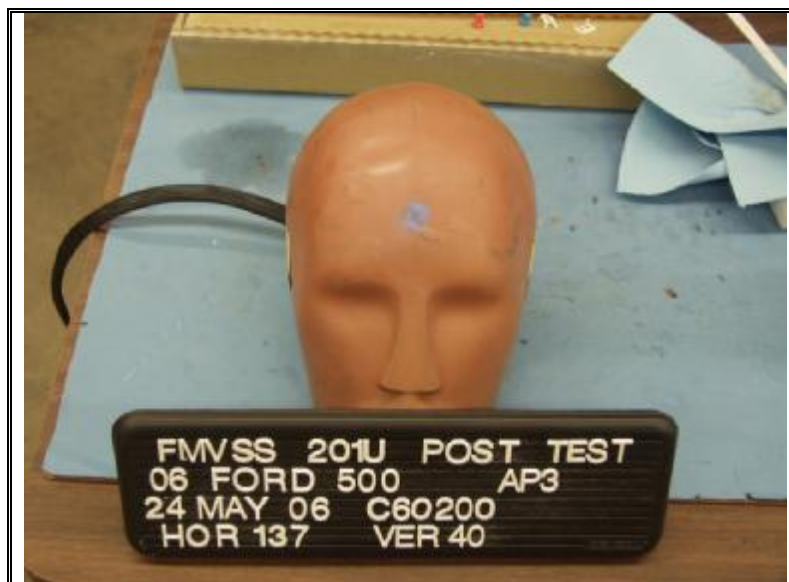
POST-IMPACT AP3 HEADFORM

Free Motion HIC	608.1
HIC(d)	625.2
Impact Velocity (kph)	23.69
HIC T1 (msec)	2.0
HIC T2 (msec)	11.6

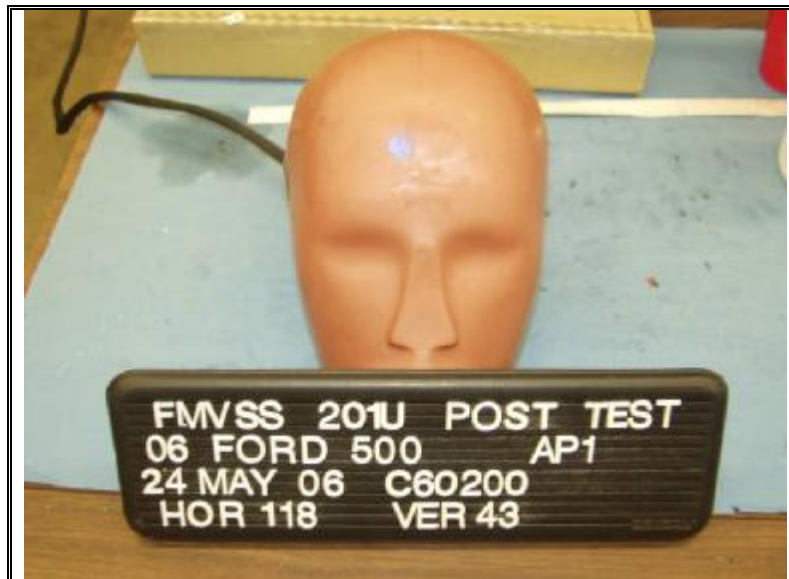
POST-IMPACT AP1 HEADFORM

Free Motion HIC	395.1
HIC(d)	464.5
Impact Velocity (kph)	23.5
HIC T1 (msec)	3.0
HIC T2 (msec)	41.7

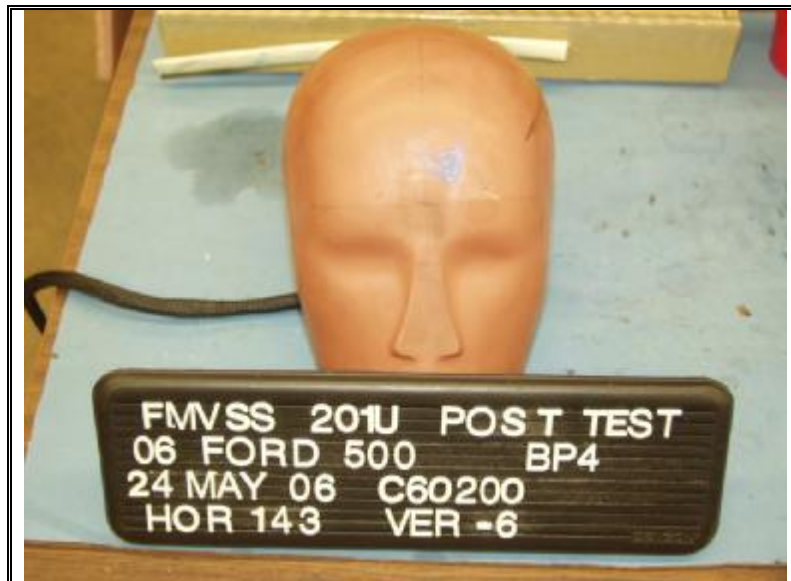
POST-IMPACT BP4 HEADFORM

Free Motion HIC	815.2
HIC(d)	781.5
Impact Velocity (kph)	23.81
HIC T1 (msec)	6.3
HIC T2 (msec)	11.1

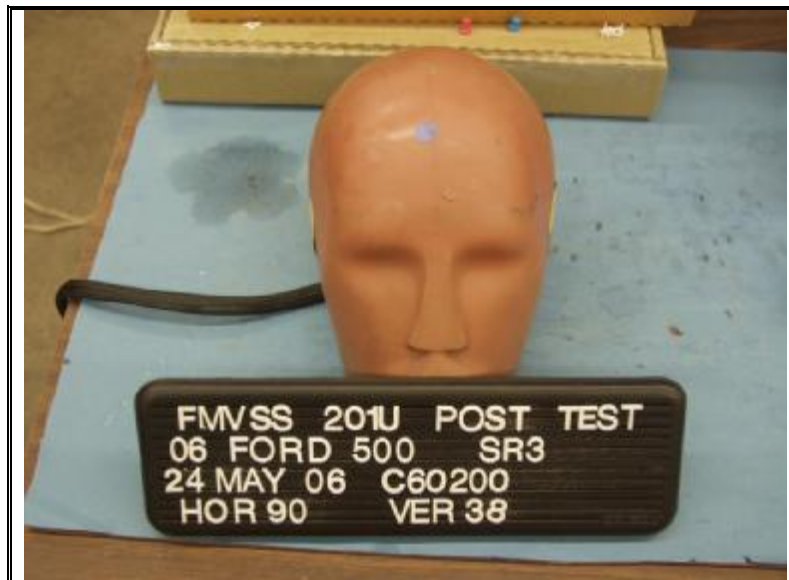
POST-IMPACT SR3 HEADFORM

Free Motion HIC	626.1
HIC(d)	638.8
Impact Velocity (kph)	23.56
HIC T1 (msec)	2.2
HIC T2 (msec)	8.6

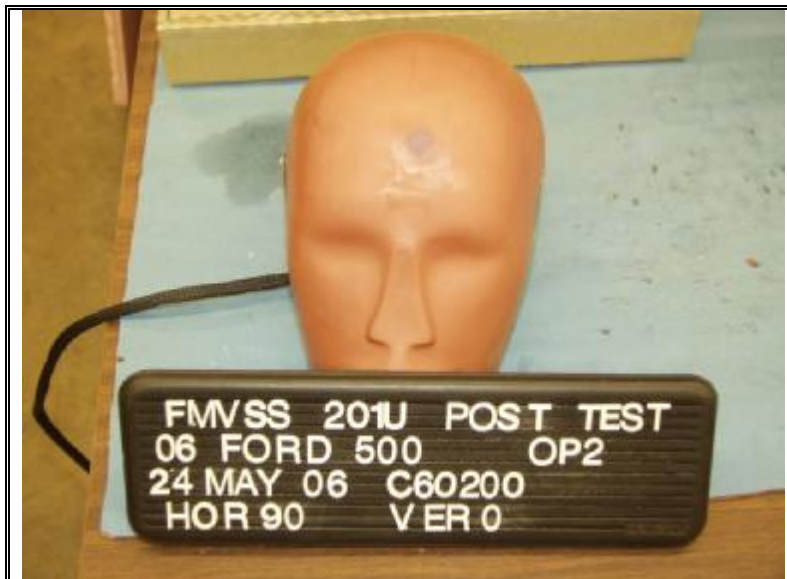
POST-IMPACT OP2 HEADFORM

Free Motion HIC	643.1
HIC(d)	651.6
Impact Velocity (kph)	23.31
HIC T1 (msec)	7.0
HIC T2 (msec)	14.2

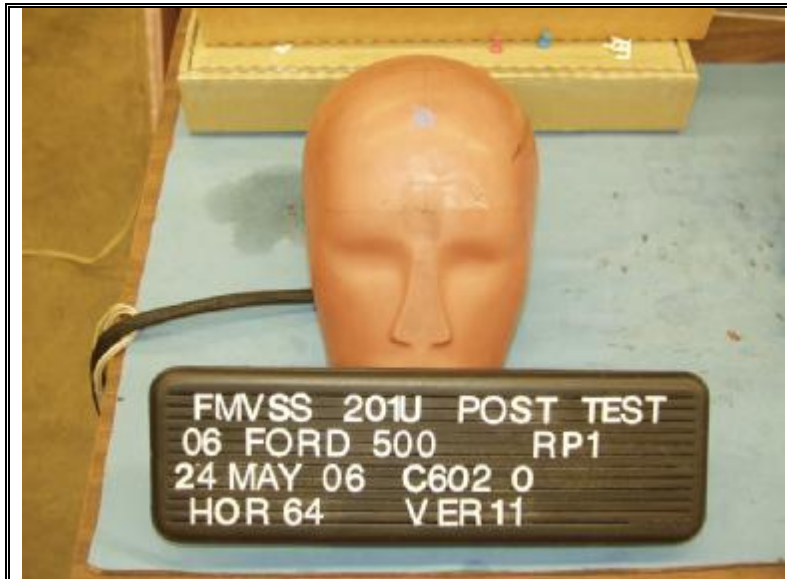
POST-IMPACT RP1 HEADFORM

Free Motion HIC	276.9
HIC(d)	375.3
Impact Velocity (kph)	23.65
HIC T1 (msec)	1.7
HIC T2 (msec)	17.2

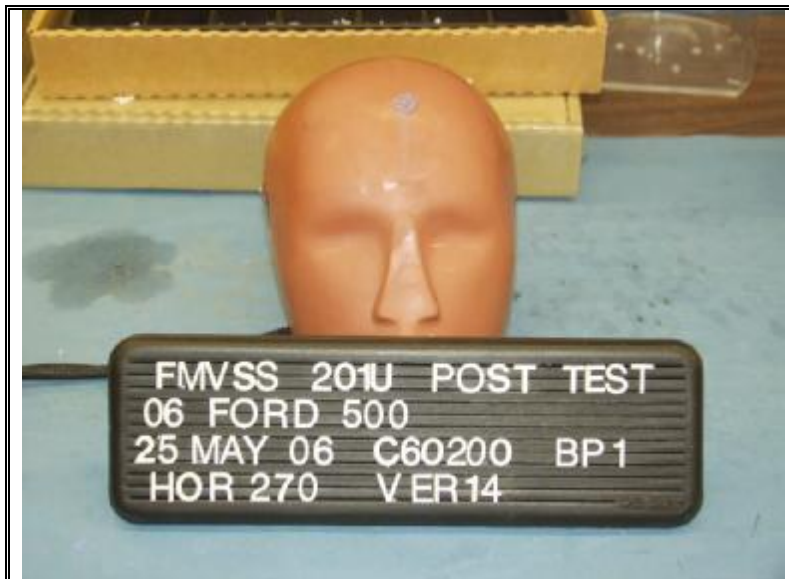
POST-IMPACT BP1 HEADFORM

Free Motion HIC	594.4
HIC(d)	614.9
Impact Velocity (kph)	23.44
HIC T1 (msec)	4.0
HIC T2 (msec)	12.0

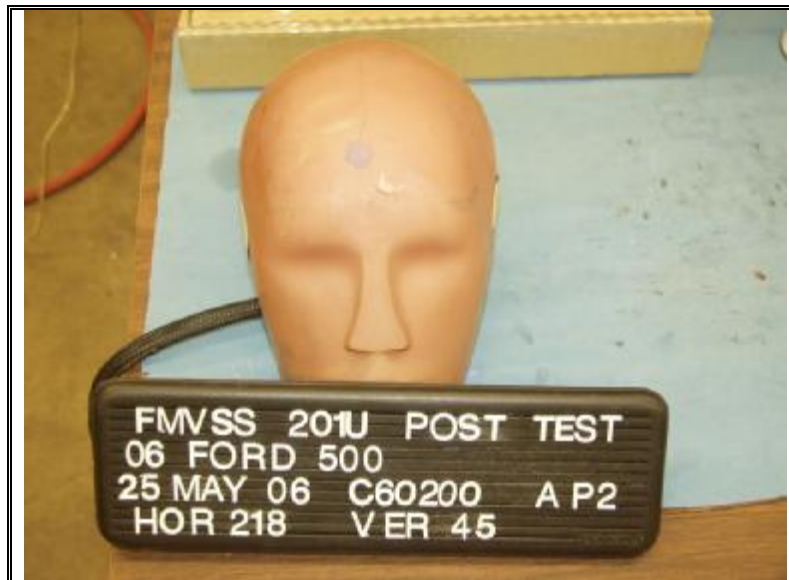
POST-IMPACT AP2 HEADFORM

Free Motion HIC	1075.2
HIC(d)	977.6
Impact Velocity (kph)	23.68
HIC T1 (msec)	7.1
HIC T2 (msec)	11.1

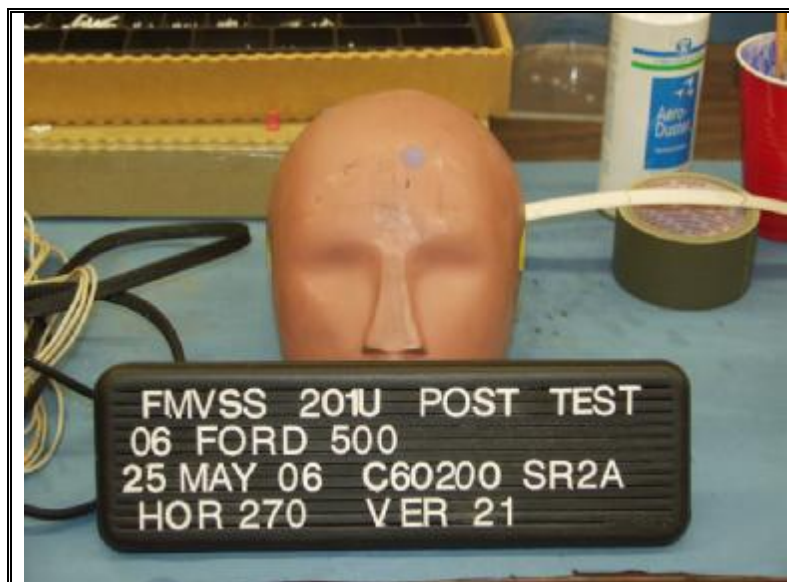
POST-IMPACT SR2A HEADFORM

Free Motion HIC	426.7
HIC(d)	488.3
Impact Velocity (kph)	23.47
HIC T1 (msec)	1.5
HIC T2 (msec)	10.6
