REPORT NUMBER 214-GTL-06-002

**SAFETY COMPLIANCE TESTING FOR
FMVSS NO. 214S
SIDE IMPACT PROTECTION (STATIC)**

**FORD MOTOR CO.
2006 FORD FUSION, PASSENGER CAR
NHTSA NO. C60202**

FINAL REPORT

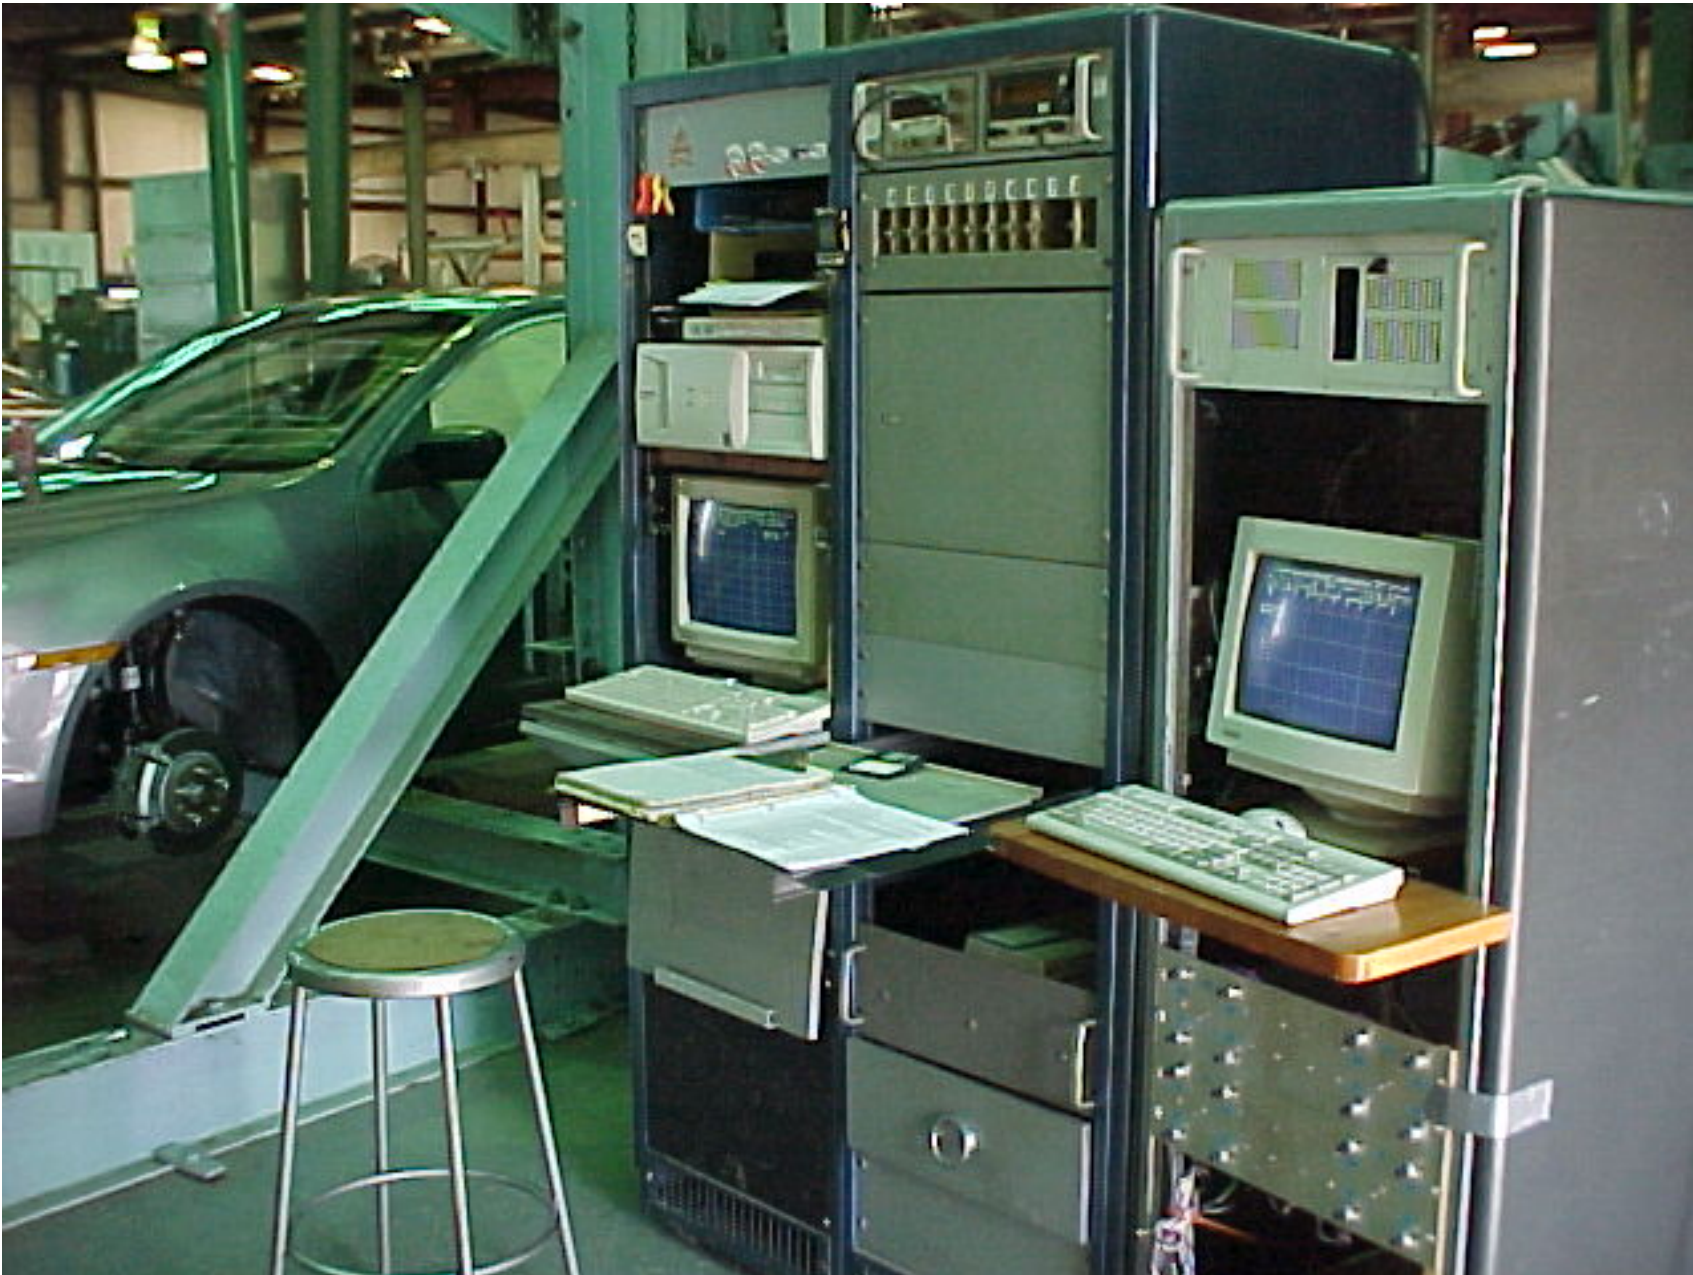
FIGURE 5.10
INSTRUMENTATION SET-UP

EQUIPMENT	DESCRIPTION	MODEL/ SERIAL NO.	CAL. DATE	NEXT CAL. DATE
COMPUTER	AT&T	486DX266	N/A	N/A
TEST FIXTURE	GTL 214	214	N/A	N/A
A/D INTERFACE	METRABYTE	DAS-16(F)	BEFORE USE	BEFORE USE
SCALES	FAIRBANKS	N/A	BEFORE USE	BEFORE USE
SIGNAL CONDITIONER	METRABYTE	EXP-RES	BEFORE USE	BEFORE USE
LOAD CELLS	REVERE REVERE	44243A 44243B	12/05	12/06
LINEAR POT.	WALDALE WALDALE	123456A 123456B	BEFORE USE	BEFORE USE
INCLINOMETER	STARRETT	360/002	05/06	05/07
DIAL INDICATOR	MIOTO	0001-2	BEFORE USE	BEFORE USE

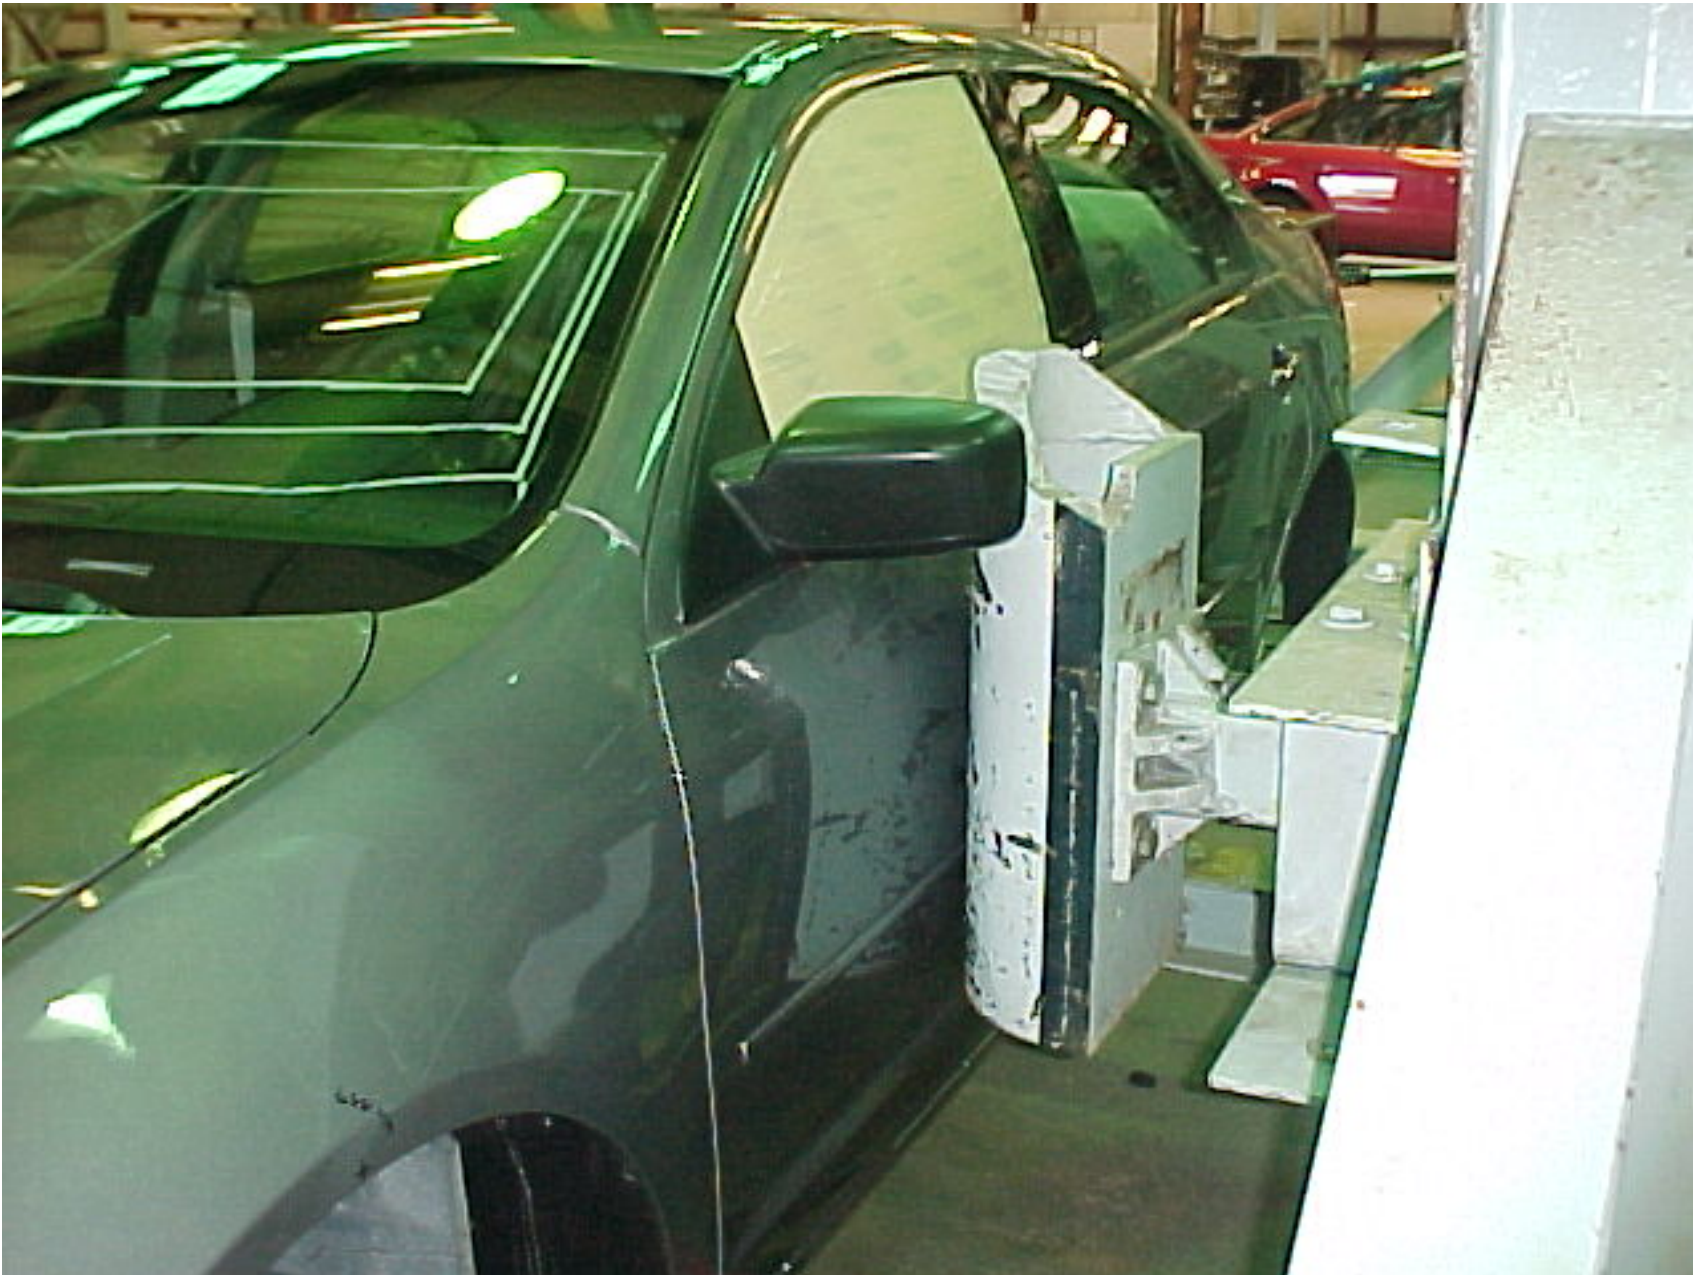
FIGURE 5.13
LOAD DEVICE AGAINST DOOR – PRE-TEST 1

C.	Close all windows	<u>X</u>	<u>X</u>
D.	Lock All doors	<u>X</u>	<u>X</u>
E.	State door tested	<u>LF</u>	<u>RR</u>
F.	State the length of a horizontal line drawn on door through a point 5 inches vertically above lowest point of test door	<u>43.0</u>	<u>29.0</u>

G.	State vertical distance from the lowest part of test door to bottom of loading device	<u>5"</u>	<u>5"</u>
H.	State position of vertical centerline of loading device on the midpoint of line determined step F	<u>21.5</u>	<u>14.5</u>

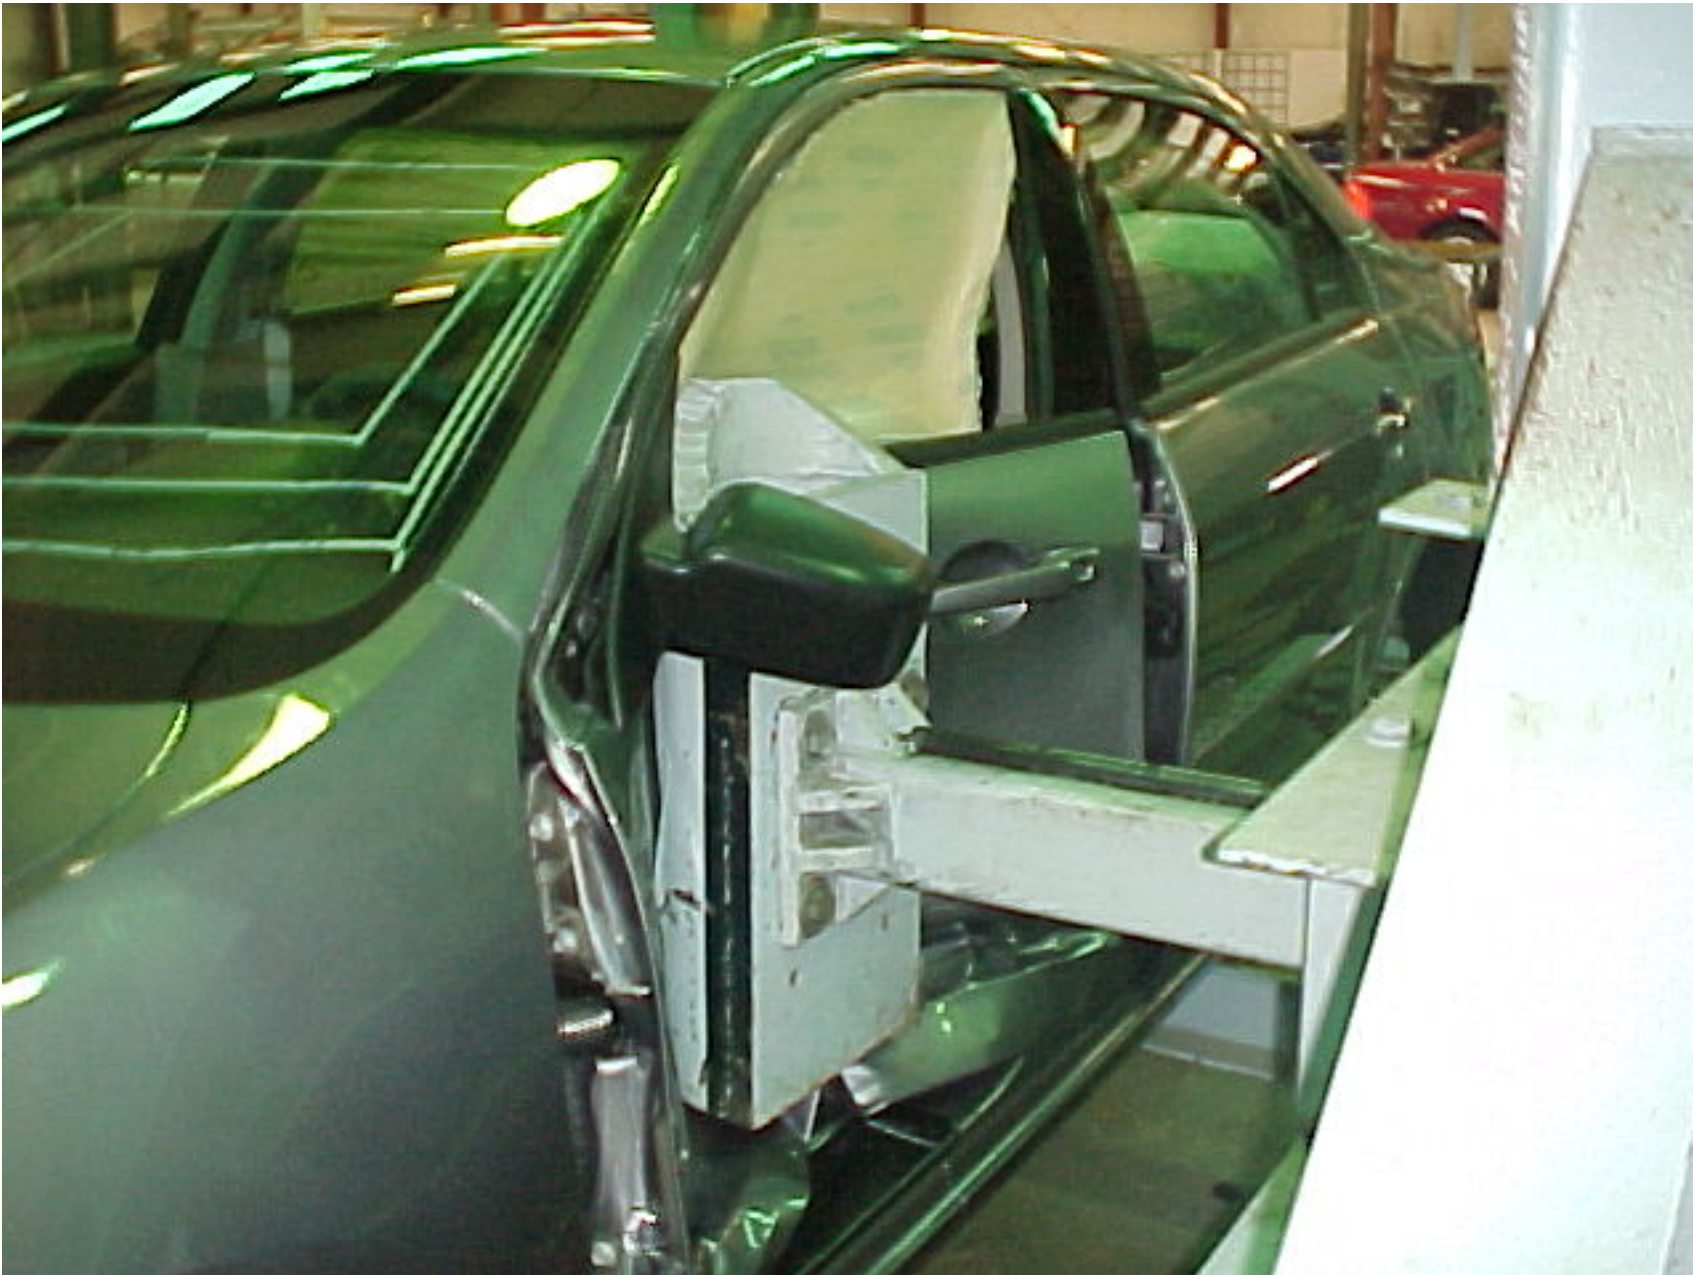
FIGURE 5.14
LOAD DEVICE AGAINST DOOR @ MAX LOAD -
TEST 1

- A. The initial crush resistance was 2889 lbs.
 B. The intermediate crush resistance was 5108 lbs.
 C. The peak crush resistance was 12,043 lbs at 12.60 inches
 D. The rate of loading was .2"/sec

- A. The initial crush resistance was 2899 lbs.
- B. The intermediate crush resistance was 5130 lbs.
- C. The peak crush resistance was 12,047 lbs at 12.60 inches

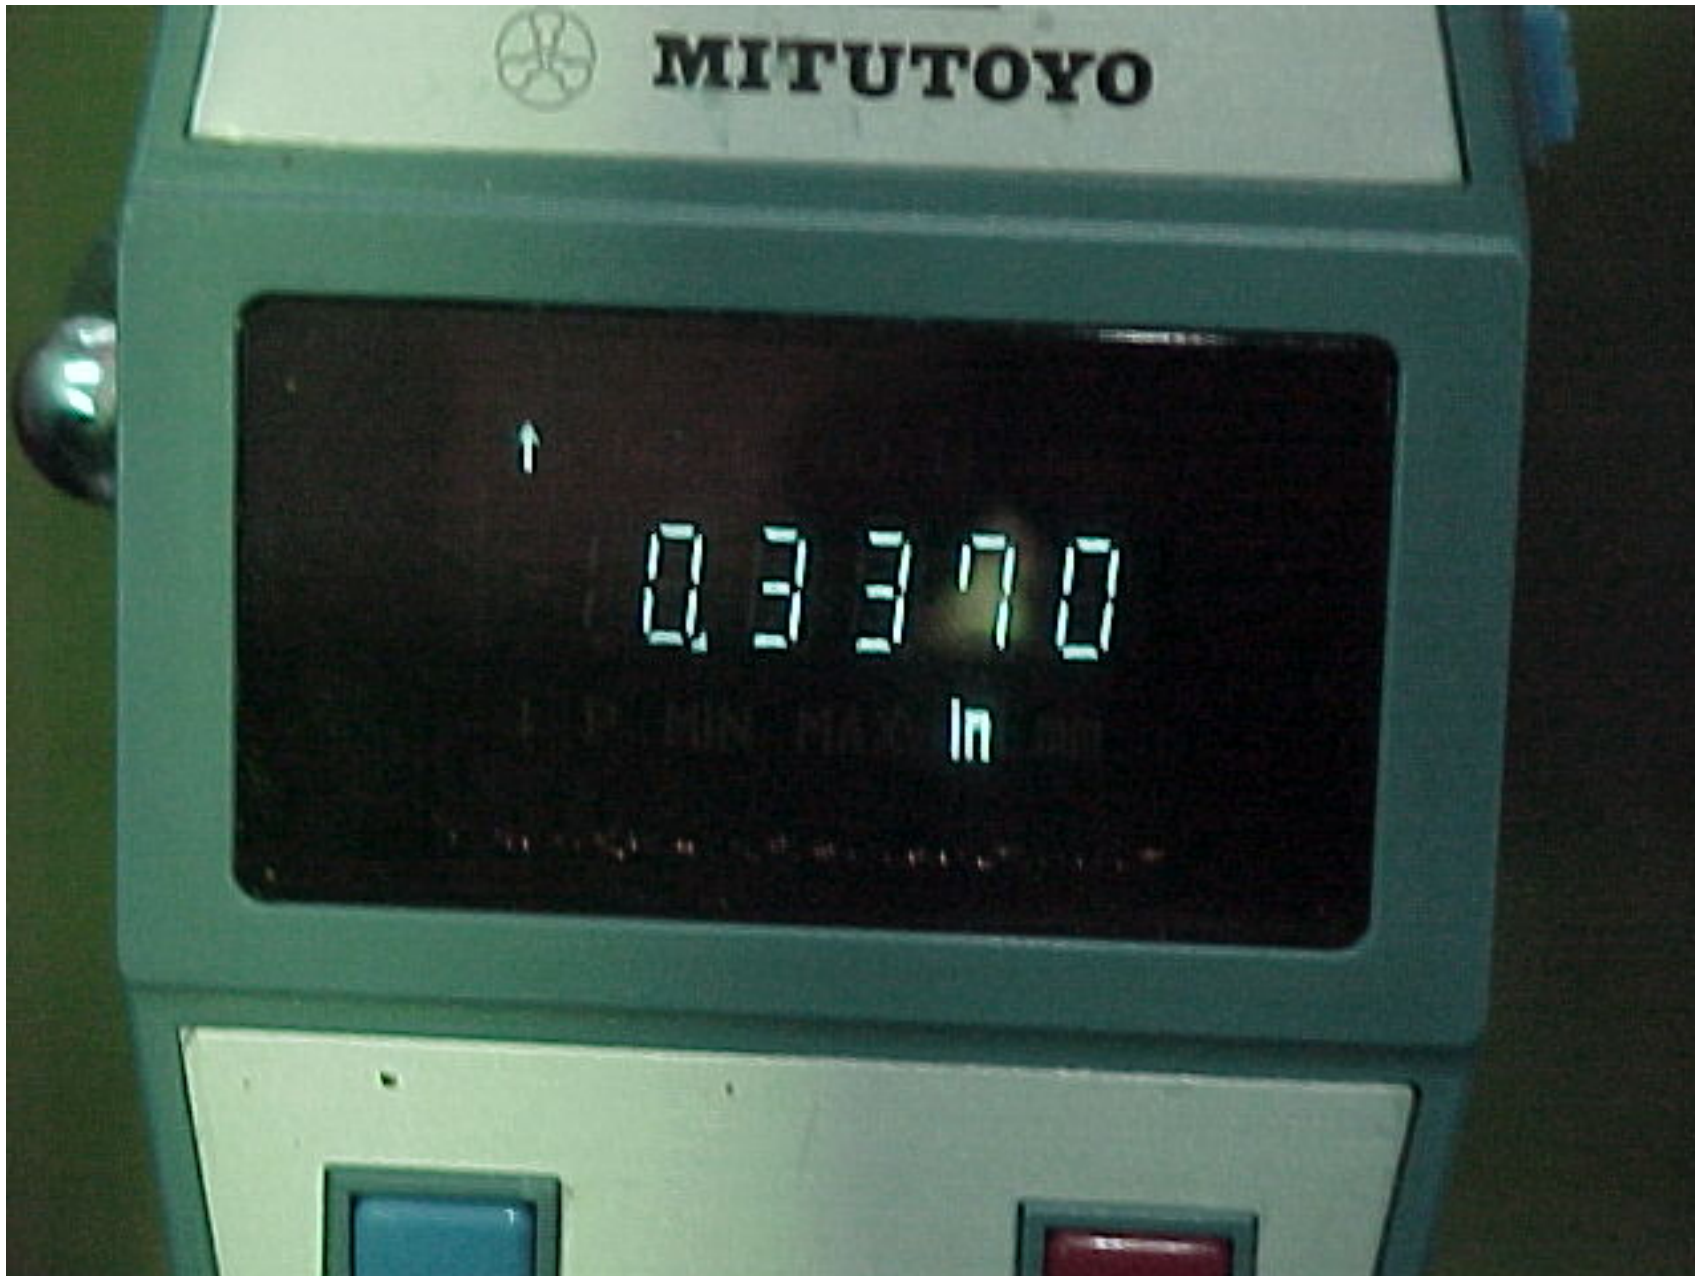
FIGURE 5.15
DIAL INDICATOR AT MAX LOAD – TEST 1

LOADING DEVICE TRAVEL	DIAL INDICATOR	INCLINOMETER
0 inches	<u>0.0000</u>	<u>0</u>
2 inches	<u>0.0230</u>	<u>0</u>
4 inches	<u>0.0890</u>	<u>0</u>
6 inches	<u>0.0990</u>	<u>0</u>
12 inches	<u>0.3250</u>	<u>0</u>
<u>12.6</u> Inches (full travel)	<u>0.3370</u>	<u>0</u>
<u>0</u> Inches (removal)	<u>0.0657</u>	<u>0</u>

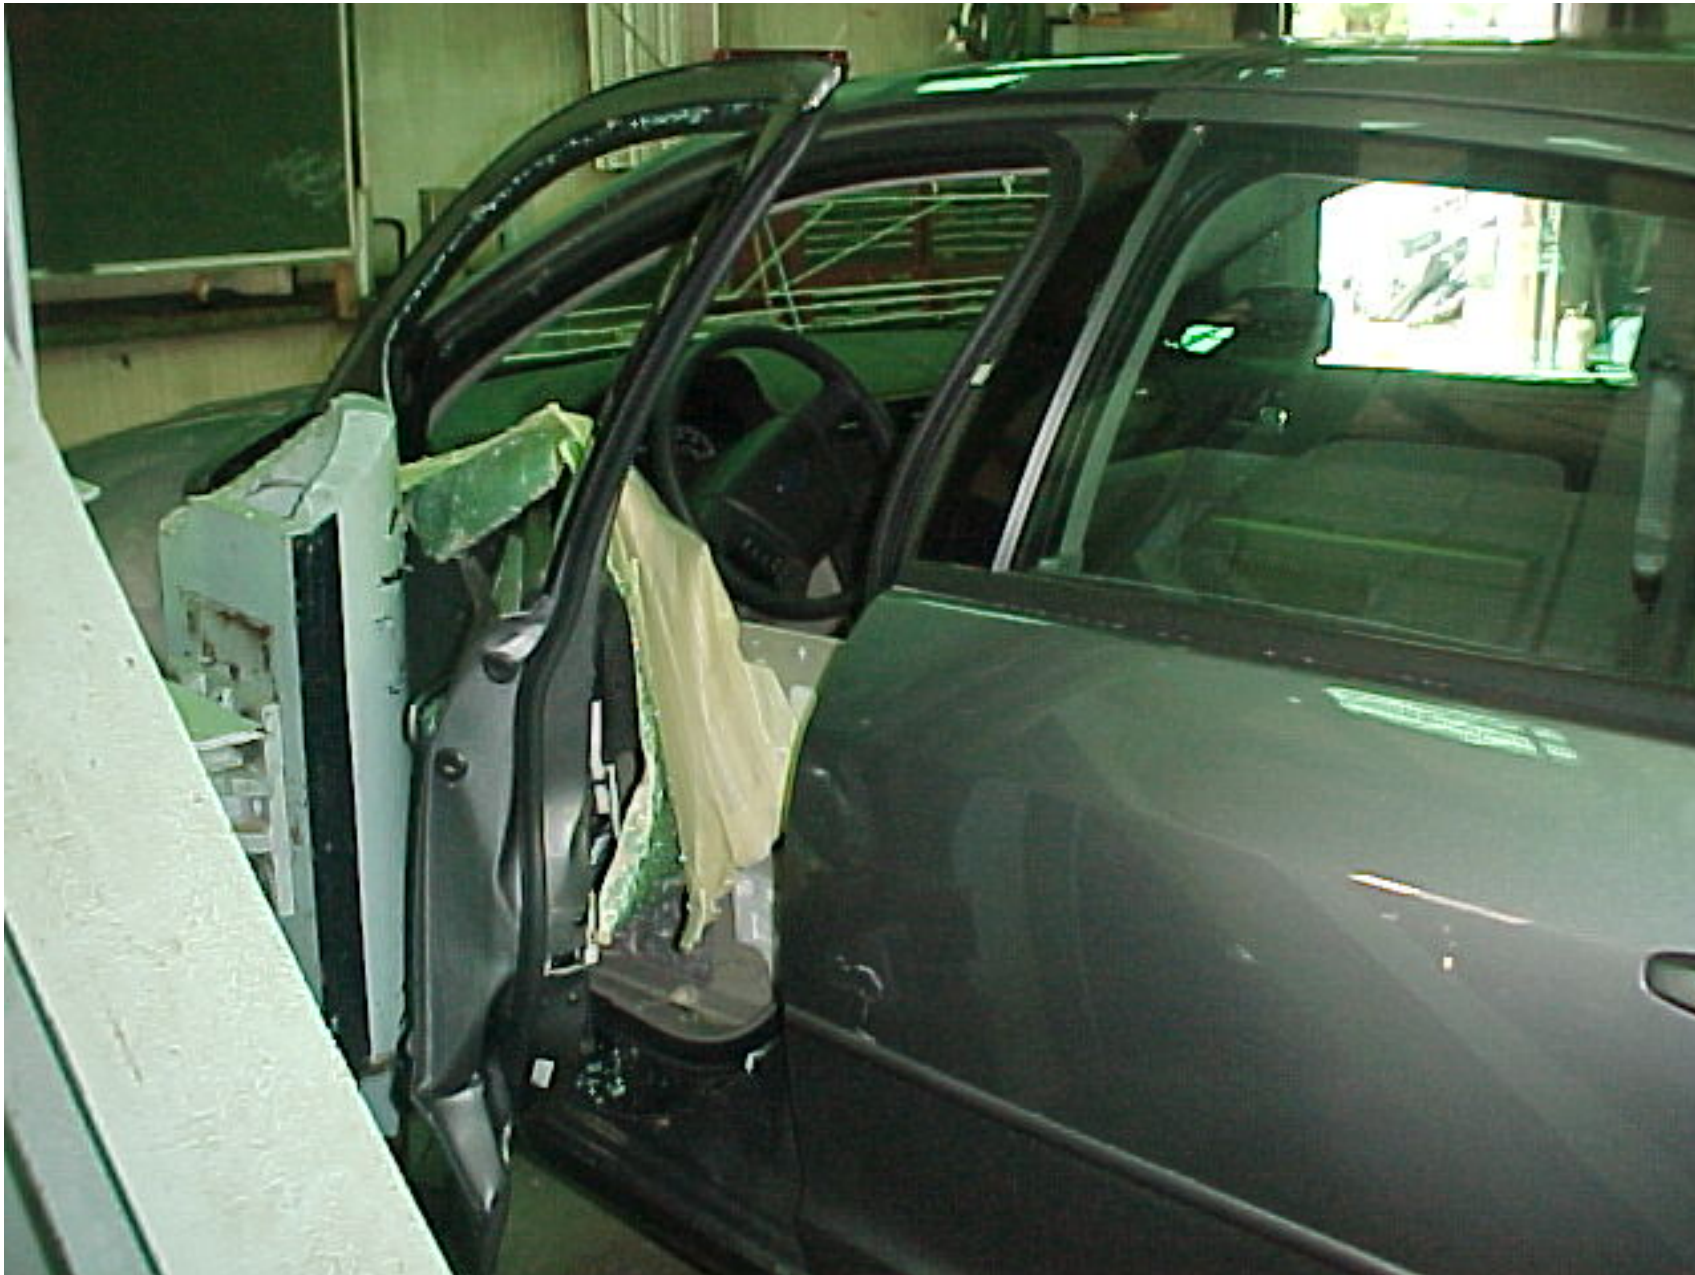
FIGURE 5.16
POST TEST DOOR OUTSIDE – TEST 1

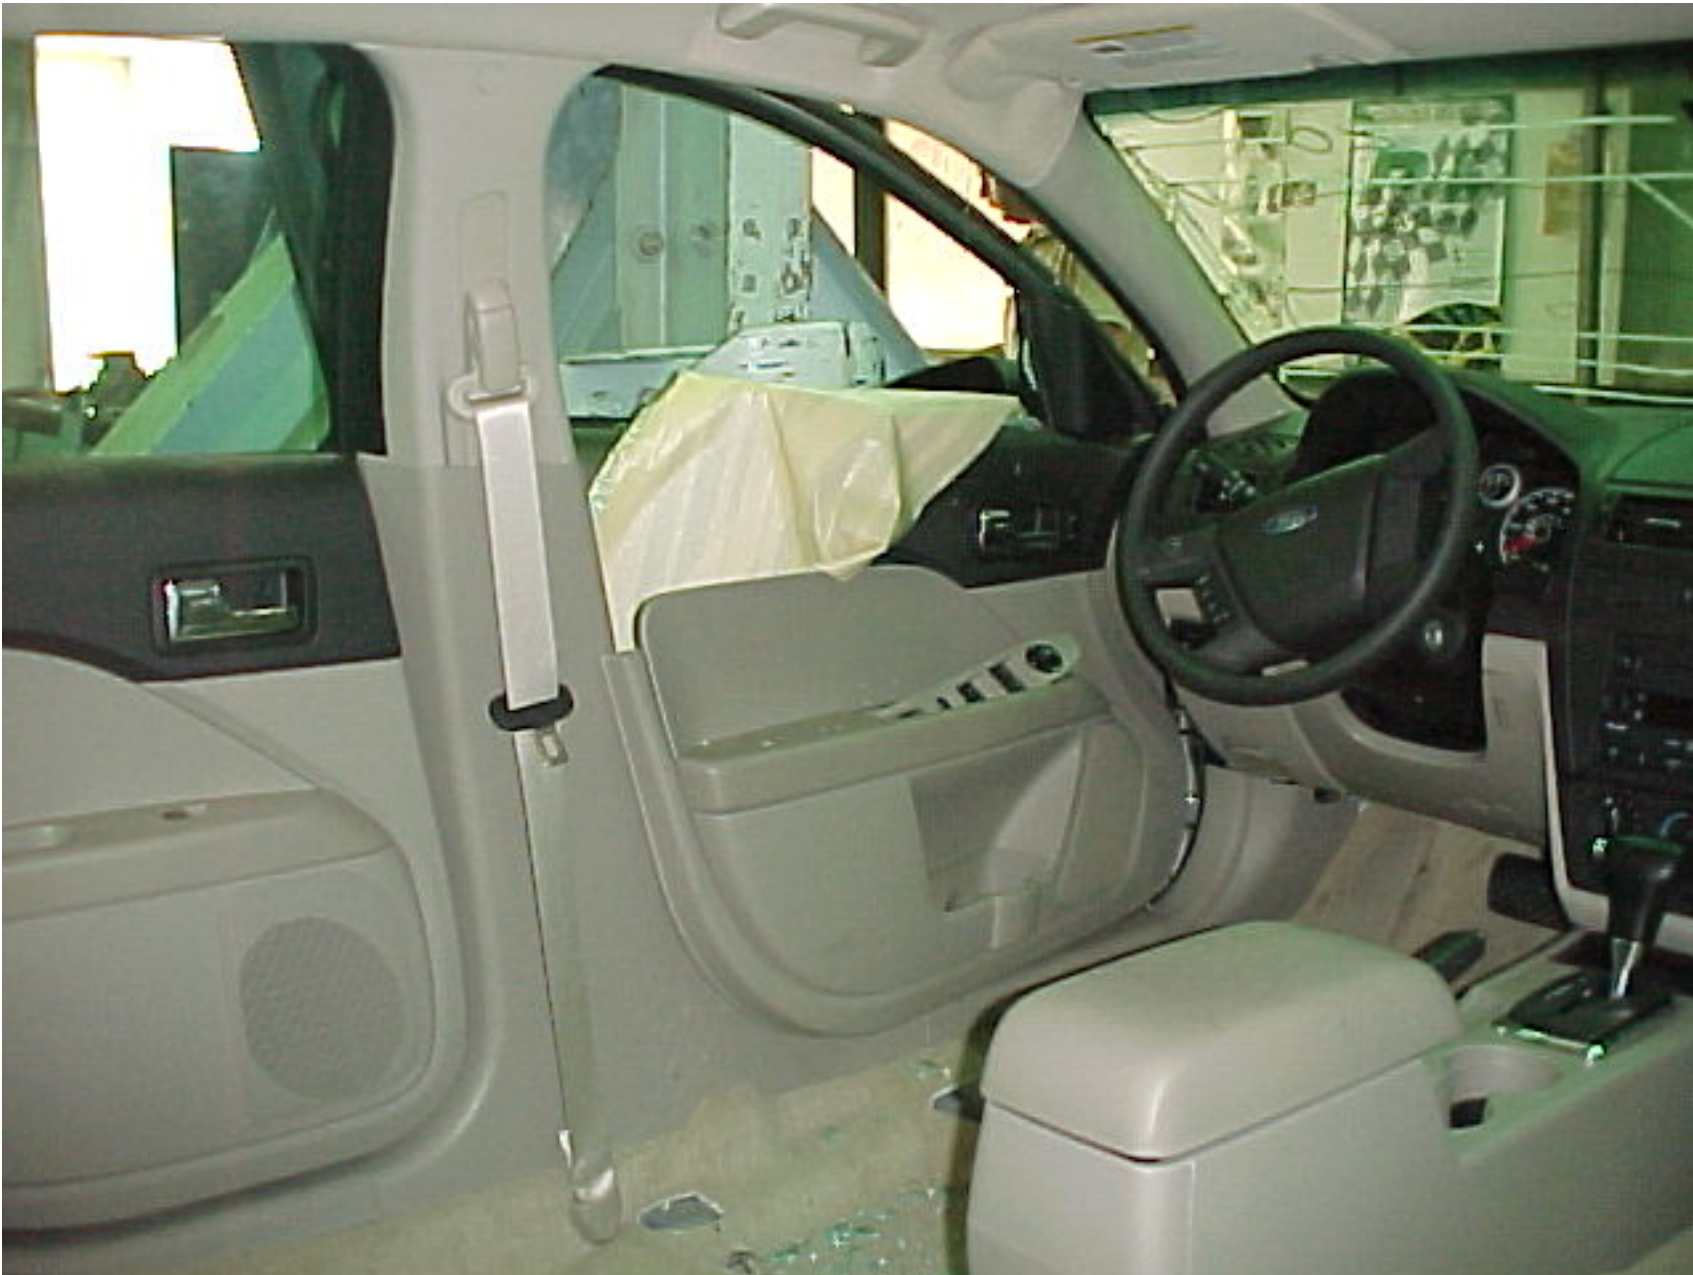
FIGURE 5.17
POST TEST DOOR INSIDE – TEST 1

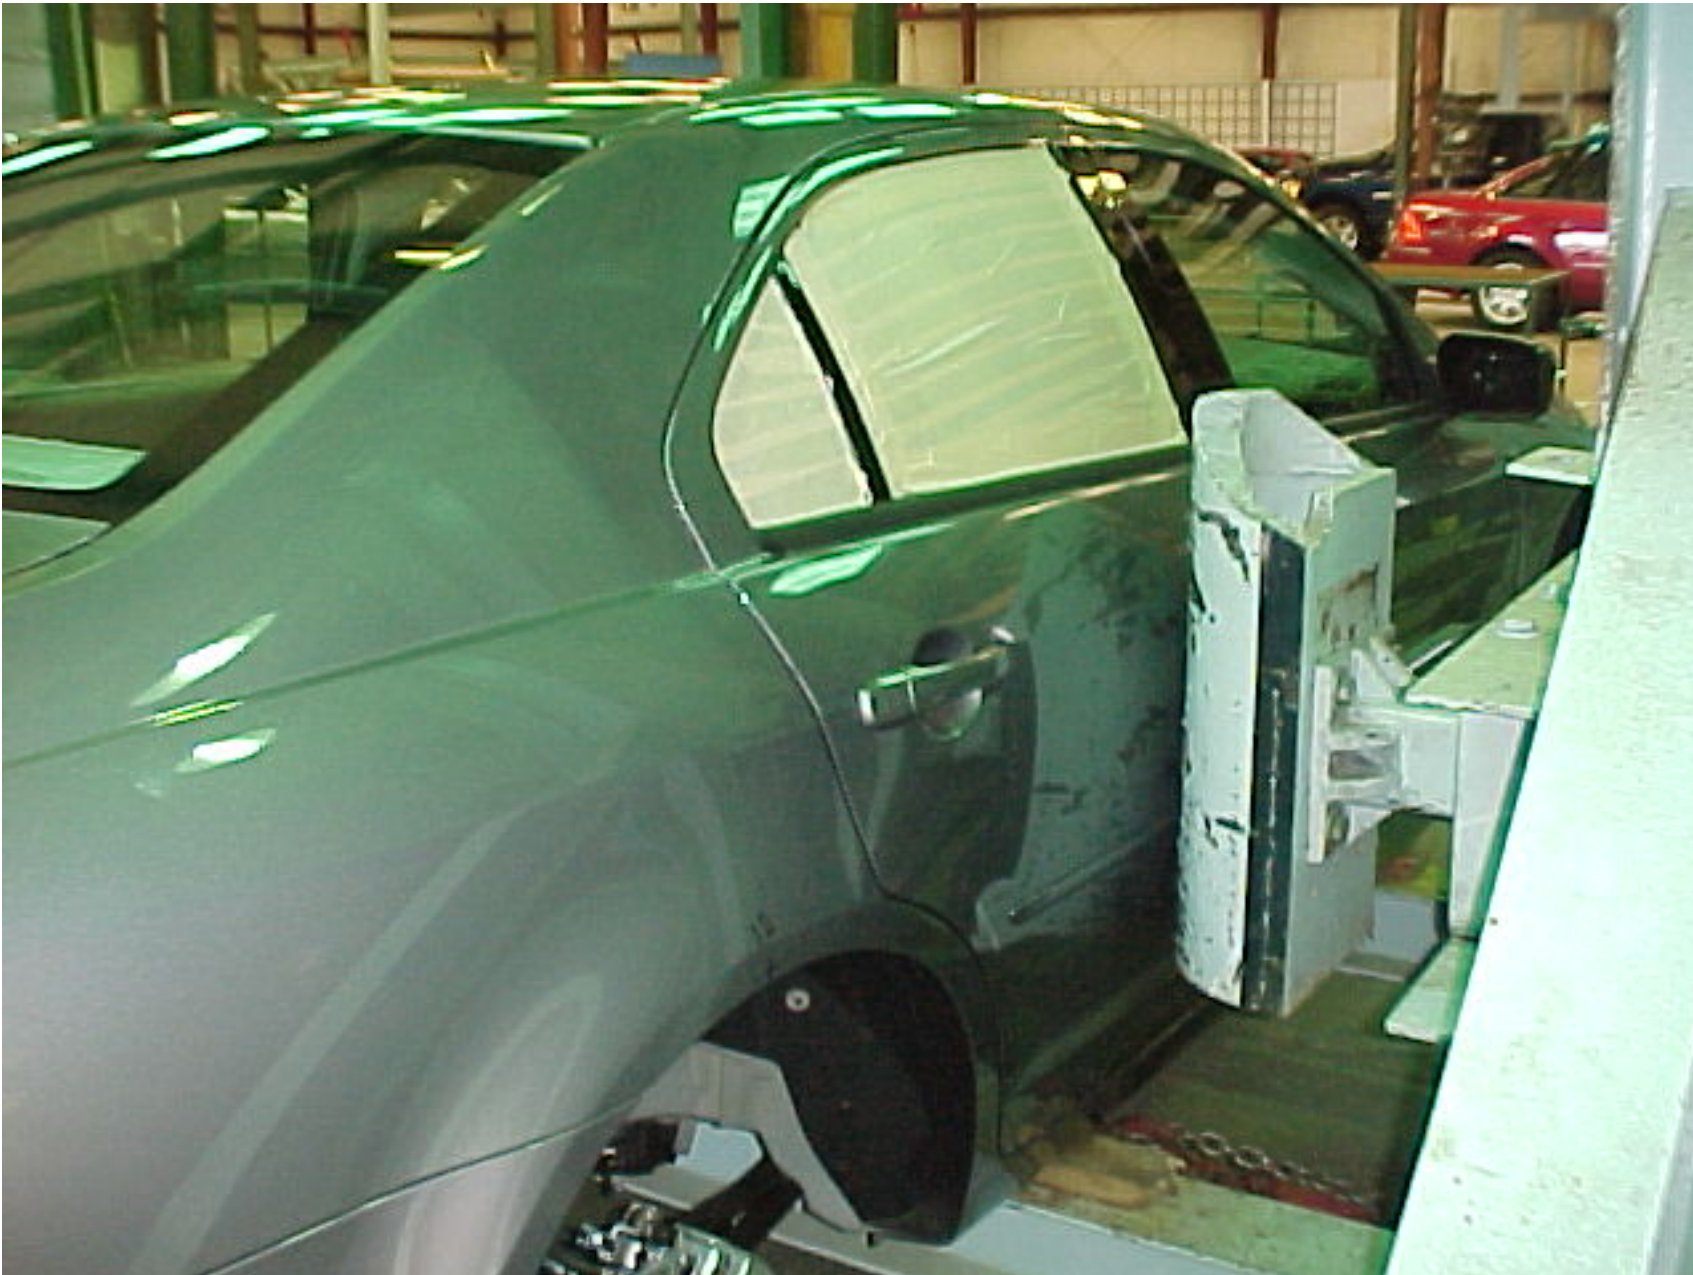
FIGURE 5.20
LOAD DEVICE AGAINST DOOR – PRE-TEST 2

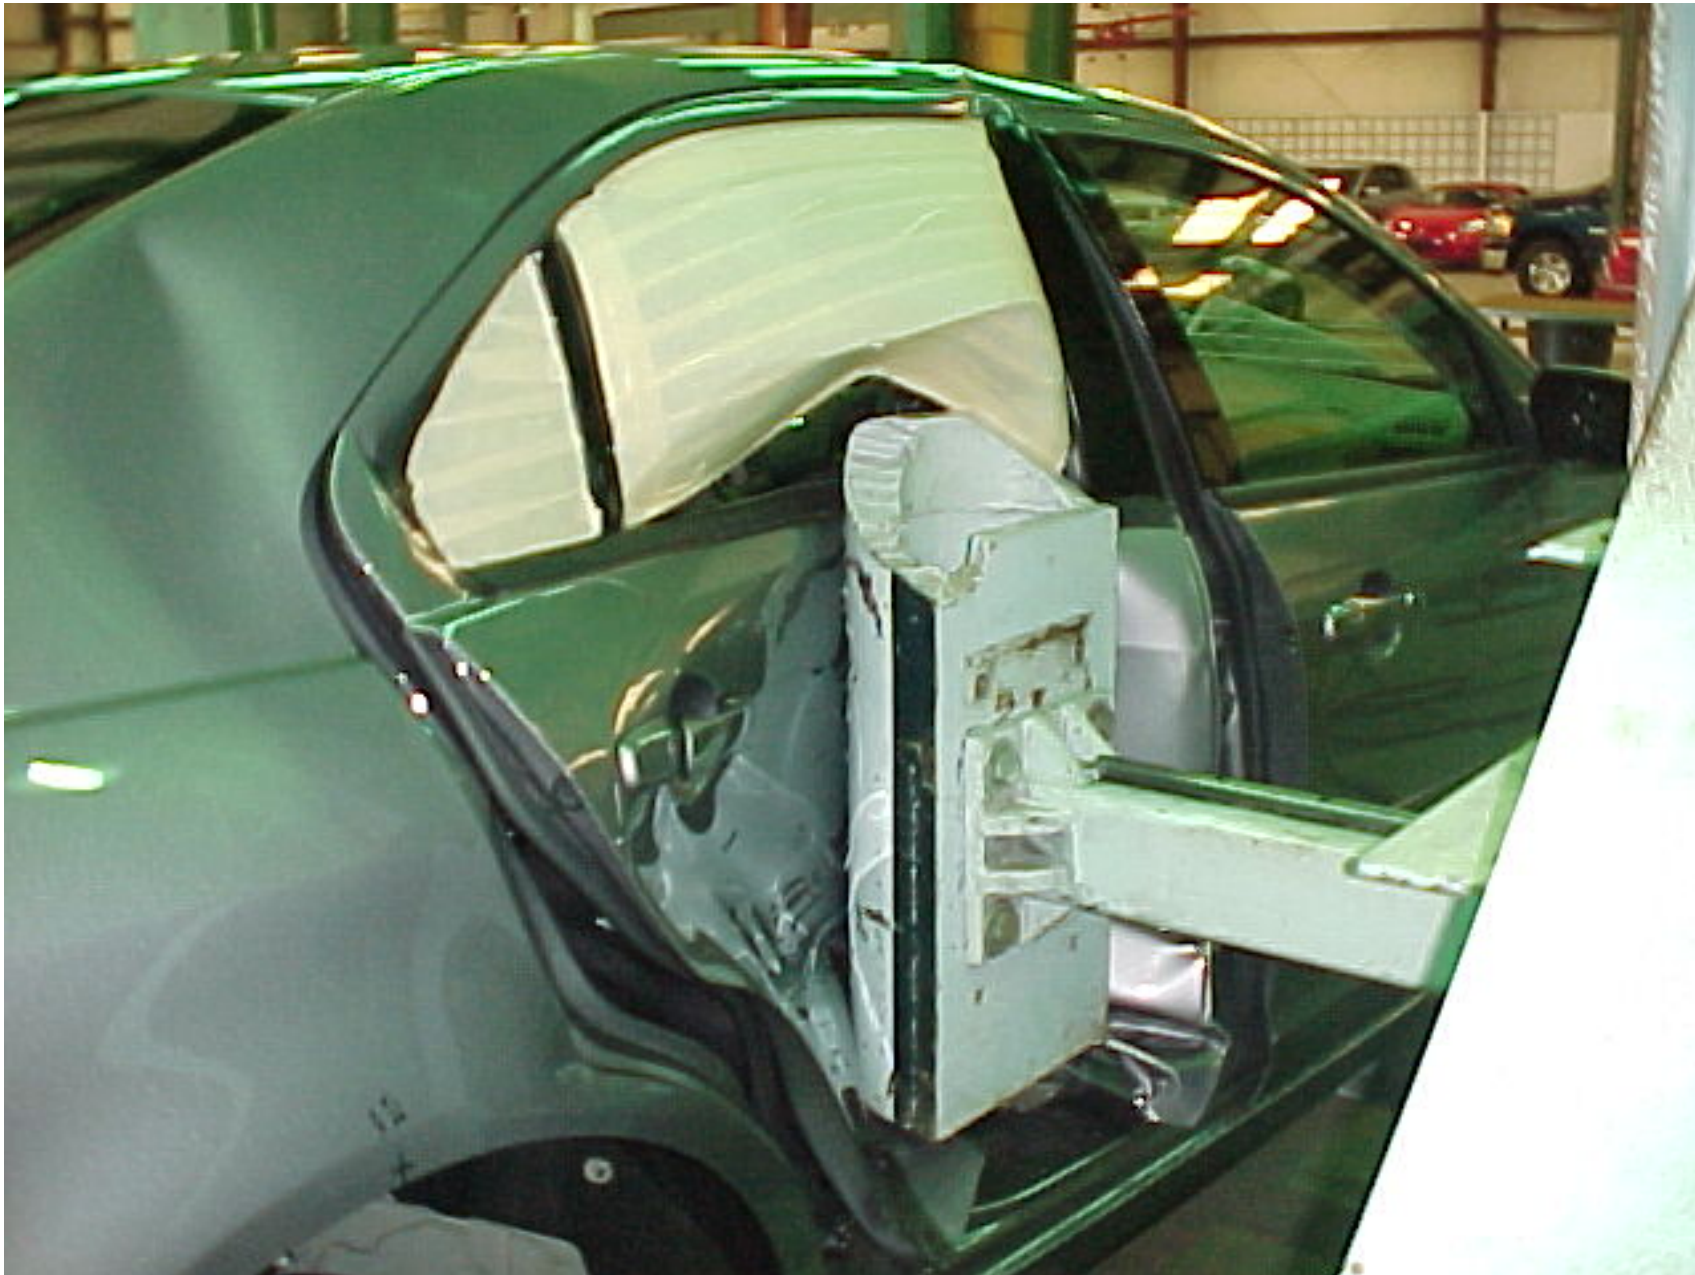
FIGURE 5.21
LOAD DEVICE AGAINST DOOR @ MAX LOAD -
TEST 2

- A. The initial crush resistance was 3194 lbs.
 B. The intermediate crush resistance was 6425 lbs.
 C. The peak crush resistance was 12,762 lbs at 11.90 inches
 D. The rate of loading was .2"/sec

- A. The initial crush resistance was 3196 lbs.
- B. The intermediate crush resistance was 6458 lbs.
- C. The peak crush resistance was 12,782 lbs at 11.80 inches

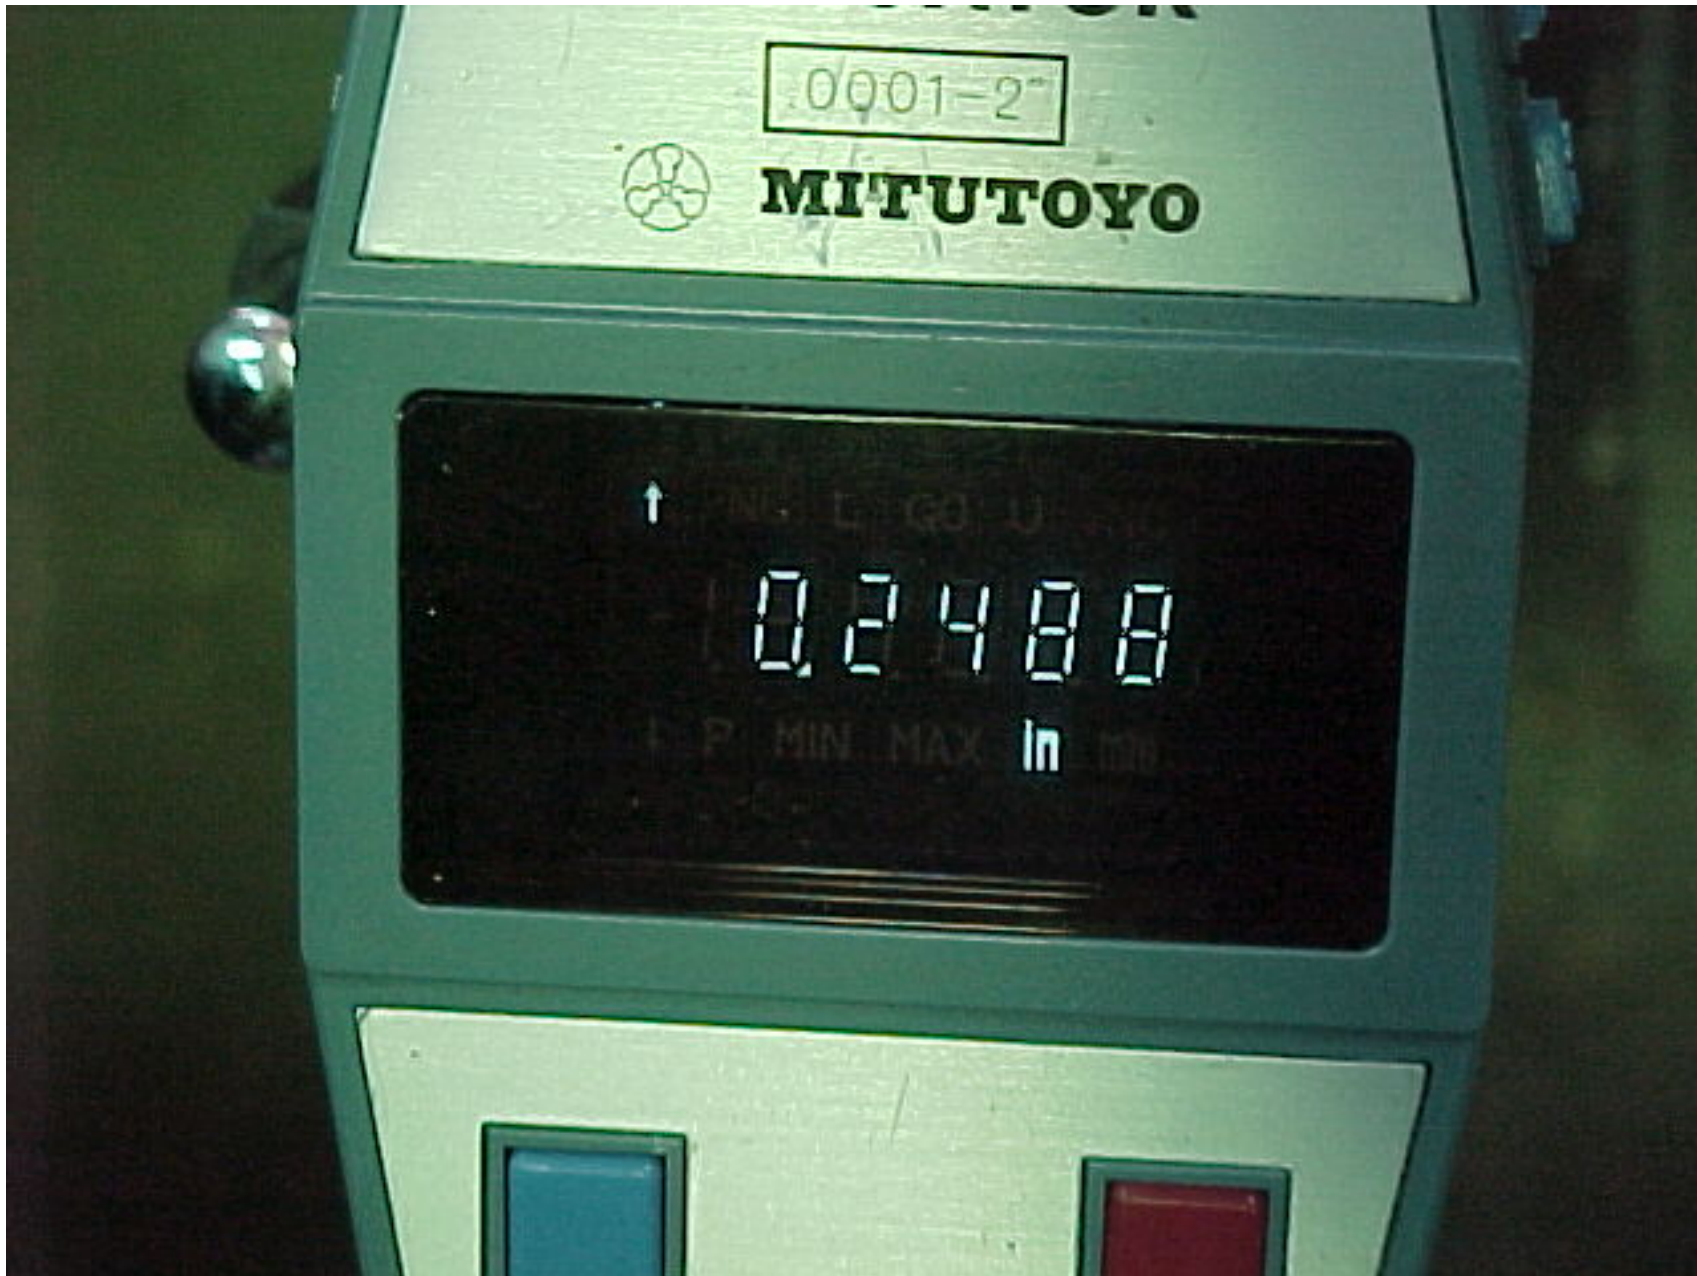
FIGURE 5.22
DIAL INDICATOR AT MAX LOAD – TEST 2

LOADING DEVICE TRAVEL	DIAL INDICATOR	INCLINOMETER
0 inches	<u>0.0000</u>	<u>0</u>
2 inches	<u>0.0015</u>	<u>0</u>
4 inches	<u>0.0030</u>	<u>0</u>
6 inches	<u>0.0052</u>	<u>0</u>
12 inches	<u>0.1910</u>	<u>0</u>
<u>12.50</u> Inches (full travel)	<u>0.2488</u>	<u>0</u>
<u>0</u> Inches (removal)	<u>0.1227</u>	<u>0</u>

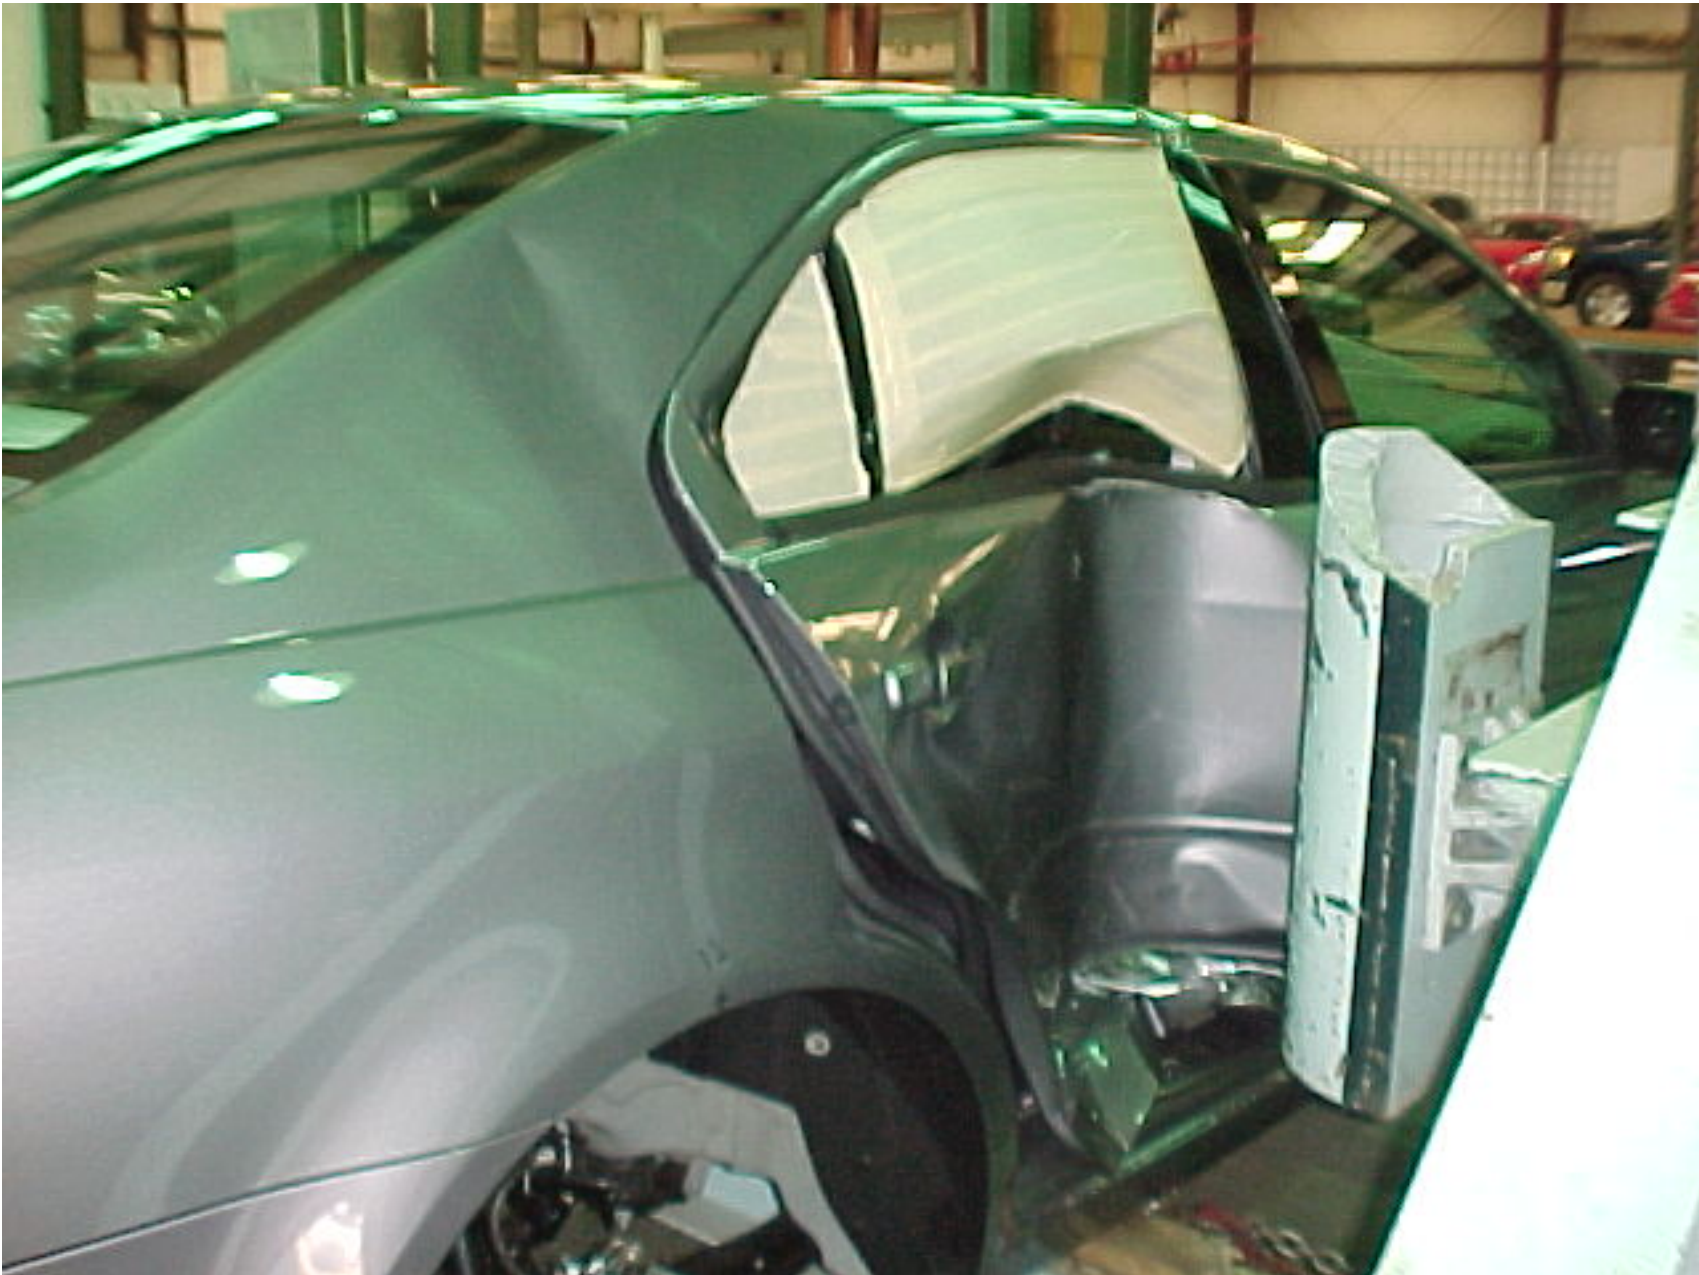
FIGURE 5.23
POST TEST DOOR OUTSIDE – TEST 2
