REPORT NUMBER 214-GTL-06-002

**SAFETY COMPLIANCE TESTING FOR
FMVSS NO. 214S
SIDE IMPACT PROTECTION (STATIC)**

**FORD MOTOR CO.
2006 FORD FUSION, PASSENGER CAR
NHTSA NO. C60202**

FINAL REPORT

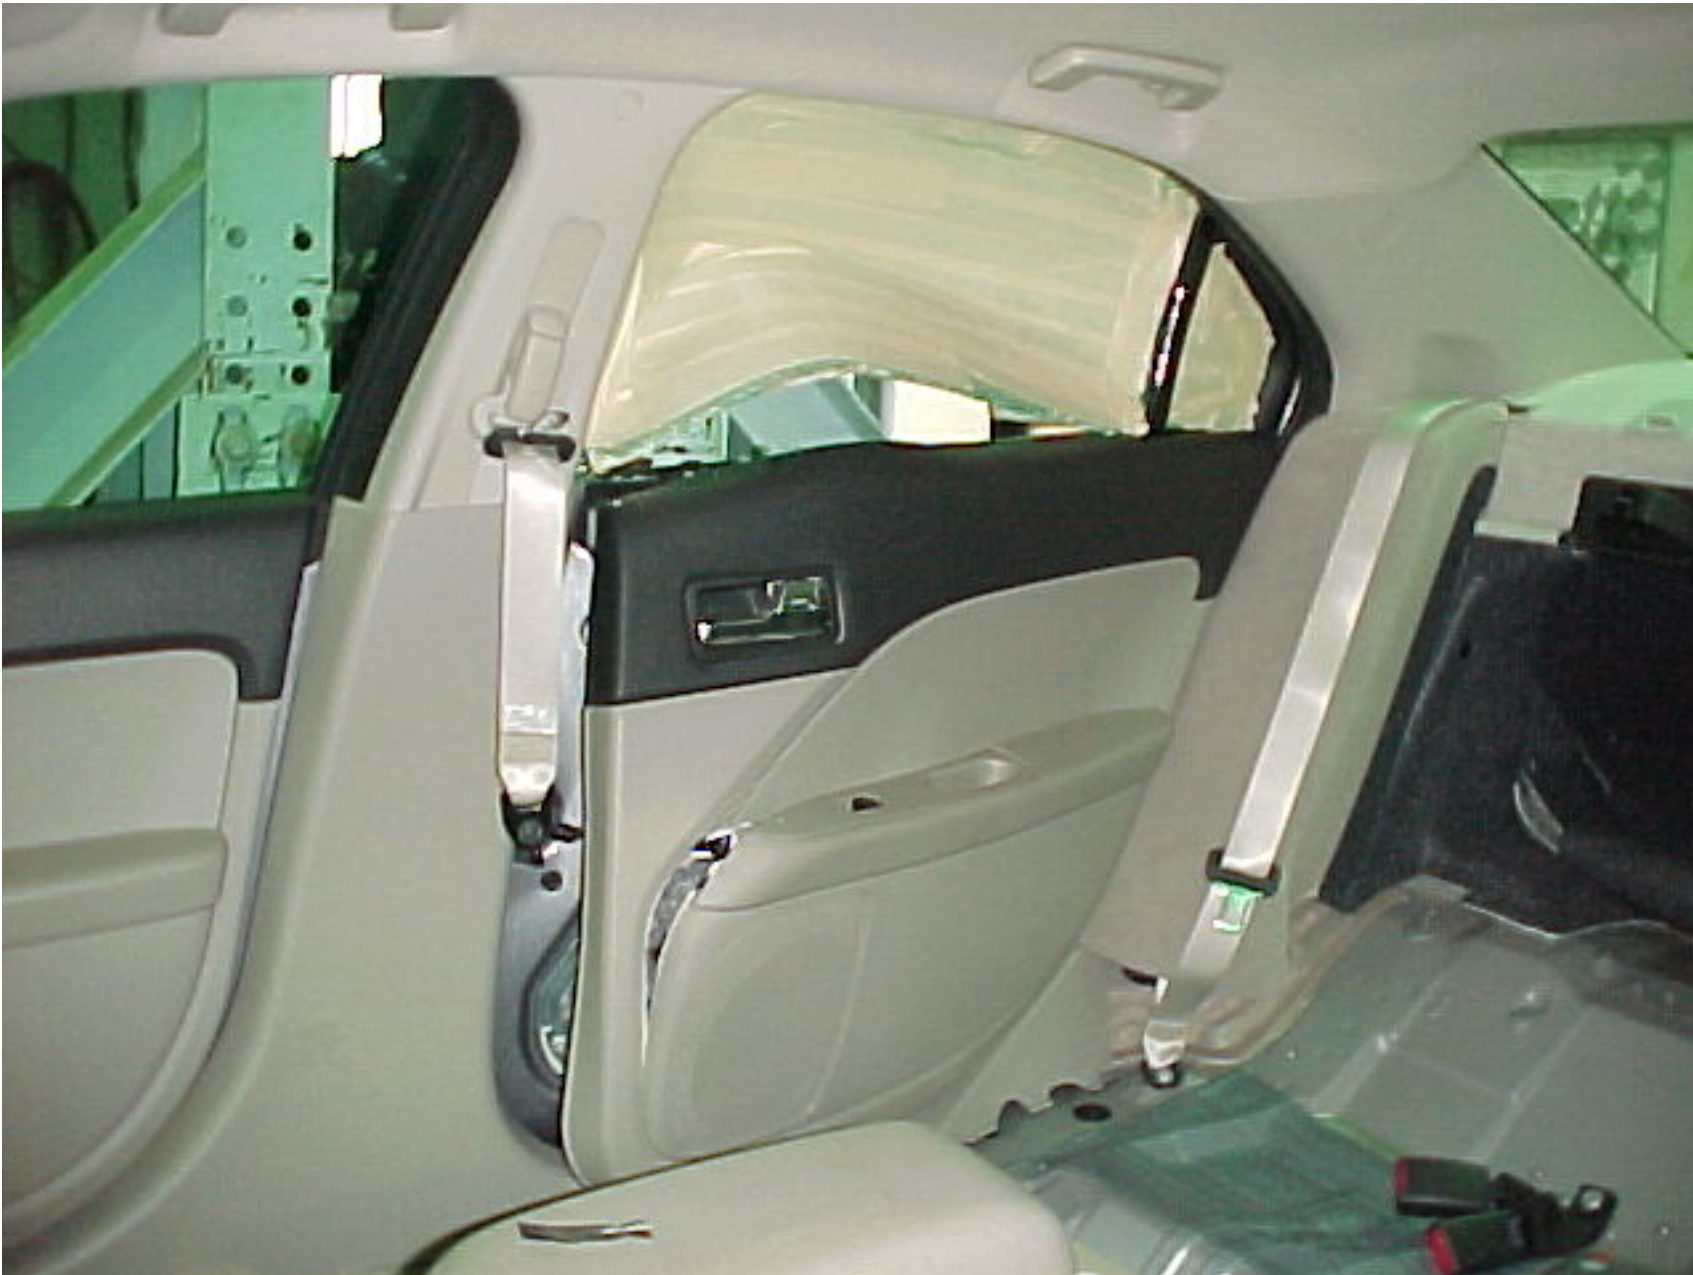
FIGURE 5.24
POST TEST DOOR INSIDE – TEST 2

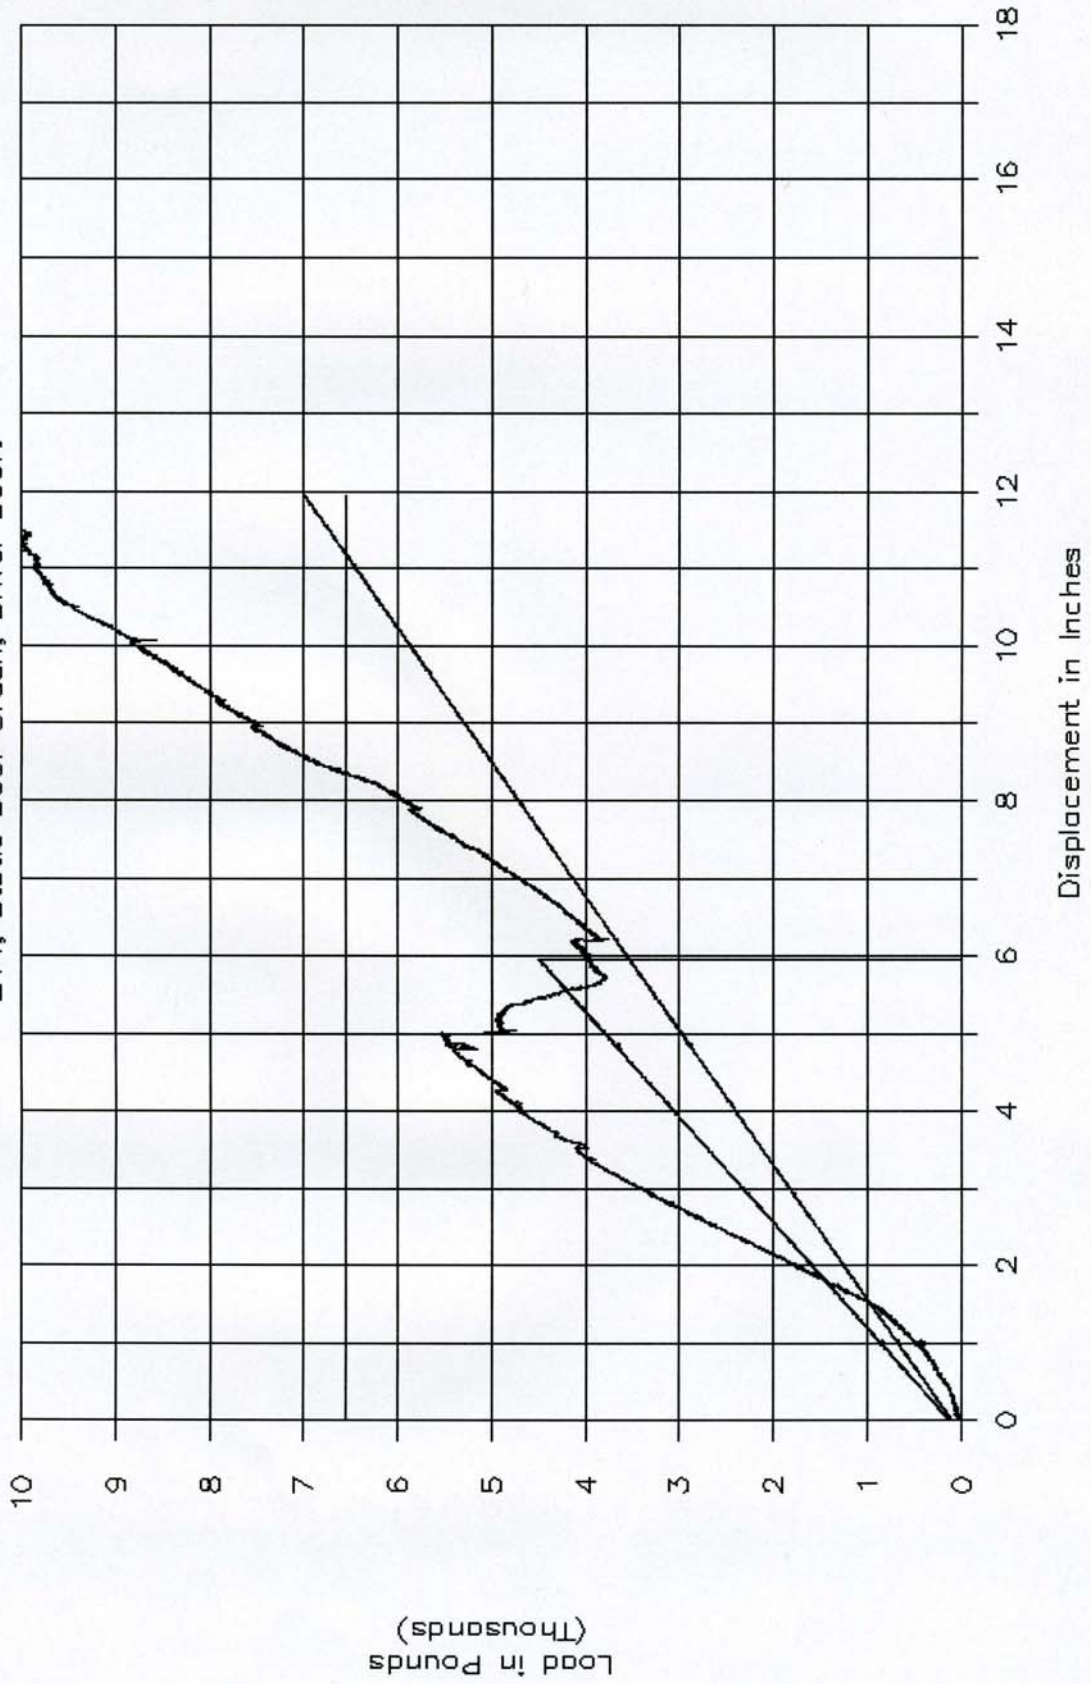
GTL 5581

214, Static Door Crush, Driver Door.

TEST #1 - GTL #5581 (LEFT FRONT DOOR)

- A. The initial crush resistance was 2899 lbs.
- B. The intermediate crush resistance was 5130 lbs.
- C. The peak crush resistance was 12,047 lbs at 12.60 inches

The rate of loading was .2"/sec

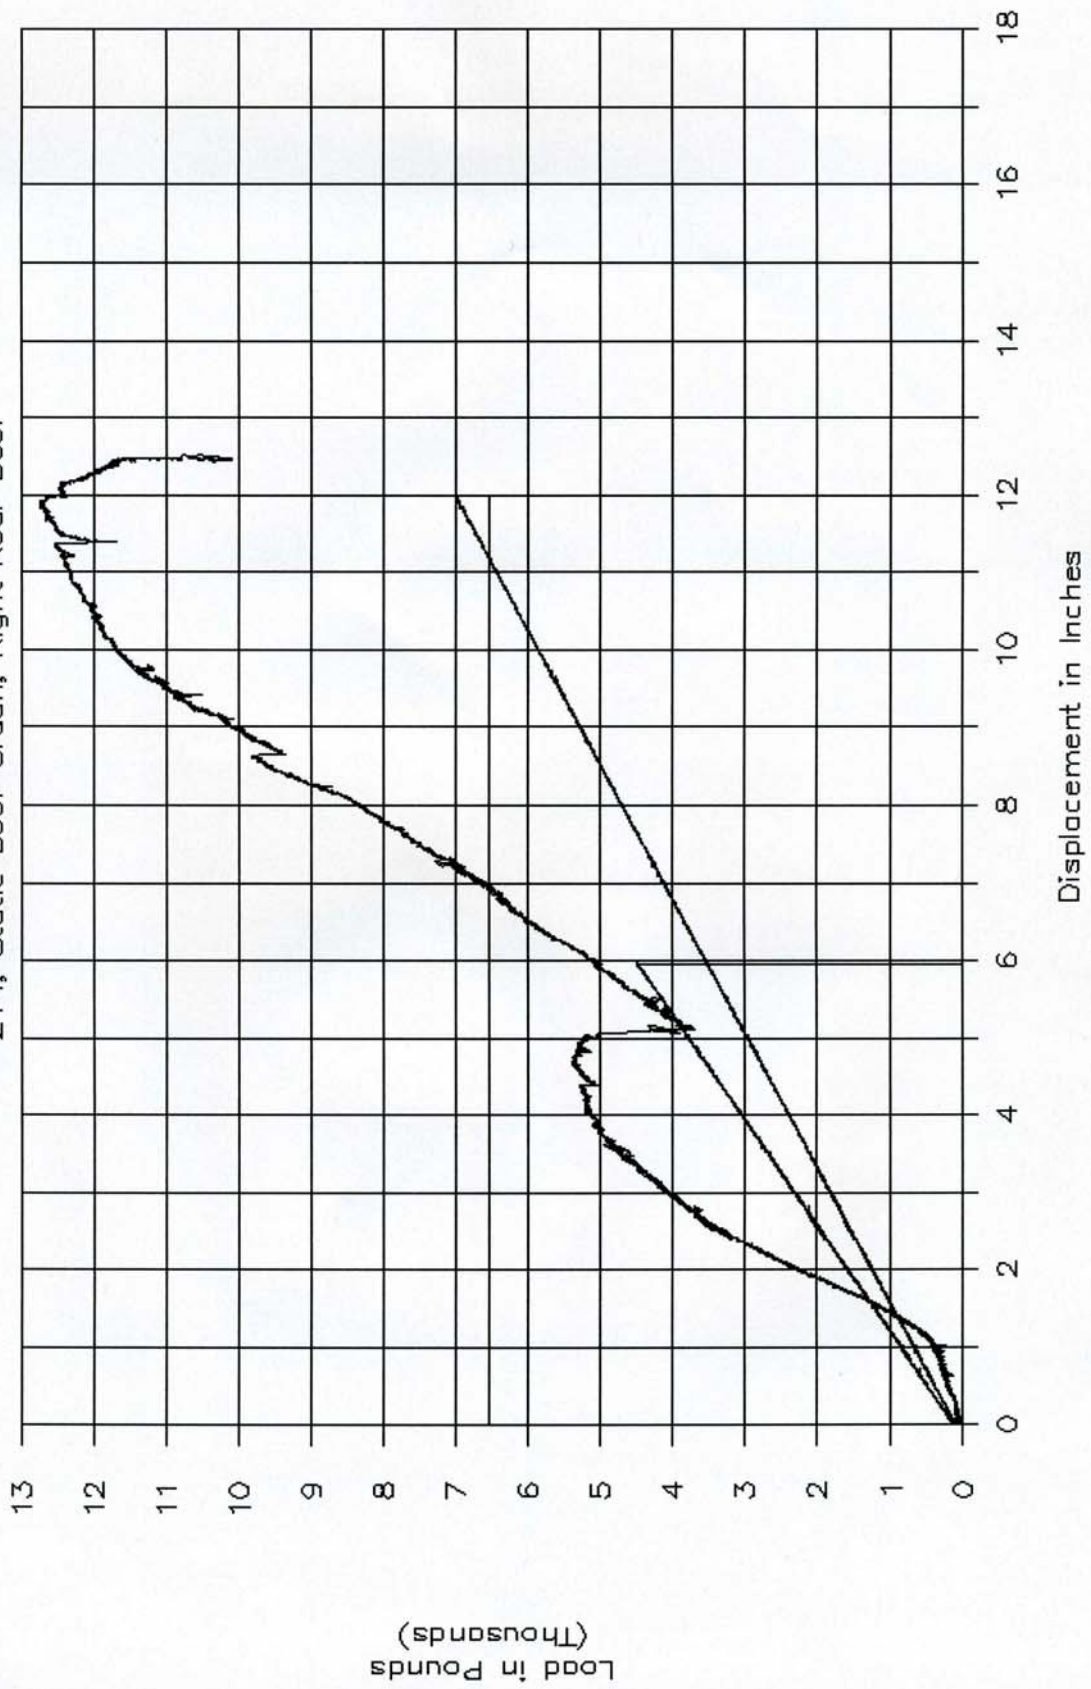
GTL 5582

214, Static Door Crush, Right Rear Door

TEST #2 - GTL #5582 (RIGHT REAR DOOR)

- A. The initial crush resistance was 3196 lbs.
- B. The intermediate crush resistance was 6458 lbs.
- C. The peak crush resistance was 12,782 lbs at 11.80 inches

The rate of loading was .2"/sec
