REPORT NUMBER: 201U-CAL-06-01

**SAFETY COMPLIANCE TESTING FOR FMVSS 201
OCCUPANT PROTECTION IN INTERIOR IMPACT
UPPER INTERIOR HEAD IMPACT PROTECTION**

**GENERAL MOTORS CORPORATION
2006 CHEVROLET COBALT, 2-DOOR, LS COUPE**

CALSPAN TEST NUMBER: 8754-FMH-08

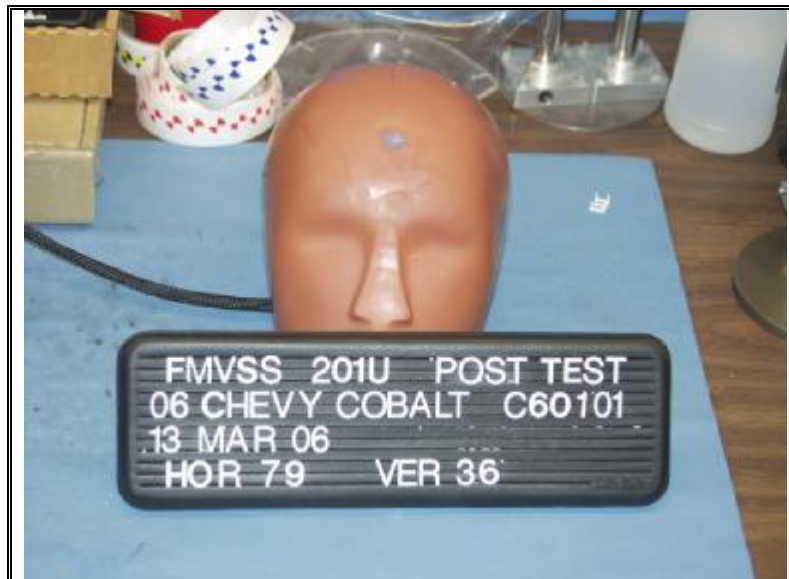
POST-IMPACT RP1 HEADFORM

Test Number:	01
Test Date:	03/13/06
Target Location:	REAR PILLAR
Target Code:	RP1
Horizontal Impact Angle:	79°
Vertical Impact Angle:	36°
Ambient Temperature:	22.1 C°
Relative Humidity:	53.8
Time of Impact:	9:49
Headform Number:	0355

Impact Point Description (from lower midpoint on midsagittal line)			
On Centerline	2	mm right	x mm left
On Centerline	30	mm up

Free Motion HIC	354.3
HIC(d)	433.7
Impact Velocity (kph)	23.56
HIC T1 (msec)	3.0
HIC T2 (msec)	10.7

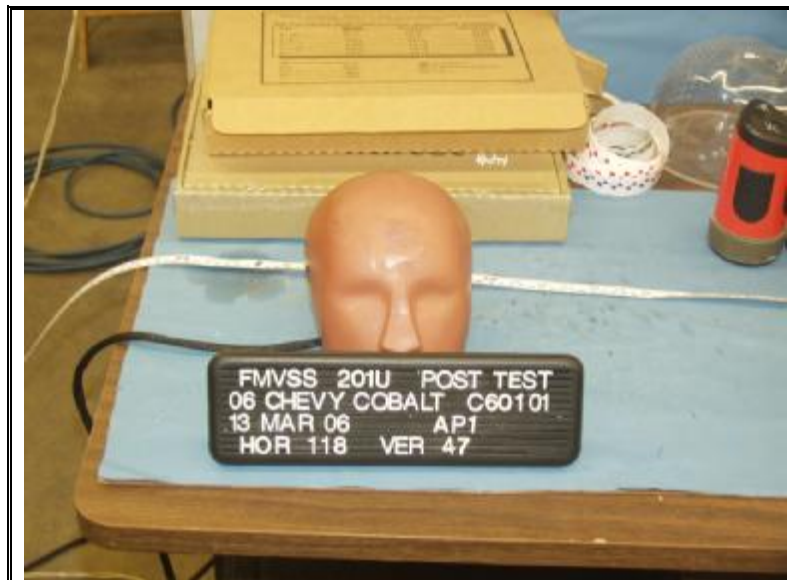
POST-IMPACT AP1 HEADFORM

Test Number:	06
Test Date:	03/13/06
Target Location:	A-PILLAR
Target Code:	AP1
Horizontal Impact Angle:	118°
Vertical Impact Angle:	47°
Ambient Temperature:	24.3 C°
Relative Humidity:	47.2
Time of Impact:	13:45
Headform Number:	0355

Impact Point Description (from lower midpoint on midsagittal line)					
On Centerline	3	x	mm right		mm left
On Centerline	24				mm up

Free Motion HIC	1162.0
HIC(d)	1043.1
Impact Velocity (kph)	23.49
HIC T1 (msec)	5.6
HIC T2 (msec)	9.3

1. <i>Report No.</i> 201U-CAL-06-01		2. <i>Government Accession No.</i>		3. <i>Recipient's Catalog No.</i>																			
4. <i>Title and Subtitle</i> Final Report of FMVSS 201 Compliance Testing of a 2006 Chevrolet Cobalt, 2-door, LS Coupe NHTSA No. C60101				5. <i>Report Date</i> March 14, 2006																			
				6. <i>Performing Organization Code</i> CAL																			
7. <i>Author(s)</i> David J. Travale, Program Manager James Czarnecki, Project Engineer				8. <i>Performing Organization Report No.</i> 8754-FMH-08																			
9. <i>Performing Organization Name and Address</i> Calspan 4455 Genesee Street Buffalo, New York 14225				10. <i>Work Unit No.</i>																			
				11. <i>Contract or Grant No.</i> DTNH22-04-C-01027																			
12. <i>Sponsoring Agency Name and Address</i> U.S. Department of Transportation National Highway Traffic Safety Administration Office of Vehicle Safety Compliance Mail Code: NVS-220 400 Seventh, SW, Room 6111 Washington, D.C. 20590				13. <i>Type of Report and Period Covered</i> Final Report March 2006																			
				14. <i>Sponsoring Agency Code</i> NVS-220																			
15. <i>Supplementary Notes</i>																							
16. <i>Abstract</i> Compliance tests were conducted on the subject vehicle, a 2006 Chevrolet Cobalt, 2-door, LS Coupe, in accordance with the specifications of the Office of Vehicle Safety Compliance Test Procedure TP-201U-01 for determination of FMVSS 201 compliance. Test failures identified were as follows in the table below:

<table><tr> <th>Target Point</th> <th>Horizontal</th> <th>Vertical</th> <th>Velocity</th> <th>HIC</th> <th>HICd</th> </tr><tr> <td>API</td> <td>118°</td> <td>47°</td> <td>23.49</td> <td>1162.0</td> <td>1043.1</td> </tr></table>

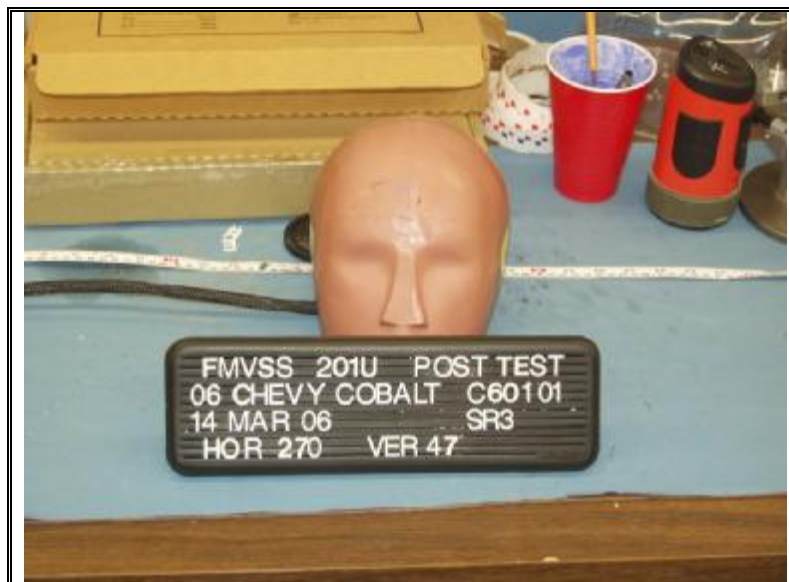
POST-IMPACT SR3 HEADFORM

Test Number:	08
Test Date:	03/14/06
Target Location:	SIDE RAIL
Target Code:	SR3
Horizontal Impact Angle:	270°
Vertical Impact Angle:	47°
Ambient Temperature:	21.3 C°
Relative Humidity:	25.8
Time of Impact:	9:10
Headform Number:	0805

Impact Point Description (from lower midpoint on midsagittal line)				
On Centerline	4	x	mm right	mm left
On Centerline	18		mm up

Free Motion HIC	615.3
HIC(d)	630.6
Impact Velocity (kph)	23.4
HIC T1 (msec)	4.8
HIC T2 (msec)	12.5

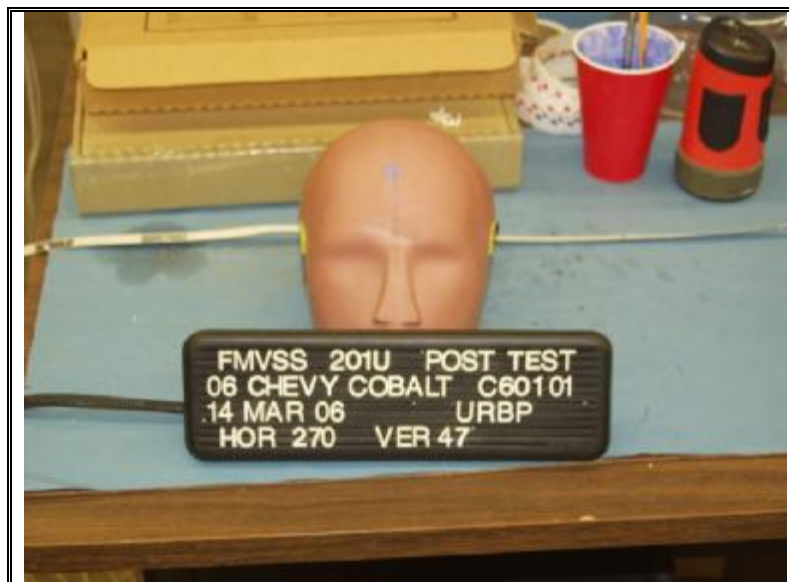
POST-IMPACT URBP HEADFORM

Test Number:	09
Test Date:	03/14/06
Target Location:	UPPER ROOF
Target Code:	URBP
Horizontal Impact Angle:	270°
Vertical Impact Angle:	47°
Ambient Temperature:	21.6 C°
Relative Humidity:	25.5
Time of Impact:	9:35
Headform Number:	1255

Impact Point Description (from lower midpoint on midsagittal line)					
On Centerline	2	x	mm right		mm left
On Centerline	36				mm up

Free Motion HIC	646.9
HIC(d)	654.5
Impact Velocity (kph)	23.42
HIC T1 (msec)	4.9
HIC T2 (msec)	12.1

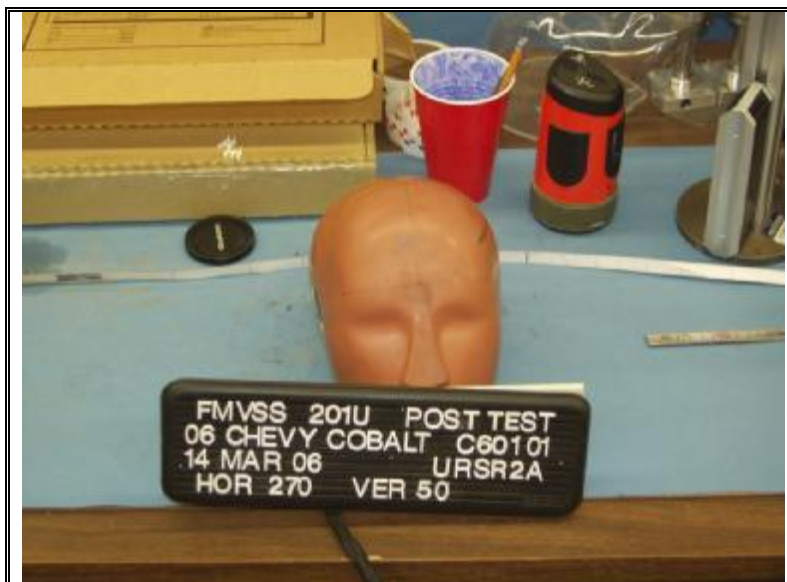
POST-IMPACT URSR2A HEADFORM

Test Number:	10
Test Date:	03/14/06
Target Location:	UPPER ROOF
Target Code:	URSR2A
Horizontal Impact Angle:	270°
Vertical Impact Angle:	50°
Ambient Temperature:	21.5 C°
Relative Humidity:	25.9
Time of Impact:	10:00
Headform Number:	0062

Impact Point Description (from lower midpoint on midsagittal line)					
On Centerline	4	x	mm right		mm left
On Centerline	32				mm up

Free Motion HIC	506.8
HIC(d)	548.8
Impact Velocity (kph)	23.48
HIC T1 (msec)	3.9
HIC T2 (msec)	14.3

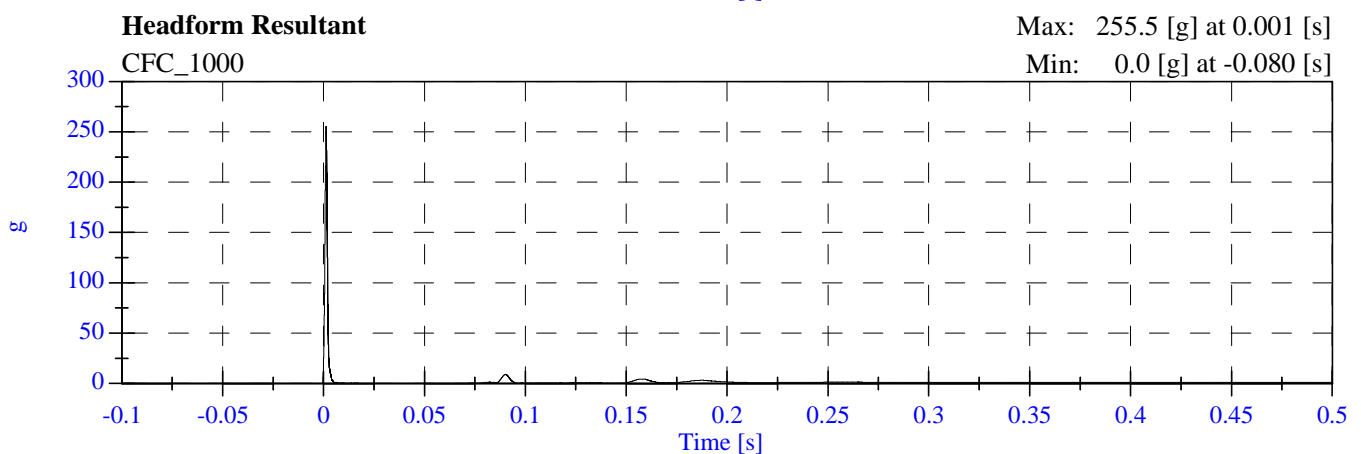
0355 - March 14, 2006

MANUFACTURER:		DENTON ATD INC.	
SERIAL NUMBER:		0355	
CALIBRATION DATE:		March 14, 2006	
TEST PARAMETER	SPECIFICATION	TEST RESULTS	
TEMPERATURE	19°C to 26°C	21.1	
RELATIVE HUMIDITY	10% to 70%	22	
PEAK RESULTANT ACCELERATION	225 Gs to 275 Gs	255.5	
PEAK LATERAL ACCELERATION	15 Gs Maximum	9.7	
IS ACCELERATION CURVE UNIMODAL?	YES	YES

FMVSS 201U - Headform Calibration Drops
