REPORT NUMBER 138-STF-06-004

# SAFETY COMPLIANCE TESTING FOR FMVSS NO. 138 TIRE PRESSURE MONITORING SYSTEMS

NISSAN MOTOR COMPANY, LTD.  
2006 NISSAN PATHFINDER LE  
4X2 FOUR-DOOR MPV  
NHTSA NO. C65200

FINAL REPORT

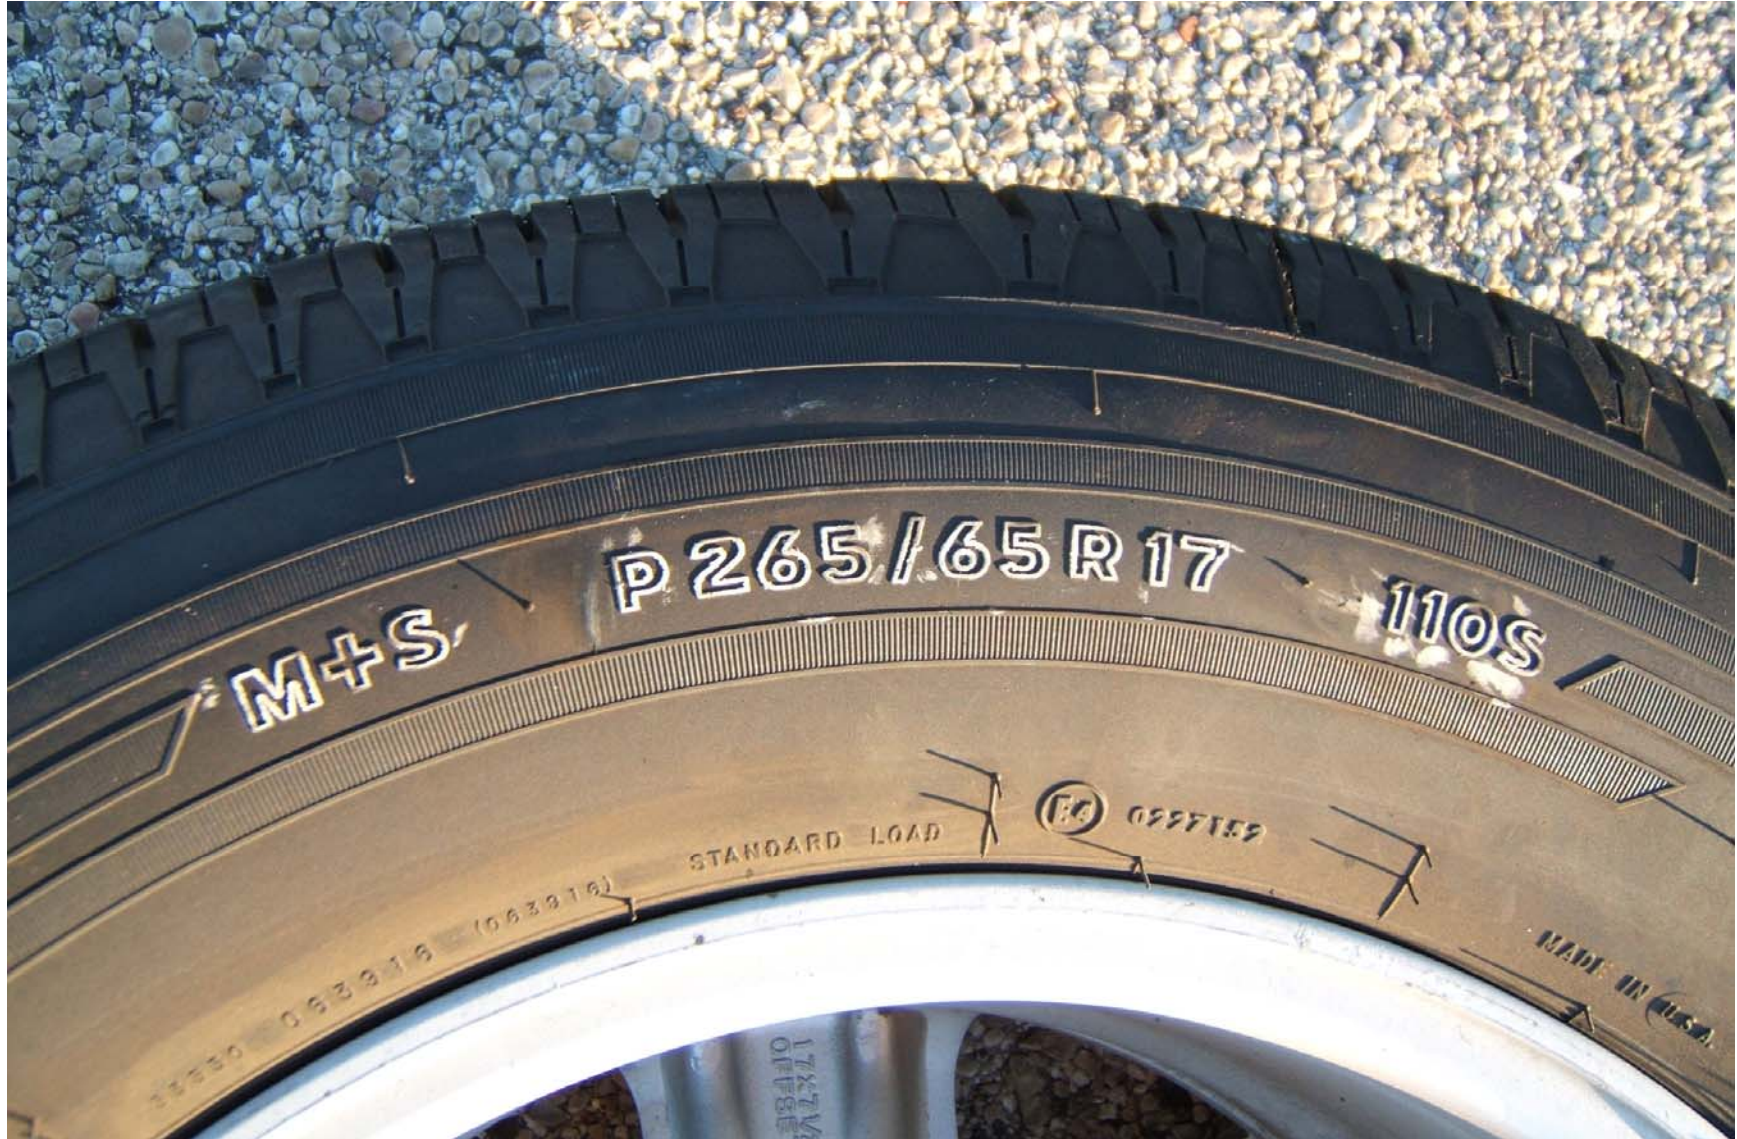
FIGURE 5.6  
TIRE SHOWING SIZE

Tire Size (ex. P225/65R15 89H): P265/65R17 110S

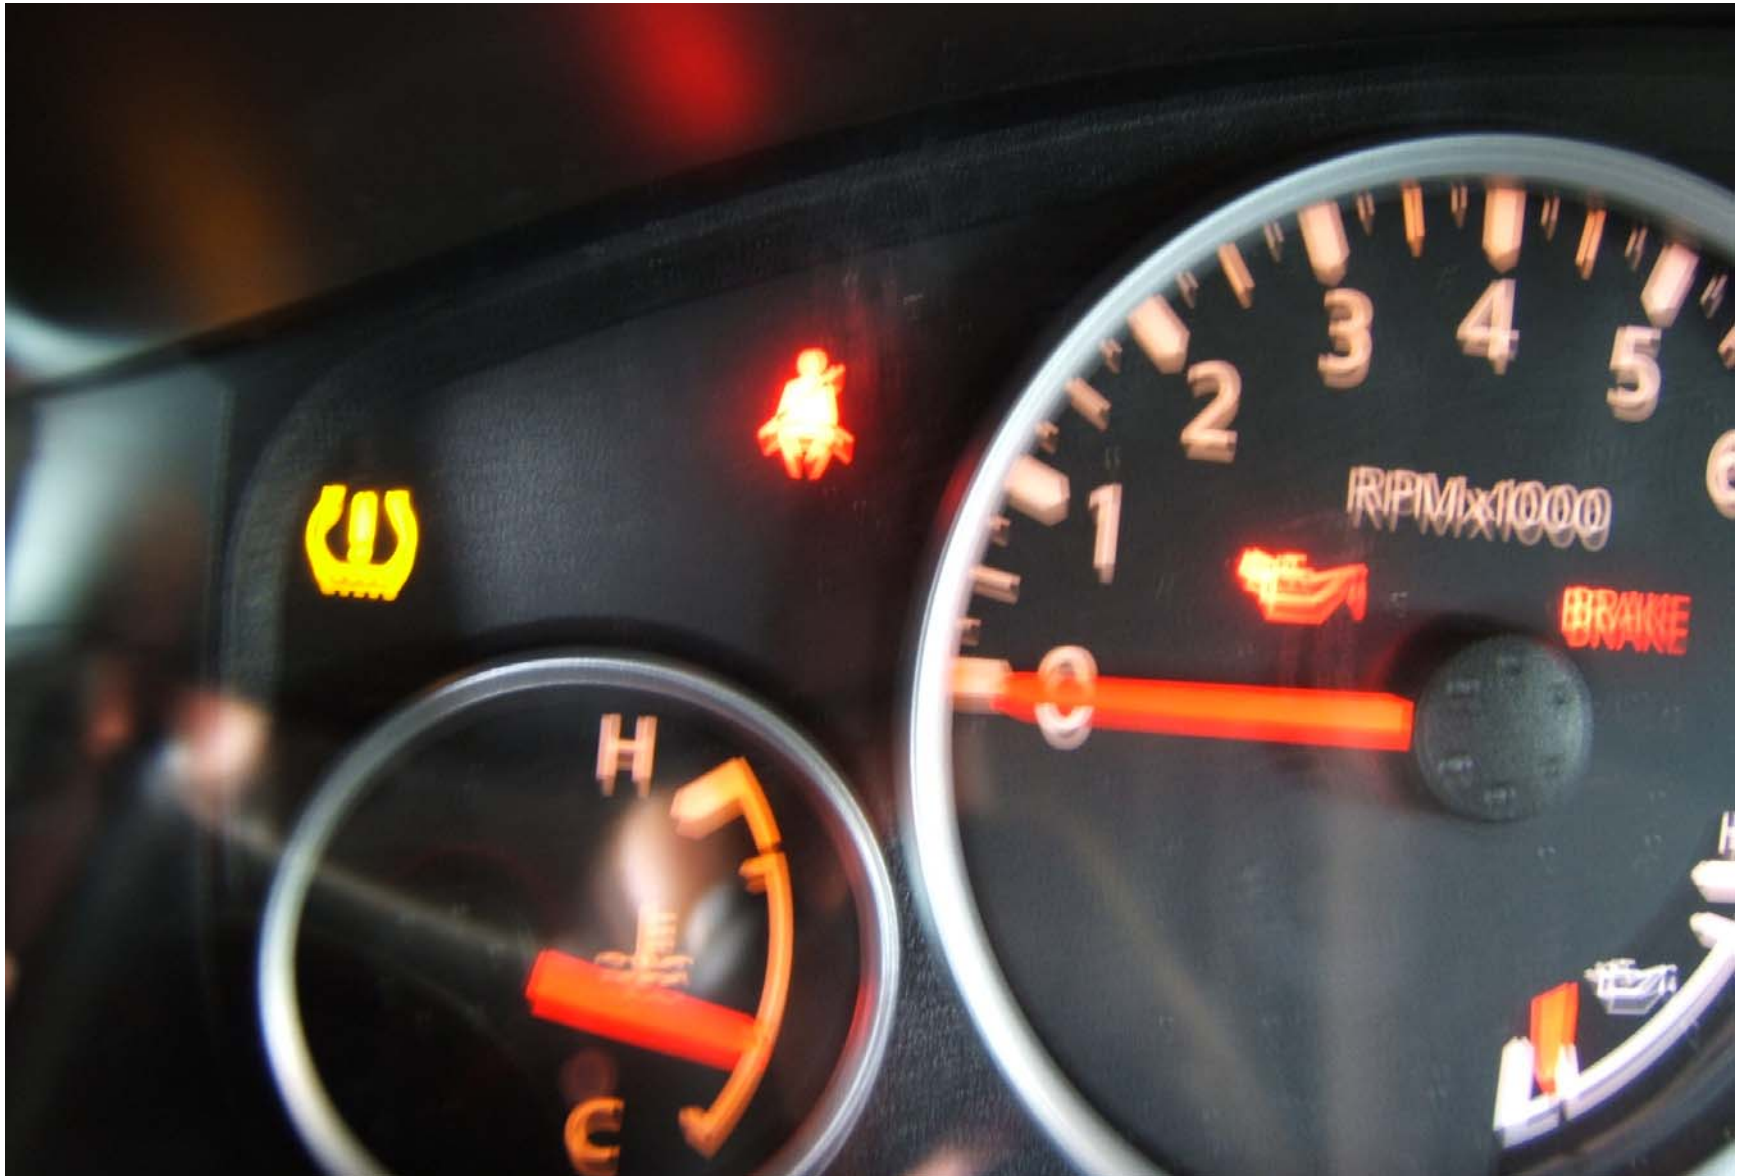
FIGURE 5.11  
INSTRUMENT PANEL SHOWING COMBINATION LOW TIRE  
PRESSURE WARNING AND MALFUNCTION TELLTALE

<b>REQUIREMENTS</b>	<b>PASS/FAIL</b>
<b>LOW TIRE PRESSURE WARNING TELLTALE</b> S138: S4.3.1 (a), (b); S4.3.3 (a), (b)	
Mounting	PASS
Symbol and color	PASS
Check of lamp function	PASS
<b>MALFUNCTION TELLTALE</b> S138: S4.4 (b) or (c)	
Mounting	N/A
Symbol and color	N/A
Check of lamp function	N/A
<b>LOW TIRE PRESSURE WARNING - OPERATIONAL PERFORMANCE</b> S138: S4.2, S4.3.1 (c), S4.3.2	
Telltale illumination	PASS
<b>MALFUNCTION INDICATOR – OPERATIONAL PERFORMANCE</b> S138: S4.4 (a)	
Telltale illumination	INDICANT TEST ONLY
<b>TPMS WRITTEN INSTRUCTIONS</b> S138: S4.5	
Image of telltales	PASS
Verbatim statements	N/A

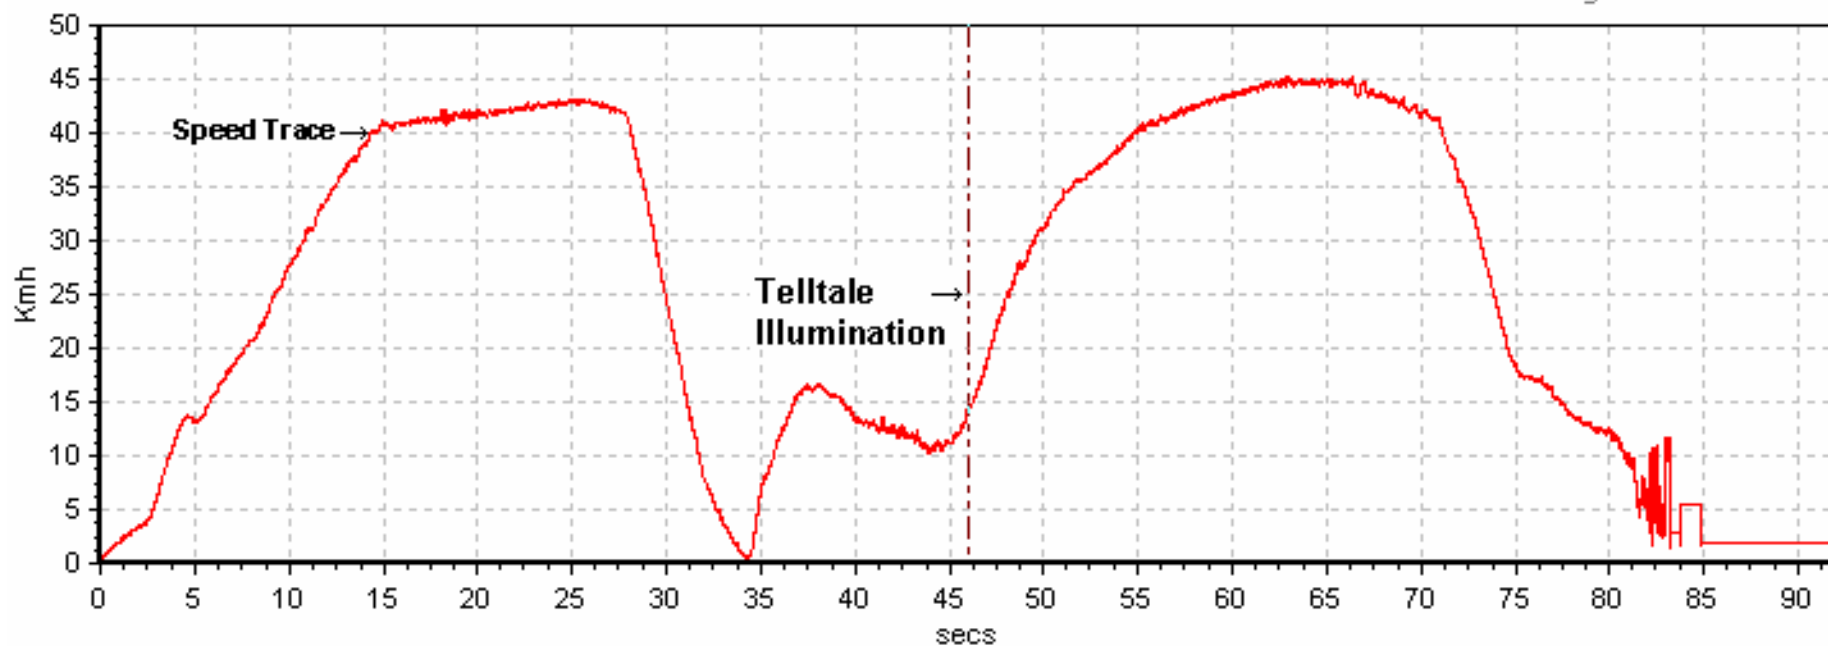
2006 Nissan Pathfinder (C65200) LR Telltale Illumination / GWR

Scenario B: Left Rear Tire  
Test Date: 8/30/06  
Data File Time: 1:32 minutes  
Illumination: 46 seconds  
Start Point: SATF shop

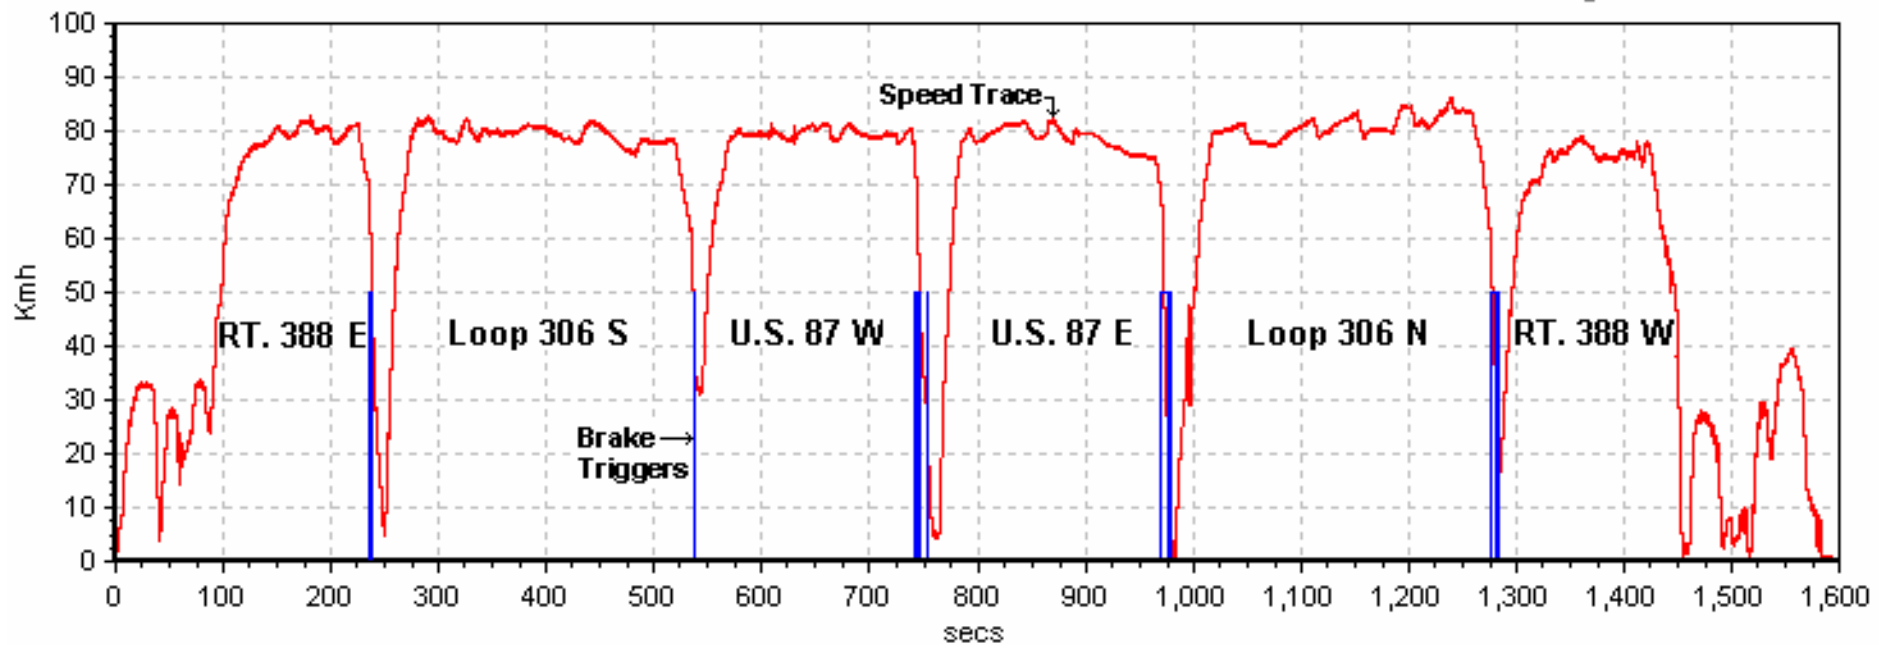
2006 Nissan Pathfinder (C65200) RR Calibration / LLVW

Scenario D: Right Rear Tire  
Test Date: 8/31/06  
Data File Time: 26:33 minutes  
Cumulative Driving Time: 20:32 minutes  
Start Point: SATF shop

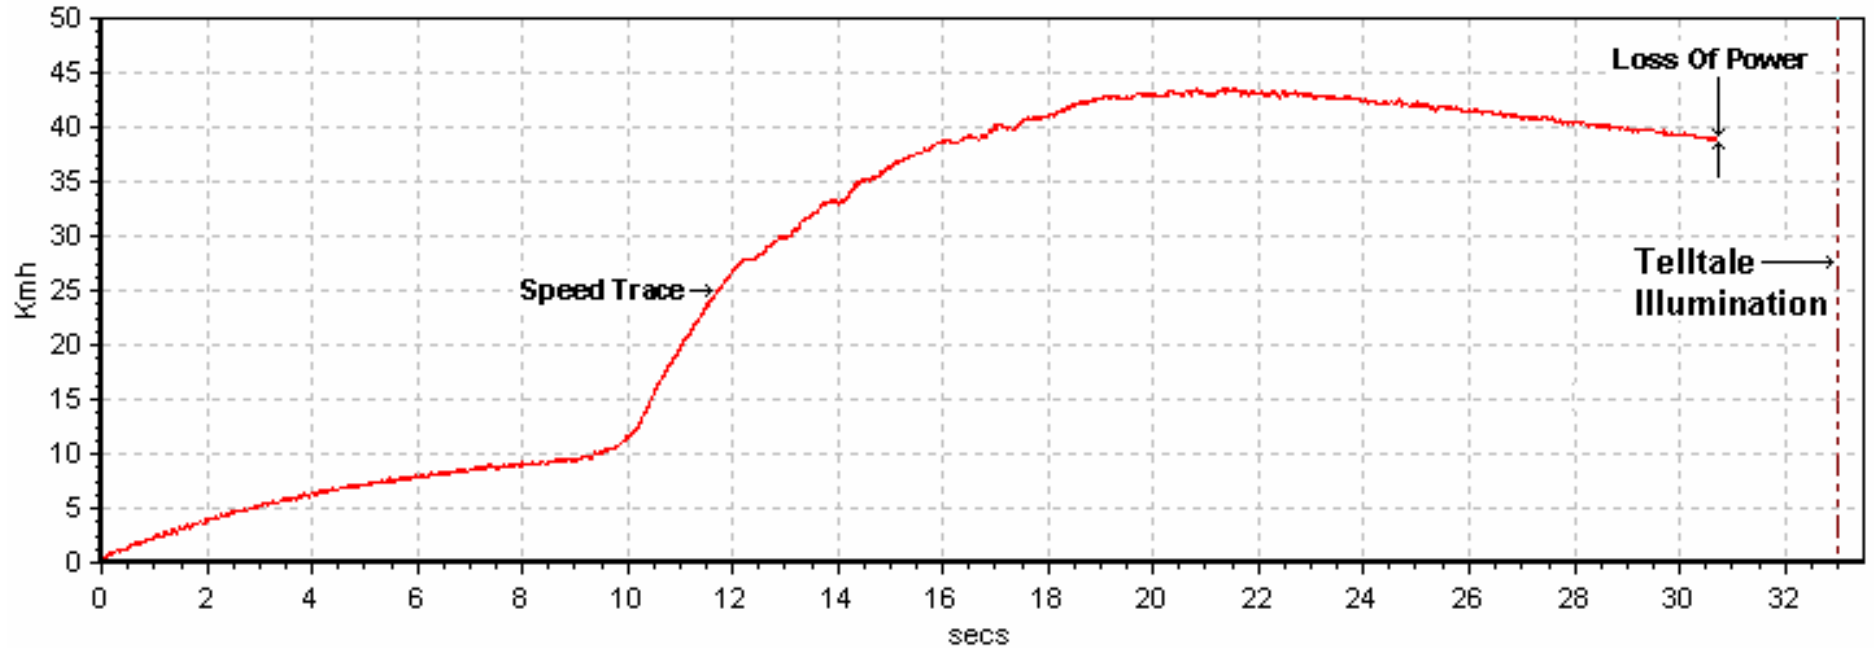
2006 Nissan Pathfinder (C65200) RR Telltale Illumination / LLWW

Scenario D: Right Rear Tire  
Test Date: 8/31/06  
Data File Time: Chart incomplete due to loss of V-Box power  
Illumination: 33 seconds  
Start Point: SATF shop

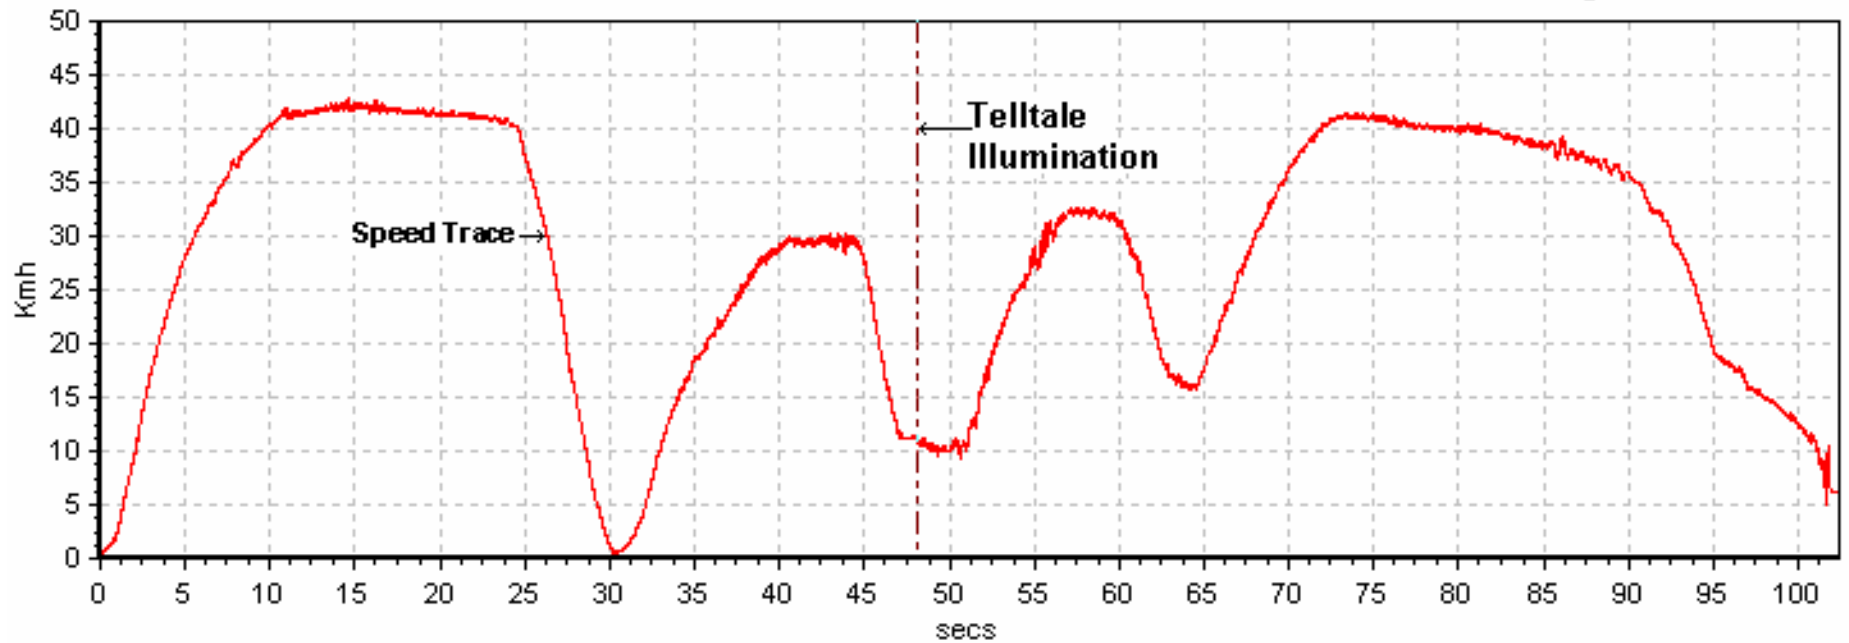
2006 Nissan Pathfinder (C65200) LF, LR Telltale Illumination / LLWW

Scenario E: Left Front, Left Rear Tires  
Test Date: 8/31/06  
Data File Time: 1:42 minutes  
Illumination: 48 seconds  
Start Point: SATF shop

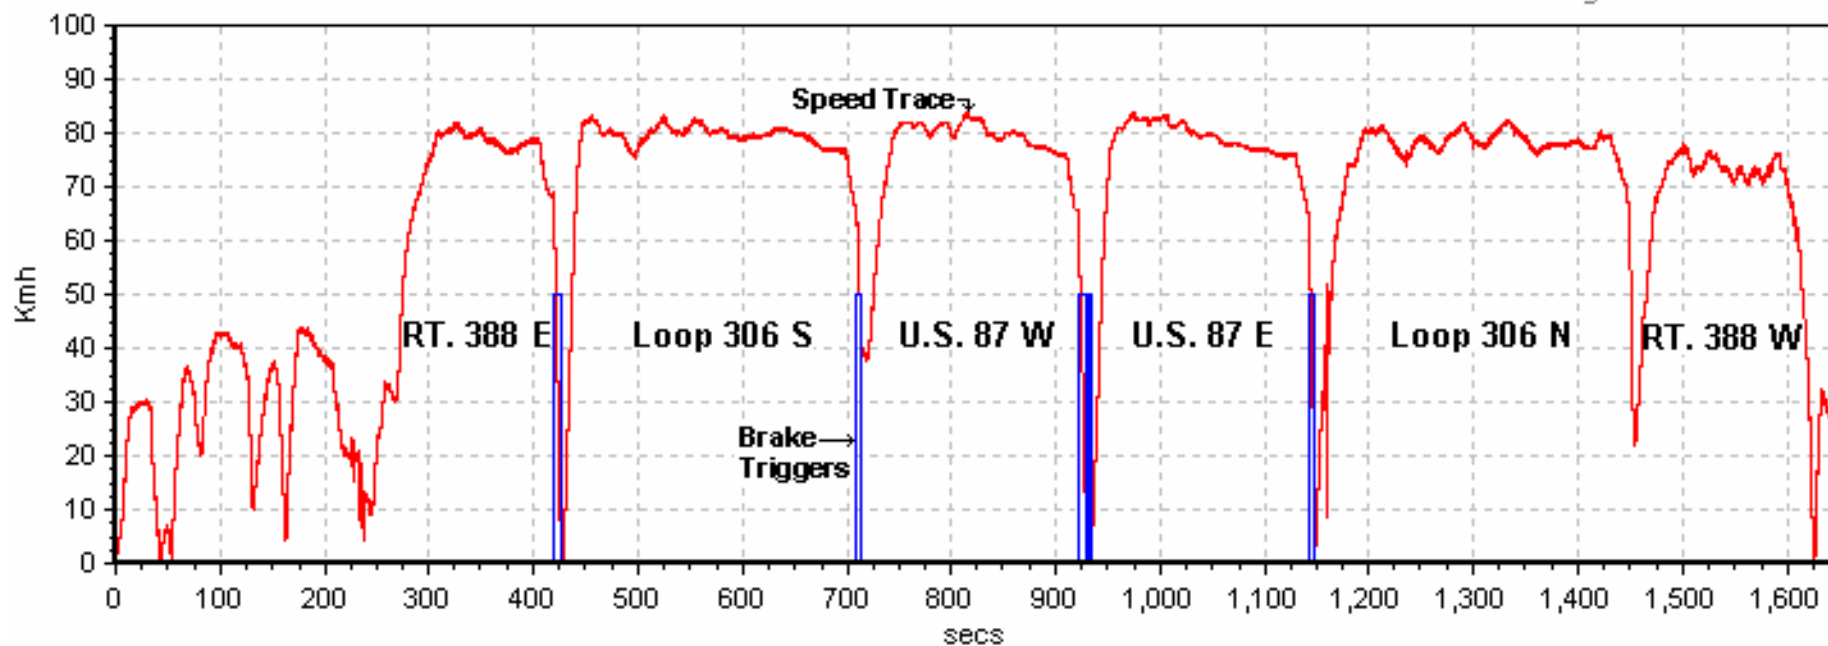
2006 Nissan Pathfinder (C65200) LF Calibration / GWWR

Scenario G: Left Front Tire  
Test Date: 9/1/06  
Data File Time: 30:42 minutes  
Cumulative Driving Time: 20:46 minutes  
Start Point: SATF shop

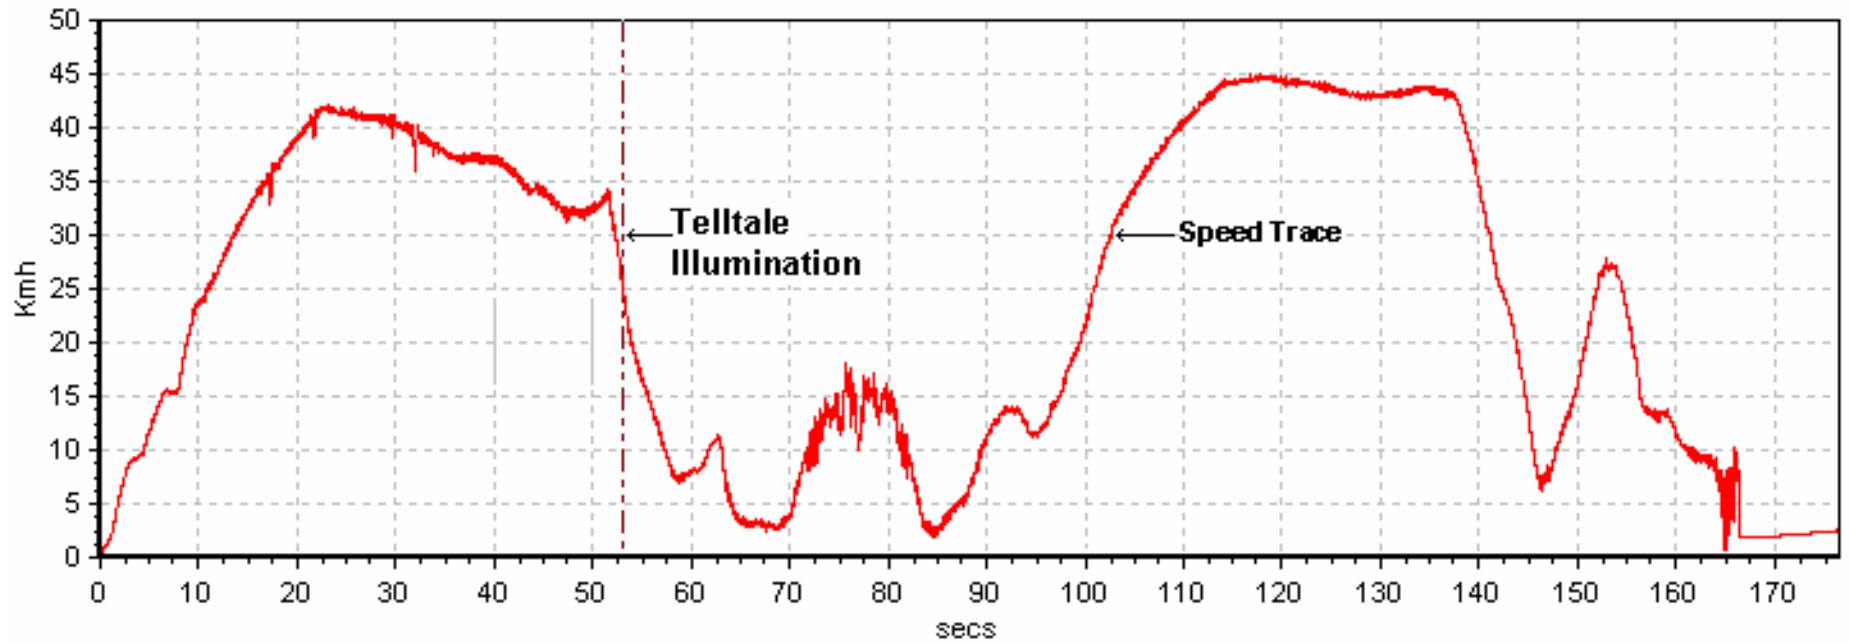
2006 Nissan Pathfinder (C65200) LF Telltale Illumination / GWWR

Scenario G: Left Front Tire  
Test Date: 9/1/06  
Data File Time: 2:57 minutes  
Illumination: 53 seconds  
Start Point: SATF shop

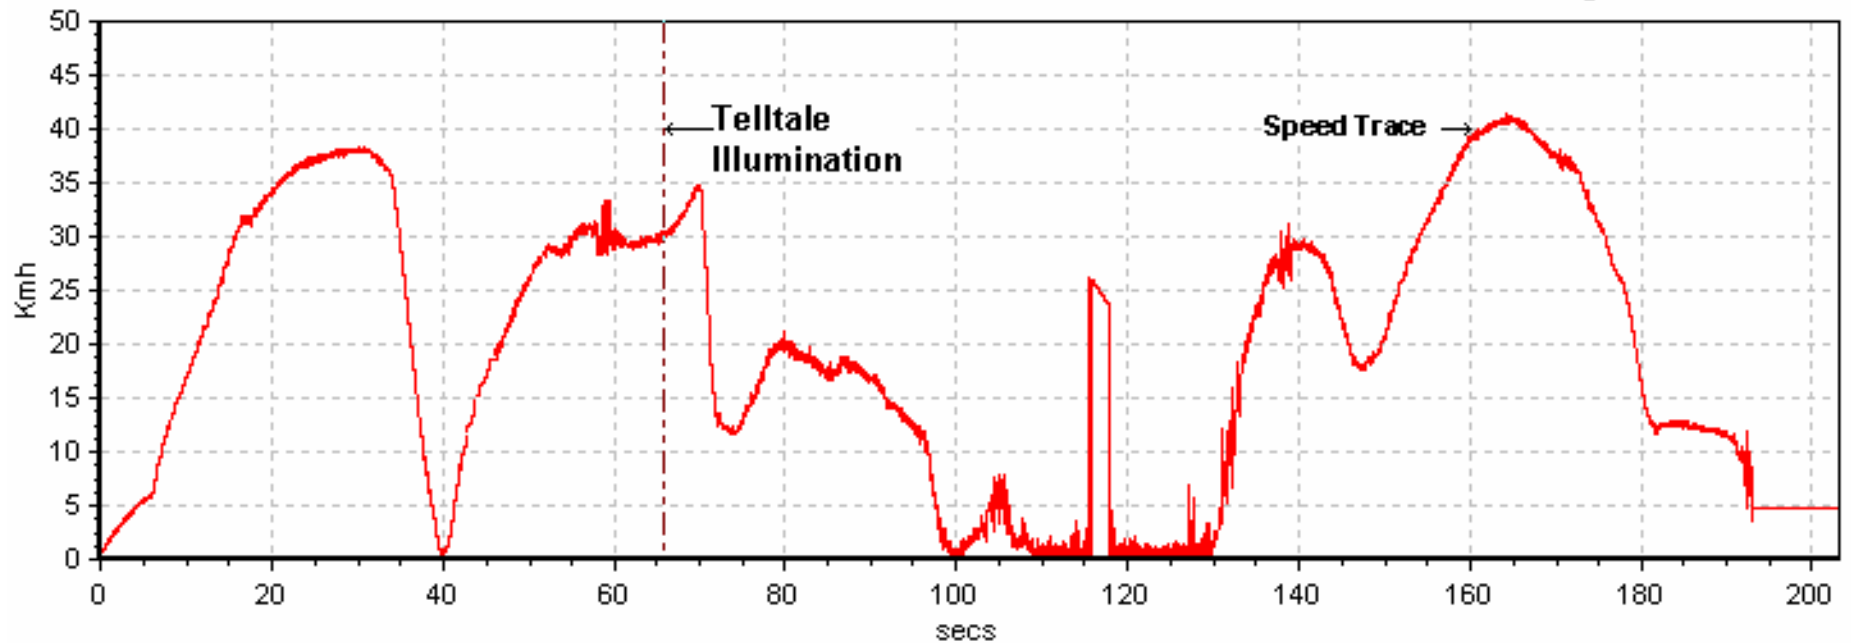
2006 Nissan Pathfinder (C65200) LF, RF Telltale Illumination / GWR

Scenario I: Left Front, Right Front Tires  
Test Date: 9/5/06  
Data File Time: 3:23 minutes  
Illumination: 1:06 minutes  
Start Point: SATF shop

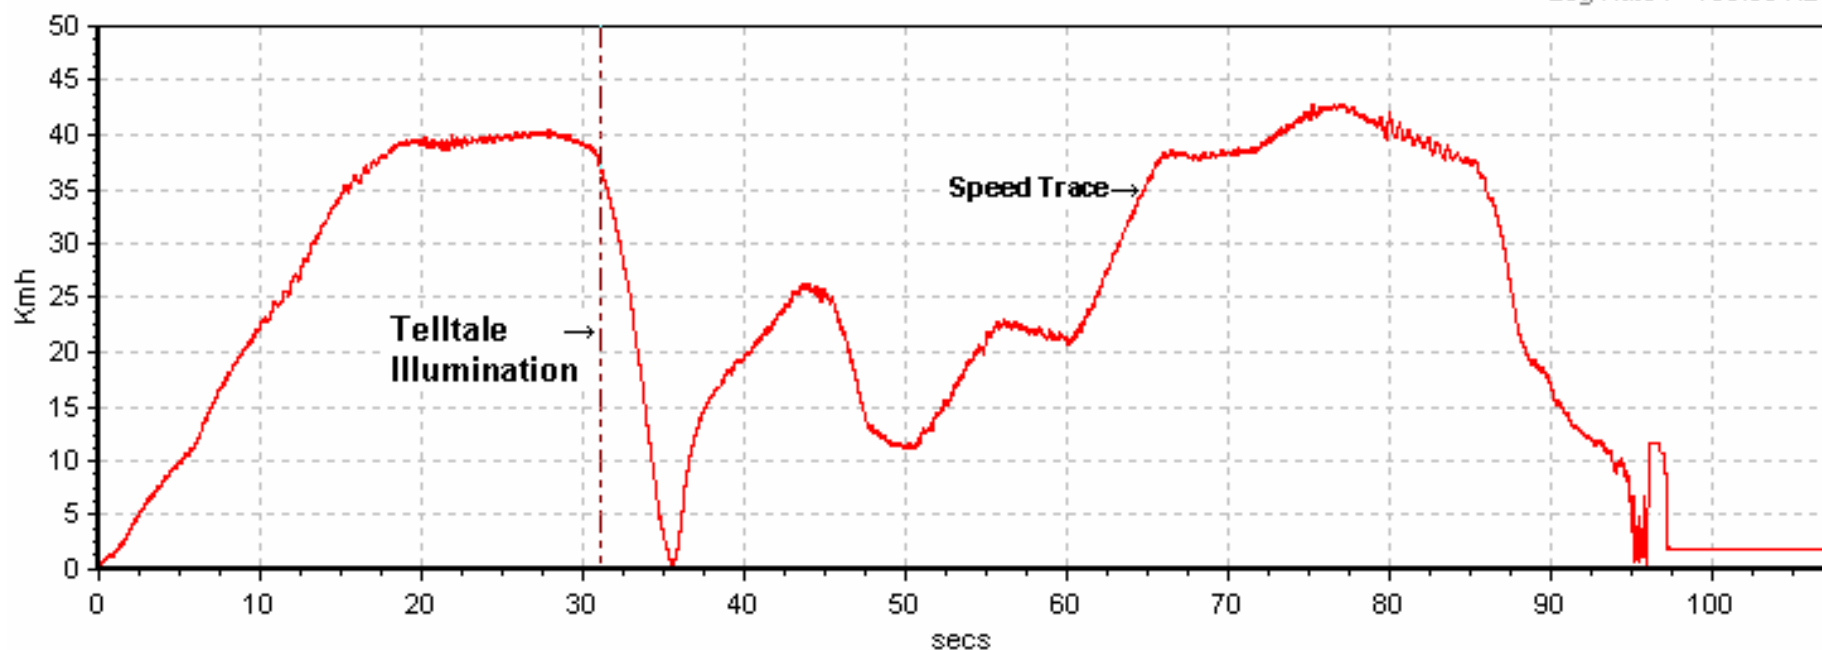
2006 Nissan Pathfinder (C65200) LF, LR, RR, RF Telltale Illumination / GWR

Scenario J: Left Front, Left Rear, Right Rear, Right Front Tires  
Test Date: 9/5/06  
Data File Time: 1:47 minutes  
Illumination: 31 seconds  
Start Point: SATF shop

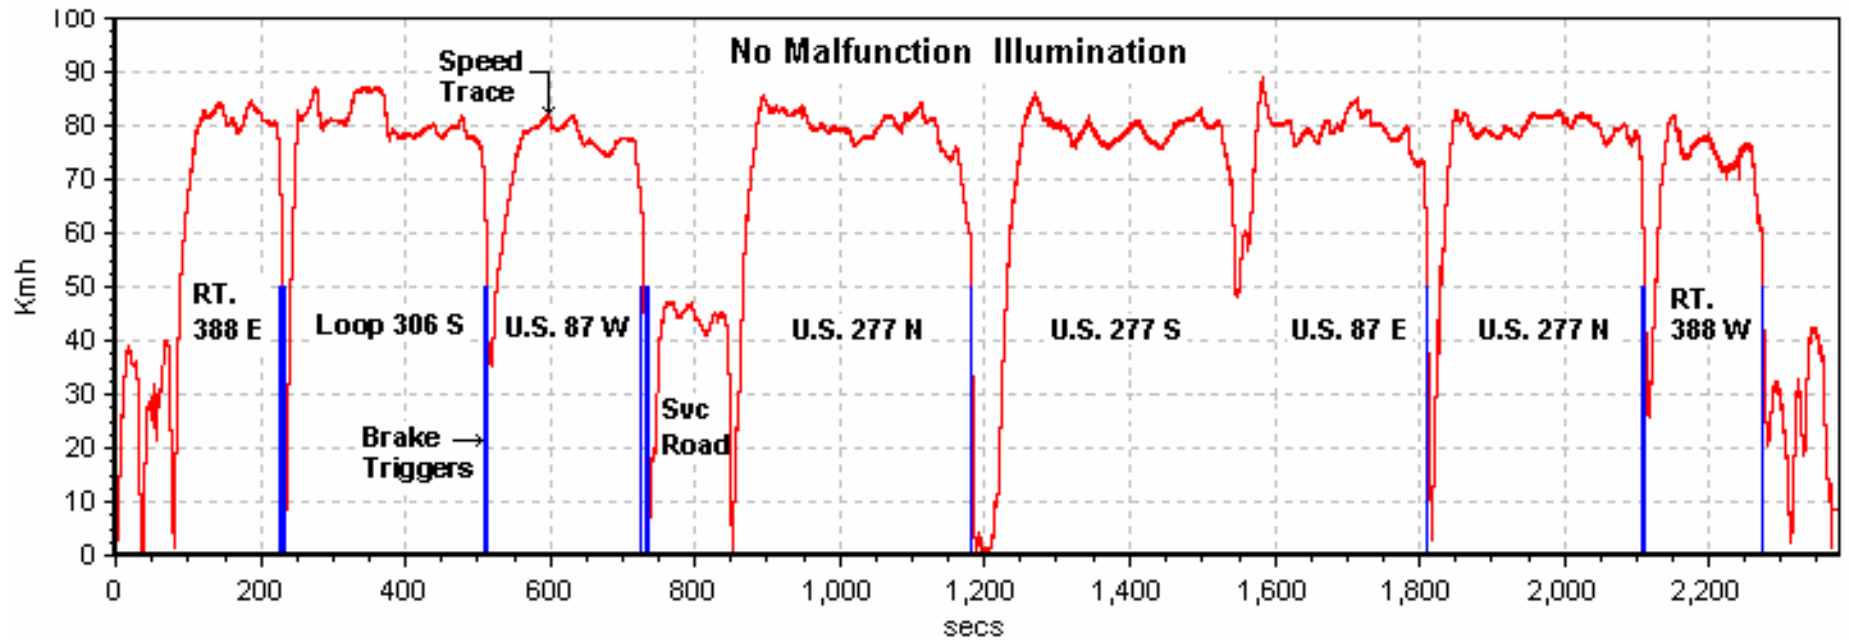
2006 Nissan Pathfinder (C65200) LR Spare Tire / Combination Low Tire / Malfunction Telltale Illumination / GWR

Scenario K: Spare without Sensor Installed on Left Rear  
Test Date: 9/5/06  
Data File Time: 39:40 minutes  
Illumination: NONE  
Start Point: SATF shop
