**SAFETY COMPLIANCE TESTING FOR FMVSS 201
Occupant Protection In Interior Impact
Upper Interior Head Impact Protection**

**NISSAN MOTOR CO., LTD.
2007 Nissan Altima, 4-Door Sedan
NHTSA No. C75202**

**MGA RESEARCH CORPORATION
446 Executive Drive
Troy, Michigan 48083**

1. Report No. 201UI-MGA-07-01		2. Government Accession No.		3. Recipient's Catalog No.	
4. Title and Subtitle Final Report of FMVSS 201 Compliance Testing of a 2007 Nissan Altima, 4-Door Sedan, NHTSA No. C75202				5. Report Date August 13, 2007

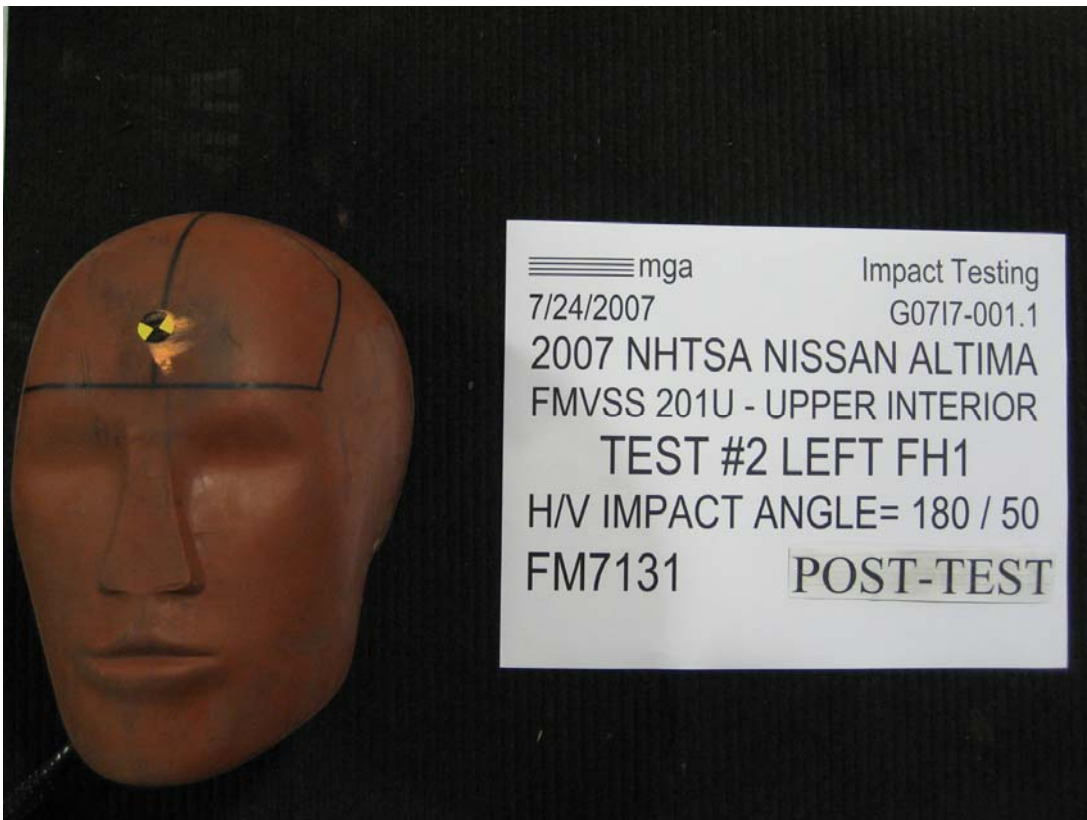
mga
7/24/2007
2007 NHTSA NISSAN ALTIMA
FMVSS 201U - UPPER INTERIOR
TEST #2 LEFT FH1
H/V IMPACT ANGLE= 180 / 50
FM7131
POST-TEST

No visible damage.

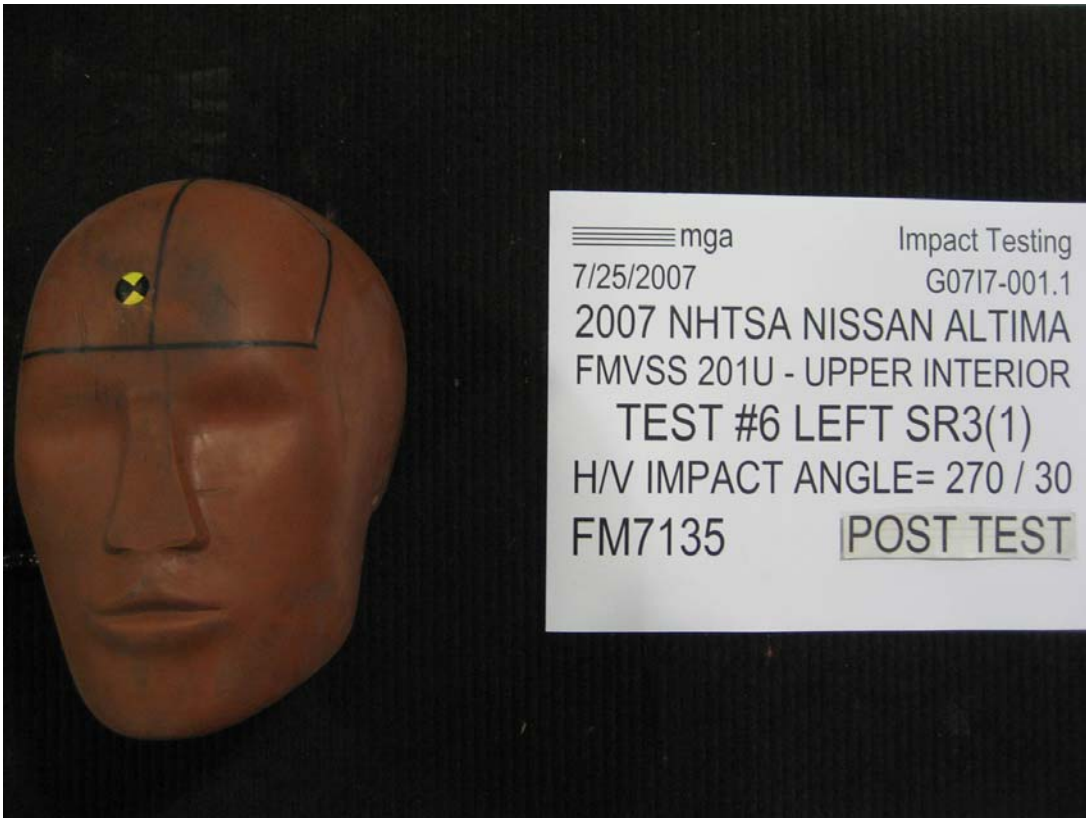
mga Impact Testing
7/25/2007 G0717-001.1
2007 NHTSA NISSAN ALTIMA
FMVSS 201U - UPPER INTERIOR
TEST #6 LEFT SR3(1)
H/V IMPACT ANGLE= 270 / 30
FM7135 POST TEST

No visible damage.
